SCHEURENBERG, R. J.

Watermeyer Legge Piesold and Uhlmann, Braamfontein, Republic of South Africa

Experiences in the Use of Geofabrics in Underdrainage of Residue Deposits**Experimentation dans l'usage de géotextiles pour le drainage sous les résidus**

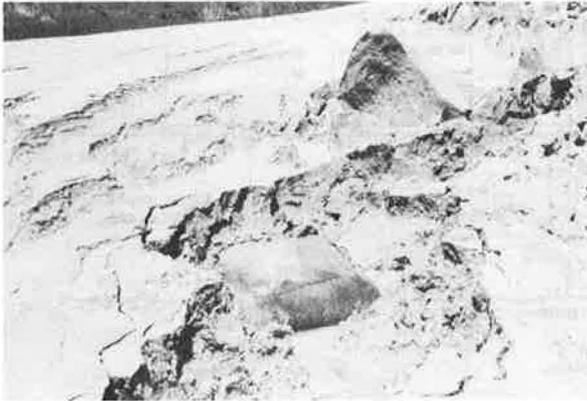
Photo 1 : ERGO Tailings dam - Exposed filter drain, no physical damage to fabric.

In one area where coarse slimes deposition had started only recently, the drain became exposed by flowing stormwater (Photos 1 and 2). In places, the fabric was torn by sharp aggregate particles carried by the water, but otherwise it was not damaged physically at this stage. However, where it had been exposed to air for any length of time, as illustrated in the lower part of Photo 2, it was discoloured and impermeable to water. Freshly exposed sections, such as in the upper part of Photo 2; were still permeable. Examination of the fabric showed that it was clogged with fine slimes particles held in place by an iron oxide precipitate.

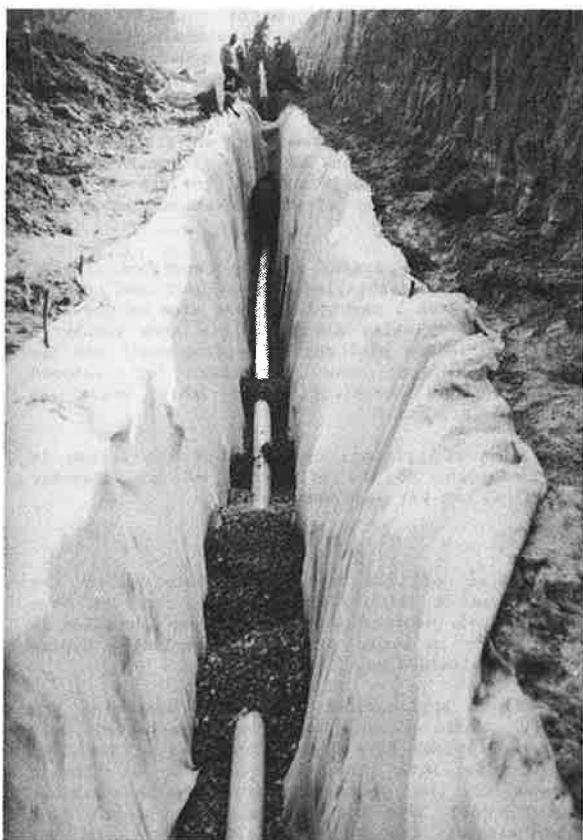
Photo 5 : Toe drain under construction - Fabric laid in excavated trench, slotted pipe inserted and stone filling started.

The drain was constructed by digging the trench from a working platform excavated into the face above the toe. A sheet of geofabric was inserted, the slotted pipe dropped in (Photo 5) and the trench filled with stone (Photo 6). Before the cut was backfilled with compacted slimes, the laminated filter drain was installed by simply pinning sheets of the material to the near vertical cut face (Photo 7).

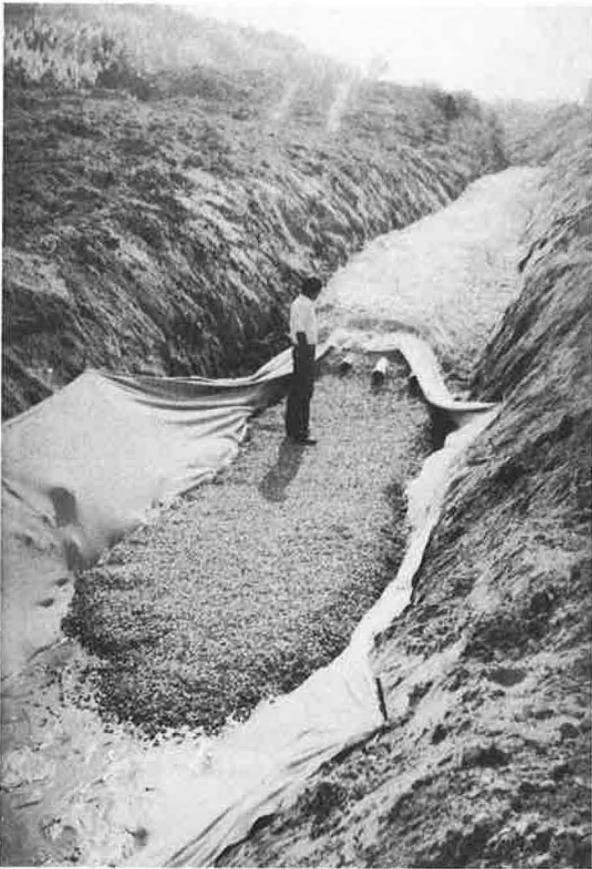
Photo 8 : Crown Sand Slimes Disposal - Filter drain under healing wall.

In addition to the drains already described, filter drains were also installed to collect and remove seepage water from a particularly wet area on the side of one of the existing dams. In this area washaways had occurred in the past and a "healing wall" was now built to complete the perimeter for renewed deposition. The construction of this drain is illustrated in Photo 8.
