Field tests on geocontainers

A. BEZUIJEN, R.R. SCHRIJVER, GeoDelft, Delft, The Netherlands
 M. KLEIN BRETELER, Delft Hydraulics, Delft, The Netherlands
 E. BERENDSEN, K.W. PILARCZYK, Dutch Ministry of Transport & Public works, The Netherlands

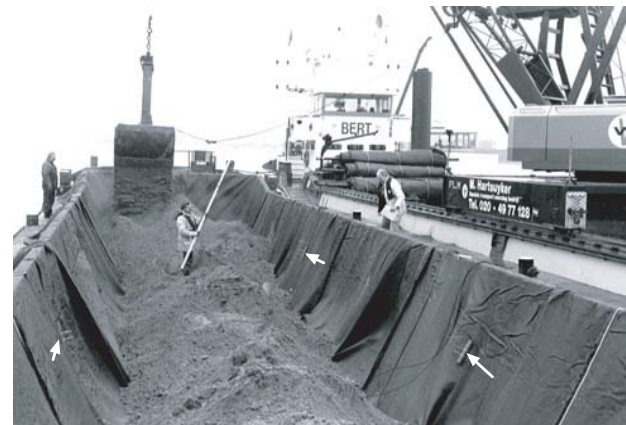
Figure 5. Overview split barge during installation of instrumentation. The arrows indicate the positions of the already installed strain gauges.

Figure 5 shows the geocontainer in the split barge during filling and mounting of the instrumentation. Figure 6 shows the geocontainer as it disappears through the opening of the split barge. The cable that connects the instrumentation to the computer can be seen on the left hand side of the barge. The container dumping started rather flat. As can be seen on the figure, the bow end fell a bit earlier than the rear side from with the picture was taken, but the difference was only small (approximately 0.5 s).

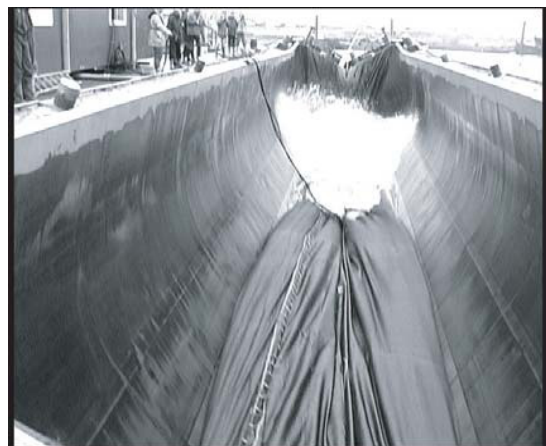
Figure 6. Geocontainer at the moment of dumping.

The 2nd container started level, see also Figure 6, but during the fall it fell more and more on an angle, up to 93.5 s, after that it got a more level position. It never reached the angles measured during the dumping of the first container. It is possible that between 93.5 and 94 s one side of the container hit the bottom (it should be realized that the ends of the container were at -15 and 15 m in the coordinates of the x-axis from Figure 7). If that is the case, it is realistic to assume that the pressures measured at 94.5 and 95 s are not very suitable as depth measurement, because of dynamic effects. It seems however, if the container rotates back to end up in a level position at $t=99$ s.

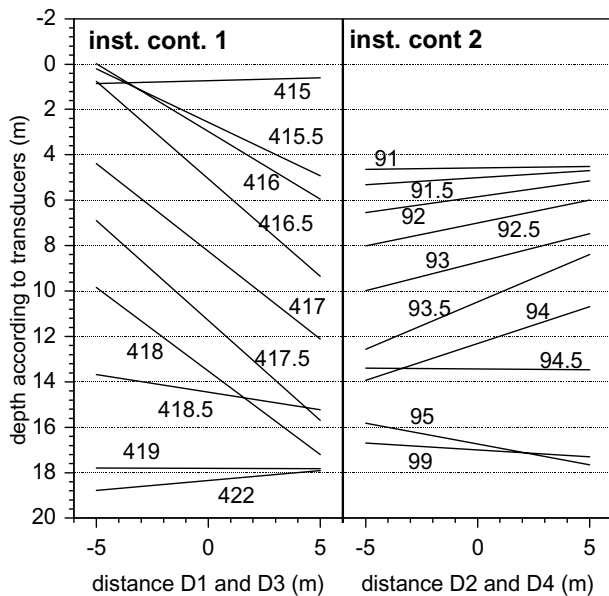
Figure 7. Depth recorded with pressure transducers at different times for both instrumented containers. Transducer located at 1/3 and 2/3 of the length of the container (transducers on top of container for instrumented container 1 and on the bottom for container 2, see also text).

The first container did not fall level from the split barge. This is demonstrated in the left plot of Figure 7. Pressure gauges were mounted at the same position in this test compared with last test, see Figure 3. In this figure the horizontal and vertical axis are plotted on the same scale. The figure shows the pressures measured with D1 and D3 at different times. The angle in the plot is the real angle the container fell between D1 and D3. The actual length of the geocontainer is approximately 3 times more, but as can be seen from Figure 3 there were no pressure gauges outside D1 and D3, thus the movement of those parts is not recorded. It is clear from the plot that the maximum angle is nearly 45 degrees. The angle only decreases when the container hits the bottom.

The right part of Figure 7 shows the falling of the second container. In this case the depth pressure gauges underneath the container D2 and D4 have been used, because the gauges on the top were located in unsaturated sand and the results were not suitable to determine the depth. This is of course a general shortcoming of using measured pressures to determine depth. The water movement around the container also influences the measured pressures as well as the impact forces, especially for the gauges underneath the container. In Figure 7 the peak pressures measured during impact are omitted, and the results as presented in that figure seems reasonable for both containers.
