# Geogrid - reinforced embankments for landslides stabilization and failures rehabilitation

Kollios, A. & Migirou, M.  
*Edafomichaniki S.A., Athens, Greece*

**ABSTRACT:** In the context of construction of a new municipal road 3.5 kms long, serving the new dam of Aposelemis in the island of Crete, Greece, various failures of certain major cuts at 8 locations were observed, one year after initial alignment excavations. Those cuts were excavated in a phyllitic formation at steep inclinations of 63°-72° approximately, because of actual expropriations restrictions at the area, not allowing for smoother slopes, as geotechnically indicated. Because of the necessary imminent provision of the road to circulation, the implementation of additional major retaining structures was not possible (pile - walls with prestressed anchors) for failures rehabilitation, therefore a system of counter - weight embankments at the toe of each failed cut was proposed and designed. These stabilizing embankments were reinforced by geogrids with the wrap-around facing system to provide a steep external slope of 55°- 63° (depending on the local space availability). Polyester geogrids of a nominal tensile stren

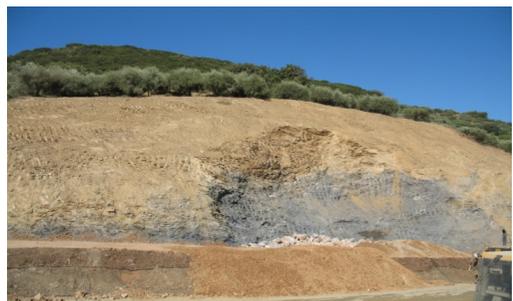
Figure 1 : Observed failures

During the construction period of the new municipal road (spring 2008) accessing the Aposelemis Dam in the island of Crete, Greece, various failures were observed at 8 locations of cuts earthworks along the 3.5 km of the alignment. Those cuts were initially excavated according to the general guidelines as provided by a rough geological design and preliminary stability assessment (December 2006). The excavation slopes were generally steep (2:1, v:h, 63°), performed within a phyllitic rock that locally presented pockets and lenses of poorer layers, disintegrated into sand-gravel. The initial geotechnical observations indicated mainly superficial and shallow, circular-like type, time-progressive defoliations and failures, whenever schistosity was favorable to the slope, locally originated by the presence of sub-vertical tension cracks.

These local failures generally extended up to the foot of the excavated cuts, therefore the risk of generalised failure was imminent, if no stabilization measures were to be provided.

The typical failure mechanism depicted in the majority of the failed cuts involves initially a wedge-type small scale failure within the unfavorable combination of critical discontinuity planes on the surface of the excavated slope and sub vertical tension cracks that progressively extend to create a potential circular-like failure of the whole slope.
