# Geogrid-reinforced structures in China subjected to seismic events

Keywords: geogrids, reinforcement, earthquake, seismic, slope, wall, highest, China

**ABSTRACT:** In recent years the use of HDPE geogrids for soil reinforcement has become widely accepted in China as high quality products made locally have become available. As a result, a number of significant geogrid-reinforced structures were built in the country in the period 2004-2008. Many of these are in mountainous regions in the South-West of China as part of the national infra-structure and hydro-power development programmes. Then, in 2008, between May and October, this region experienced a series of earthquakes ranging up to 8.0 on the Richter scale. This paper describes 5 geogrid-reinforced projects that were subject to seismic accelerations during these earthquakes: 2 projects with walls of heights 10.5 and 12 metres, and 3 projects with slopes of heights 26, 52 and 66 metres. All survived these seismic events undamaged.

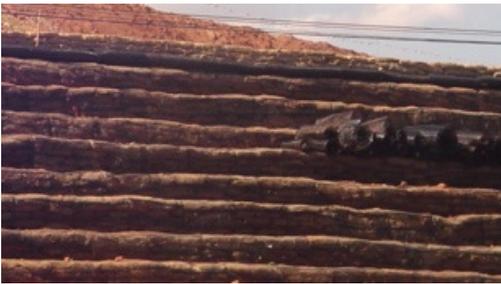
Figure 9: Chuxiong Transformer Station Slope: face detail

Each lift of the geogrid-reinforced slopes was built as a small step with the geogrid wrapped up around soil-filled sand-bags and bodkin-joined to the layer above to give continuity of face constraint as shown in Figures 7 & 9. Reinforced fill was primarily clay with  $\phi_{cv}=25^{\circ}$ .

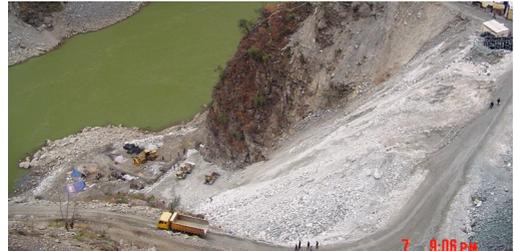
Figure 11: The start of construction of Mianshagou slope.

The start of construction of the slope in April 2005 is shown in Figure 11. The finished slope, completed in October 2005, is shown in Figure 12.

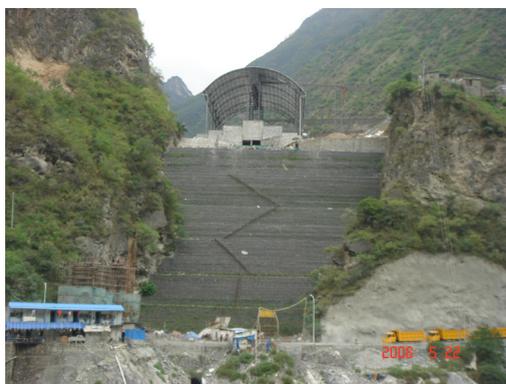
Figure 14: Jinping Yinbazigou Slope completed.

and was completed later that year as shown in Figure 14.
