## Geomembrane cutoff wall installation utilizing a narrow trench technique

**ABSTRACT:** This paper details the improved constructability of a groundwater cutoff wall system at a Contaminated site in Belgium. A high strength, flexible geomembrane was used in a bentonite-cement slurry trench in lieu of a thicker bentonite wall to contain contaminated groundwater and leachate. An additional bentonite-cement slurry wall, and geosynthetic cap were also used to provide secure drainage and groundwater flow characteristics. The selected geosynthetic-based containment alternative provided a more environmentally reliable solution and produced savings of over 2 million Euros. Post construction monitoring has confirmed project success.

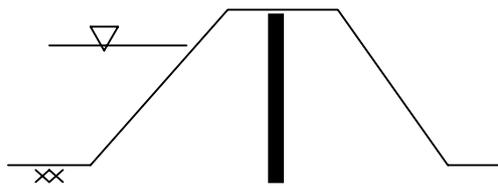
Figure 1. Typical Hydraulic Cutoff Wall Layout

In situ disposal of wastes often presents an economically viable long term option for waste management. Environmental effects are usually minimal and, in fact, may be less than “dig and dispose” methods. Cutoff walls have traditionally been used in water containment projects, where a cutoff wall serves as a waterproofing, or water barrier, feature. The wall contains the liquid inside some type of containment as shown in Figure 1. Similarly, in waste containment applications, the principal role of the cutoff wall is to prevent waste constituents from leaving a secure containment. The cutoff wall may also prevent intrusion into the waste containment area and, with additional drainage features, can be a dewatering or groundwater control structure. While cutoff walls along with any associated dewatering features are considered passive control techniques, they may incorporate some amount of active features, typically in the form of pumping of groundwater or leachate.

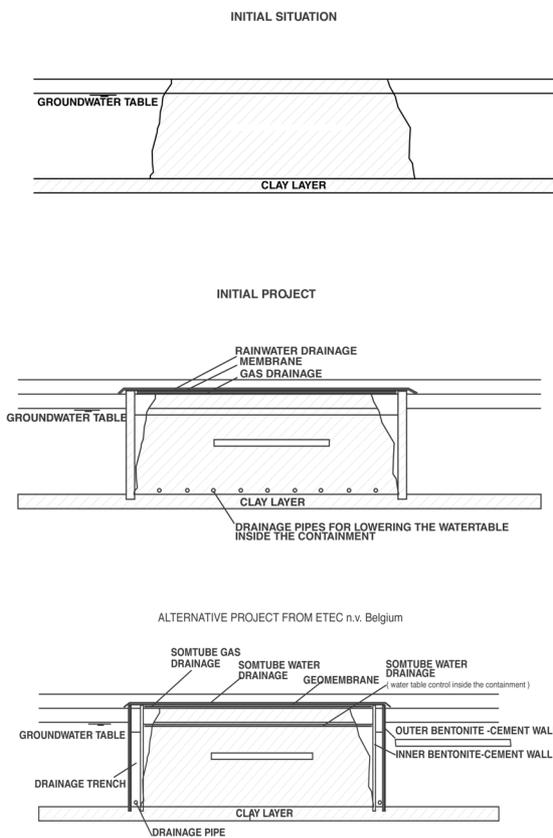
Figure 4. Containment Cross Sections

The proposed containment solution is illustrated as "Initial Project" in Figure 4. The 60-cm bentonite wall was to be

The ultimate site contractor, ETEC s.v. Antwerp, Belgium, proposed an alternate solution as shown on Figure 4, consisting of:

- Geomembrane Cap with water/gas drainage features, and
- 22-cm Bentonite-cement slurry/Geomembrane cutoff wall.

The geomembrane cap consisted of a water drainage pipe/geotextile system sandwiched between double geomembranes. This same pipe/geotextile system was placed over the fill, under the geomembranes for gas removal. One meter of backfill was placed over the top geomembrane to facility vegetation. Note on Figure 4 that an additional layer of pipe/geotextile is placed within the fill. Because of variability in the hydraulic conductivity within the fill, this drainage feature was used to ensure distribution of trapped water, preventing mounding.

A 22-cm bentonite-cement slurry wall was placed from the ground surface to the bottom clay layer. A geomembrane was inserted vertically in the center of the slurry. Construction of the wall is discussed later in this paper. The geomembrane was welded at the top to the lower geomembrane cap, creating and encapsulated fill. A finite element analysis revealed that the combination bentonite-cement/geomembrane wall provided a mean  $k$  value of  $10^{-12}$  cm/sec over the entire site wall.

Post construction water level monitoring showed increased water levels in the containment area. It was concluded that a natural breach existed in the bottom clay containment layer. The proposed solution consisted of a second, interior bentonite-cement slurry wall, with a drainage system between the two walls. This wall was estimated to have a mean  $k$  value of  $10^{-10}$  cm/sec, resulting in a net outflow to the drainage system.

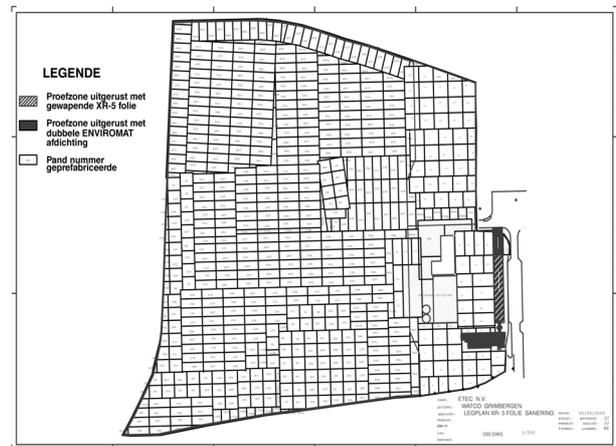
Figure 5. Geomembrane Cap Panel Layout

The capping and cutoff wall construction took place simultaneously. Prefabricated panels of geomembrane, up to 1400 square meters in size were deployed for the cover, in an ultimate layout as shown on Figure 5. Figure 5 delineates the experimental GCL area. Also, an additional geomembrane layer

was used under the soil treatment plant area per direction of OVAM. These panels were welded together using hot wedge equipment. Figure 6 illustrates cap construction and shows channel construction in the fill to facilitate gas/water drainage via the pipe/geotextile components.

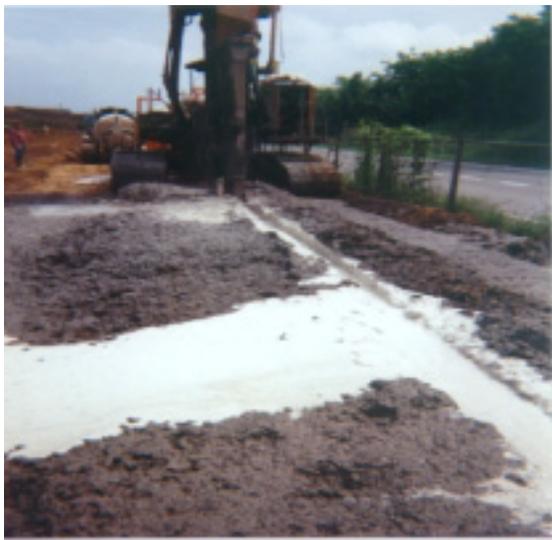
*Figure 7. Bentonite-Cement Wall Installation*

Figures 7 and 8 show the cutoff wall construction. A special trenching machine with a cutting saw on a gliding framework was used to install the bentonite-cement wall, without open excavation. The bentonite-cement was mixed at a plant on-site and the mixture included special additives to give improved plastic qualities. A second machine (Figures 9 and 10) was used to install the geomembrane. Attached to the leading edge of a knife-like instrument, the geomembrane was pulled into the slurry and then released using vibration combined with bentonite-cement slurry pressure from the center of the tool. The membrane was pressed into the bottom clay layer. These two

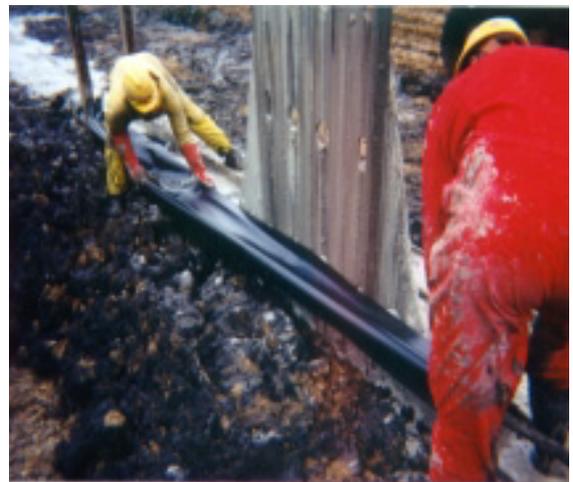
*Figure 9. Geomembrane Wall Installation*

machines were designed specifically for this project and represent an innovation in groundwater cutoff wall technology. The geomembrane was installed in sections 7m deep and 3m wide, and overlapped in the slurry 30 cm. The mean k value calculation included the torturous 52-cm hydraulic path through this overlap.
