Geosynthetic barriers systems for dams

Cazzuffi, D.

Giroud, J.P.

Scuero, A. & Vaschetti, G.

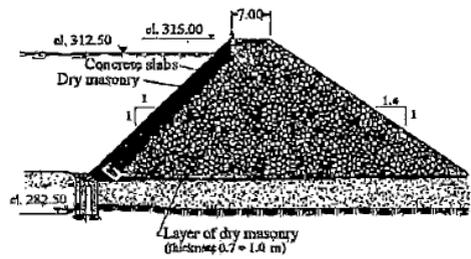
Figure 1. General cross section of Contrada Sabetta Dam (modified after Cazzuffi 1987 and ICOLD 1991).

- The geomembrane barrier was covered by unreinforced 2 m × 2 m concrete slabs, 0.20 m thick, cast on site. The joints between adjacent slabs were left open, 1 mm wide, and were not filled by any porous material, to allow for free circulation of water and to provide some flexibility in case of settlement. There was a sheet of bituminous paper-felt between the concrete slabs and the upper geomembrane layer to protect the geomembrane during the casting of the concrete slabs.

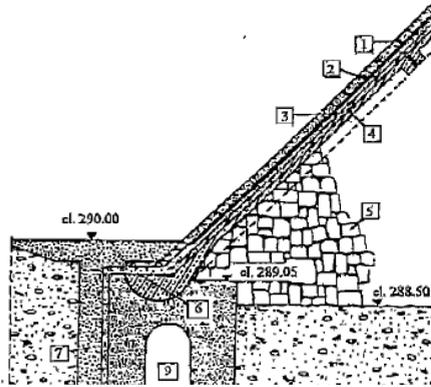
Figure 2. Detailed cross section of upstream toe of Contrada Sabetta Dam (modified after Cazzuffi 1987 and ICOLD 1991): [1] 0.20 m thick concrete slabs, [2] one sheet of bituminous paper-felt + two sheets of polyisobutylene geomembrane (2.0 mm thick) + bituminous adhesive, [3] porous concrete (0.10 m thick), [4] reinforced concrete slabs (0.25 m thick), [5] dry masonry (thickness ranging from 2.00 to 3.00 m), [6] joint between plinth and upstream facing, [7] plastic concrete diaphragm wall, [9] inspection and drainage gallery.

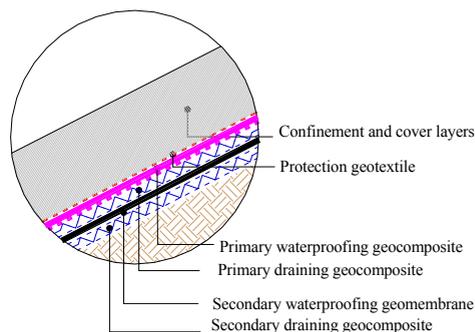
Figure 3. Cross section of the double geomembrane liner system on the slopes of Les Arcs Dam.

To decrease construction time (i.e. to ensure that the liner system could be constructed in the two months time allotted by extreme climatic conditions at the site even in summer) and to reduce costs, the waterproofing contractor proposed to modify the original design including two gravel drainage layers each 0.15 m thick, so as to adopt exclusively geosynthetic components. In total nine different types of geosynthetics are used in the liner system, either independently or in combination to form geocomposites. The cross section of the liner system used on the slopes is shown in Figure 3.

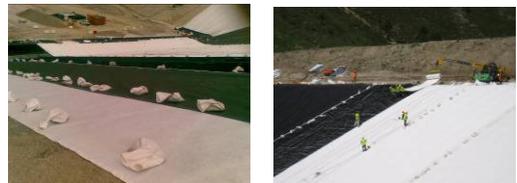
Figure 4. At left, soil subgrade, white secondary draining geocomposite, black VLDPE geomembrane, black primary draining geocomposite, and white PVC geomembrane. At right, the geomembrane being unrolled down the slope.

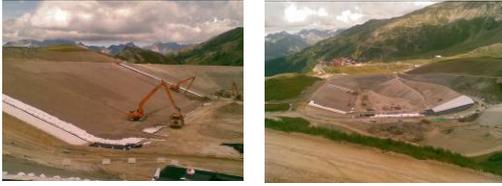
Figure 5. The cover layer placed on top of the geotextile at the right slope, and a general view of the site.

- To minimize outdoor exposure of the liner system materials, the cover layer (Figure 5) was placed immediately after placement of the various components of the liner system.

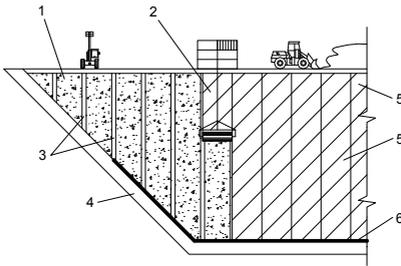
Figure 7. Placement and anchorage of geomembrane.

The sheets of composite geomembrane are unrolled downslope over the base layer, and anchored to the protruding portion of the anchor strips by heat welding (Figure 7). Adjacent composite geomembrane sheets are joined by watertight vertical welds, creating a continuous watertight liner over the entire upstream face of the dam.

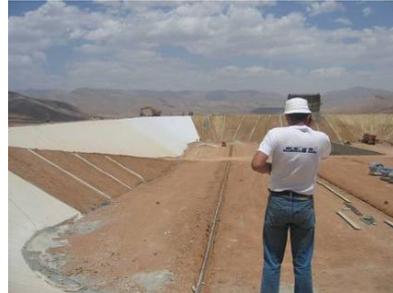
Figure 8. Kohrang Reservoir. The anchor strips embedded in the trenches of the dams, and the geomembrane anchored by welding to the strips on dams and bottom.

The exposed geomembrane liner was placed directly over the compacted fill that forms the 14 m high dams and the bottom, and the anchorage against uplift was provided by welding the geomembrane sheets to the anchor strips.

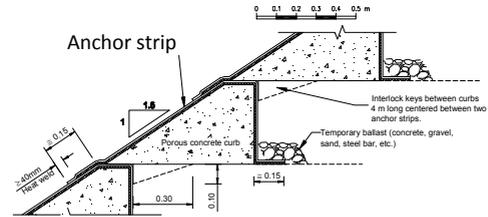
Figure 9. Extruded concrete curbs with one geomembrane anchor wing per curb.

The spacing of the anchor strips was calculated based on the uplift that would be caused by the wind load, using the methodology developed by Giroud and mentioned in Sections 3.3.1 and 3.3.2. The calculated spacing of the strips was 6 m.

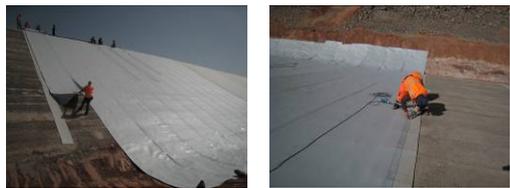
Figure 10. Sar Cheshmeh, Iran 2008. Placement of composite geomembrane sheets and welding to the anchor strips.

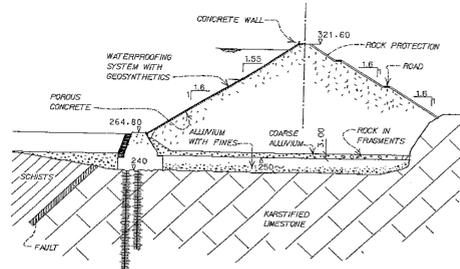
Figure 12. Main cross section at Bovilla Dam.

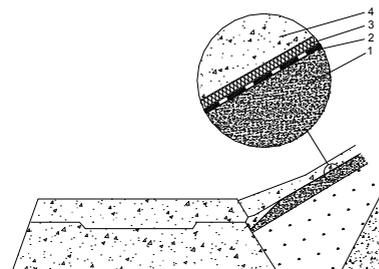
1. Gravel stabilized with cement slurry
2. Geomembrane
3. Anti-puncture PP geotextile, 800 g/m²
4. Unreinforced concrete slab

Figure 13. Bovilla Dam facing system.

The geomembrane was covered with unreinforced concrete slabs that were placed on an 800 g/m² geotextile (Figure 13). The slabs are 6 m long in the slope direction and 3 m horizontally. The slabs are 0.20 m thick except near the bottom where they are 0.3 m thick as they serve of buttress to the slabs. The geotextile had a double function: providing anti-puncture protection to the geomembrane against casting of the slabs, and act as a light reinforcement for the slabs themselves.

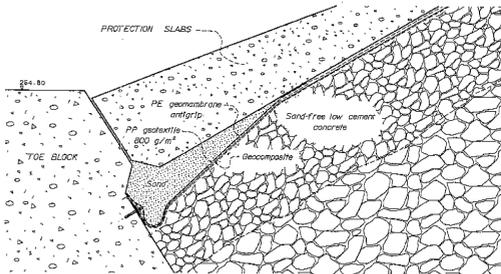
Figure 14. Bottom seal at Bovilla Dam.

At Bovilla Dam, the bottom seal of the geomembrane on the toe block was designed to be able to accept differential movements and settlements one order of magnitude larger than the estimated ones (Figure 14). Extra material and protection/decoupling layers were placed for this purpose over the geomembrane at the seal.

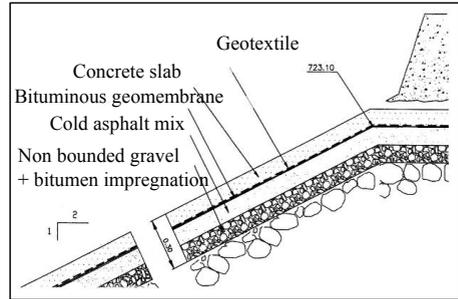
Figure 15. Typical cross section at La Galaube Dam (after Gautier, 2003).

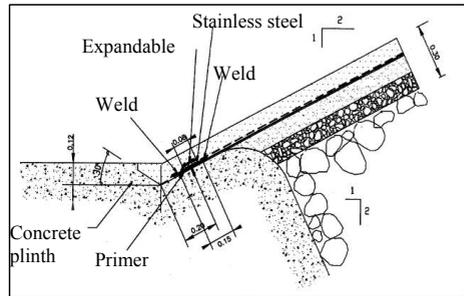
Figure 16. Typical cross section at La Galaube Dam (after Gautier, 2003).

The bottom anchorage (Figure 16) is made on the concrete plinth and is of the tie-down type (see Section 4.4.4). Installation of 22,000 m² of bituminous geomembrane was completed in 2000.

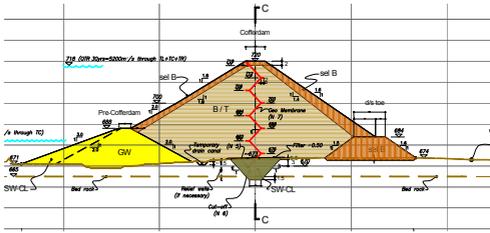
Figure 18. Typical cross section of Gibe III Cofferdam.

the downstream side with a height of 6 m. The next sections follow one upstream and one downstream and have each a constant height of 12 m.

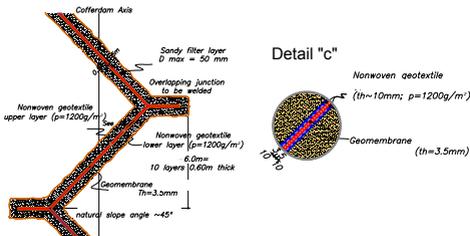
Figure 19. Detail of the impervious core of Gibe III Cofferdam.

In the flat area at the crest of each section, the geomembrane lining the lower section is overlapped by the geomembrane lining the section above it, for a width of about 2 m, where the two geomembranes are connected by a double track automatic seam. Quality control of the seams was done with air pressure test using the air channel between the two tracks of the seam.

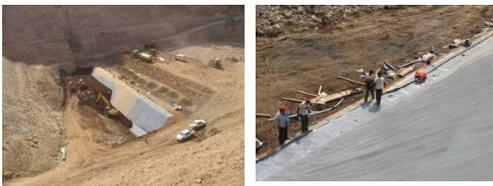
Figure 20. Gibe III Cofferdam. Placement of the geomembrane on the first section of the fill (left) and welding the geomembrane of the bottom section to the geomembrane of the upper section.

The execution of this horizontal longitudinal connection seam, parallel to the axis of the dam, is made at the same time of installation of the PVC geomembrane sheets over the inclined slope of the upper section (Figure 20). Before the execution of this seam the protection placed to avoid damages on the geomembrane is removed, the area is cleaned, the integrity of the geomembrane is checked and, if needed, damages are repaired.

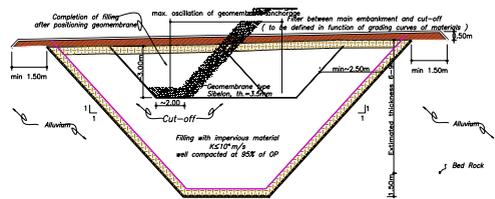
Figure 21. Gibe III Cofferdam. Anchorage of the impervious geomembrane core in the clay cut-off trench.

The anchorage at the bottom boundaries is made by embedding the geomembrane in the 6 to 8 m deep clay cut-off and by backfilling with the same clay (Figure 21). At the two abutments, due to the difficulty of excavating the cut-off with the same depth because of the presence of surfacing rocks in the river bed, the geometry was slightly modified during construction by adapting the thickness of the clay layer below and above the geomembrane.

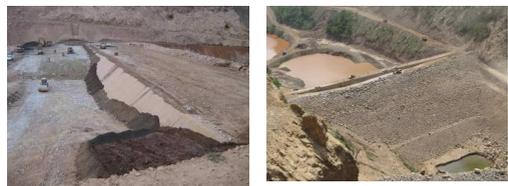
Figure 22. Gibe III Cofferdam. Placement and compaction of the fill for the fourth section of the cofferdam, and the 50 m high cofferdam nearing completion.

Top anchorage of the geomembrane is made with steel anchor and plates fixed to the reinforced concrete crest wall. Final stages of construction are shown in Figure 22.

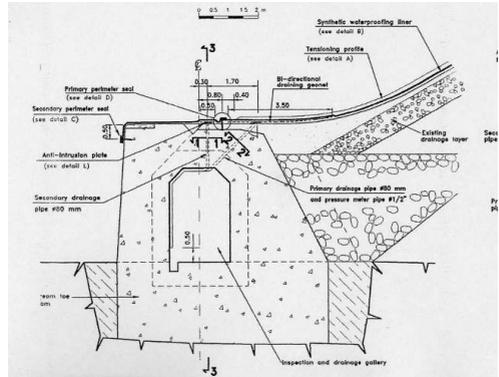
Figure 25. Moravka Bituminous Concrete Face Rockfill Dam, Czech Republic: the two bottom seals.

upstream face (geomembrane system); the secondary seal confines the drainage system for water coming from foundation/abutments/failing joints in the concrete. The two drainage systems discharge in the gallery with separate discharge pipes to allow monitoring the system (Figure 25).

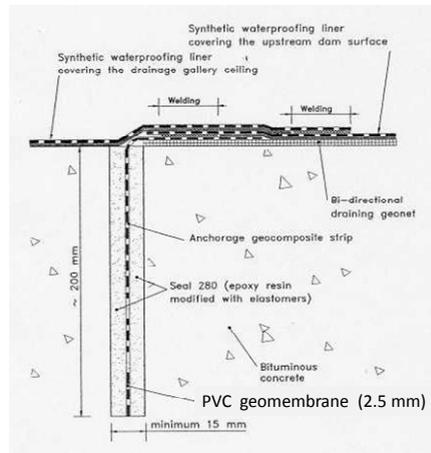
Figure 26. Moravka Dam: the insert type bottom seal on bituminous concrete

The secondary seal made on concrete is of the tie-down type (see Section 4.4.4). The primary seal made on bituminous concrete is of the insert type (Figure 26); the watertight resin making the seal allowed maintaining watertightness at the fissures intercepted by the seal.

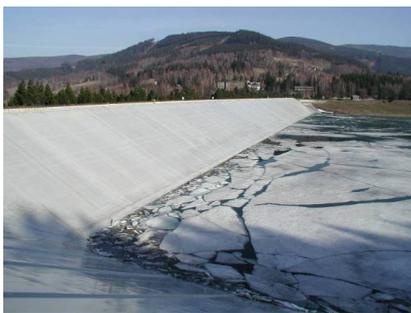
Figure 27. Moravka Dam: heavy ice impact did not damage the exposed PVC geomembrane.

The exposed geomembrane system was released in 2009 from the ten years warranty. The geomembrane has resisted ice impact (Figure 27).

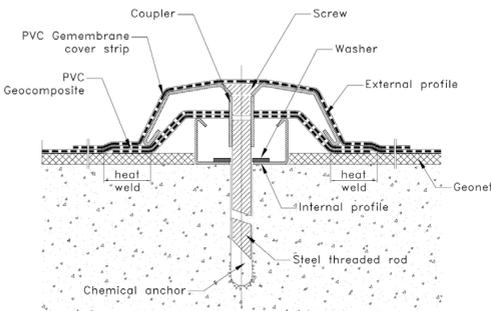
Figure 28. Cross section of the patented anchoring and tensioning system used for concrete dam rehabilitation.

In addition to anchoring and tensioning the composite geomembrane, the vertical profiles create vertical channels that contribute to the drainage capacity of the system (see Section 4.4.4).

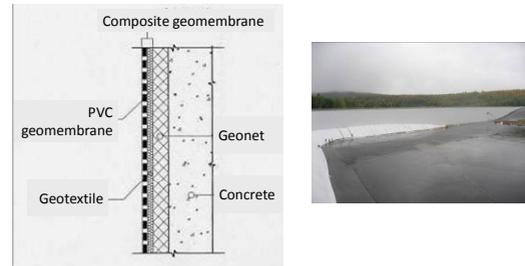
Figure 30. At Waldeck gravity dam in Germany, 2008, the composite geomembrane is placed on a drainage geonet.

When increased drainage capability is required, a drainage geonet is placed under the composite geomembrane. A cross section and a typical example are shown in Figure 30.

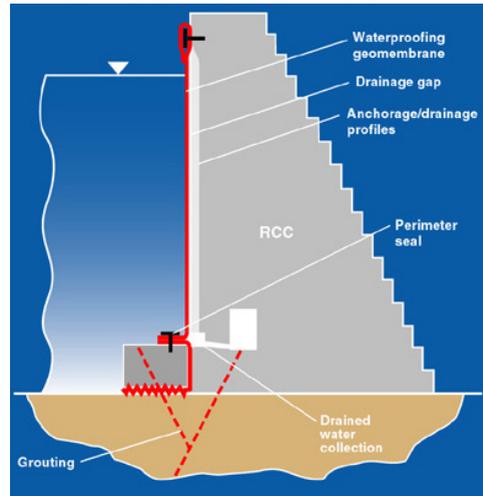
Figure 33. Concept of the exposed geomembrane system in RCC dams.

The composite geomembrane consists of a 2.5 mm or 3.0 mm thick high performance PVC geomembrane, laminated during manufacturing to a needle-punched nonwoven geotextile. The composite geomembrane is placed against the completed RCC lifts, covering the upstream face including all joints, from crest down to the heel. The composite geomembrane is fastened by a face anchorage system and by perimeter sealing.

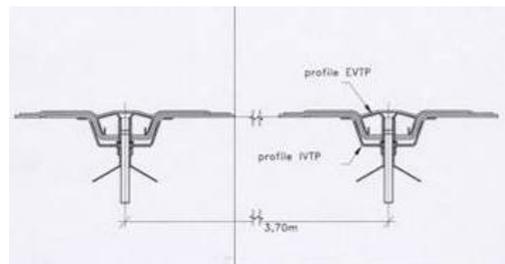
Figure 34. The tensioning system with embedded “U” profile.

In RCC dams the tensioning system can be installed in two possible configurations: the U profile can be embedded into the dam during construction (“embedded profile”, Figure 34), or it can be installed after the dam is completed, on the finished surface (“external profile”), and, in such a case, the configuration is identical to the one described for the rehabilitation of concrete dams (see Figure 28).

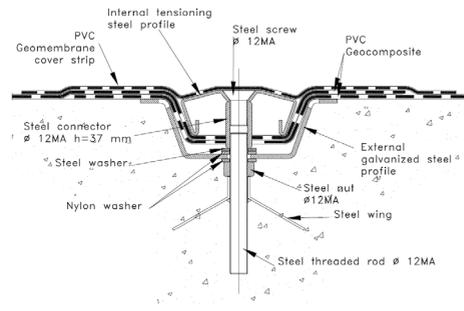
Figure 35. Embedded tensioning profile at Miel I RCC Dam.

The attachment system for the composite geomembrane on the dam face is made by parallel vertical anchoring and tensioning profiles, placed at 3.70 m spacing. The first component of the tensioning profile assembly was attached to the formworks, and embedded in the 0.3 m high RCC lifts (Figures 35 and 36).

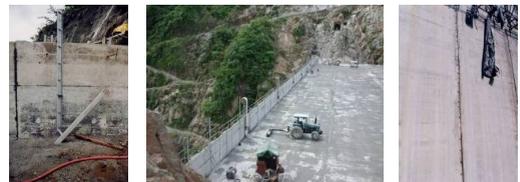
Figure 36. Miel I RCC Dam, Colombia 2002. At left and middle, the U profiles and drainage collector attached to the formworks are embedded in the RCC. At right, the U profiles after embedment appear as vertical grooves in the face of the dam.

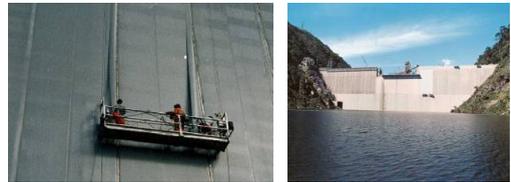
Figure 38. Miel I RCC Dam, Colombia 2002. At left, the stainless steel profiles are waterproofed with PVC cover strips. At right, the composite geomembrane already installed in the lower sections allowed impounding the reservoir while RCC placement and waterproofing works were ongoing above.

The second component of the tensioning profile assembly, i.e. the omega-shaped profile placed over the installed composite geomembrane and connected to the first component (i.e. the U-shaped profile), secures and tensions the composite geomembrane liner on the upstream face. Where the water head is higher, from elevation 268 m to 358 m, the profiles have a central reinforcement. The profiles are waterproofed with PVC cover strips (Figure 38).

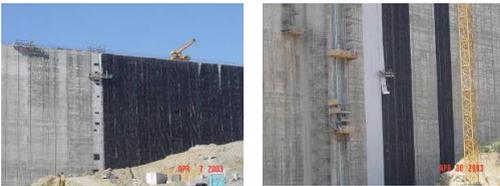
Figure 39. Olivenhain RCC dam, USA 2003. At left, the black drainage geonet is placed on the RCC to enhance drainage collection and discharge; at right, the composite geomembrane is placed over the geonet.

The face drainage system is similar to the one adopted at Miel I Dam, with the addition of a drainage geonet installed against the RCC (Figure 39), which will enhance discharge capabilities should accidental damage occur to the impervious geomembrane. Under the hydrostatic pressure of the reservoir water, the geonet will maintain high transmissivity, thereby preventing water from migrating through lift joints in the body of the dam. As a result, saturation levels and pore pressures in the dam will be lowered, with beneficial effects on the stability safety factors, and on appearance at the downstream face.

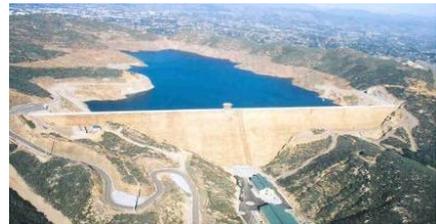
Figure 41. Olivenhain RCC dam and reservoir, USA.

On 16 June 2004, with reservoir almost full (Figure 41), a 5.5 Richter scale earthquake occurred at about 100 km from the dam. The blocks of the dam shook and moved, but no damage has been reported and watertightness of the dam has been totally maintained, fully meeting the design and safety requirements.

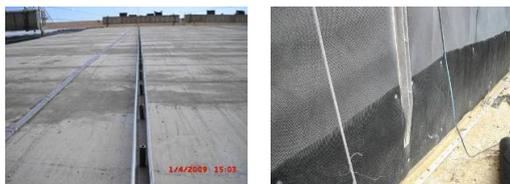
Figure 42. Boussiaba RCC Dam, Algeria 2009. At left, the U profiles installed external to the dam, on the completed RCC lifts. At right, detail of the drainage geonet placed on the upstream face, and of the drainage geonet band placed as longitudinal drainage collector at heel.

body (external configuration) (Figure 42) instead of being embedded in the dam as it was done at Miel I Dam and Olivenhain Dam. Additionally, the drainage bottom collector has been modified: instead of the embedded box drain planned in the original design, a 1m high strip of drainage geonet, of the same type as the one constituting the drainage layer, has been placed as bottom collector along the bottom perimeter of the waterproofing system (Figure 42). This modification simplified construction because the only embedment required was that of the transverse discharge pipes of the five drainage compartments.

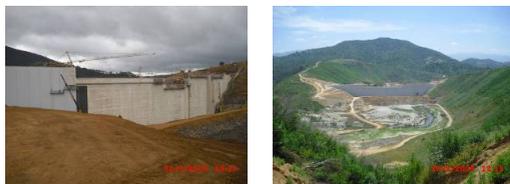
Figure 43. Boussiaba RCC Dam, Algeria 2009. At left, installation starting at the spillway section on 30 March 2009; at right, a view of the dam at crews' demobilization on 28 May 2009.

The waterproofing system was installed starting at the left abutment and installation proceeded according to the section of the dam completed by the main contractor (Figure 43). Installation of the geosynthetic system started on 24 January 2009 and was completed on 22 May 2009 on schedule, notwithstanding interruptions caused by more than 20% days of bad weather.

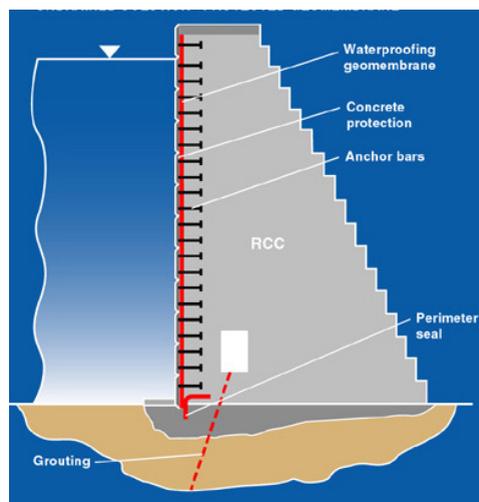
Figure 44. Concept of the covered geomembrane system in RCC dams.

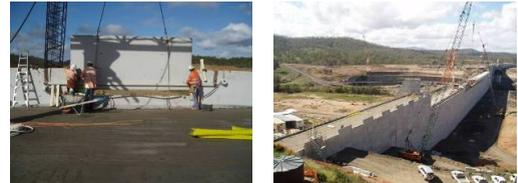
Figure 45. Paradise RCC Dam, Australia 2004. Erection of precast panels, and view from the upstream side.

Construction is illustrated in Figure 45. Construction of the covered geomembrane system started with preparation for the perimeter seal at the heel of the dam. A PVC geomembrane sheet was embedded in the conventional concrete at the foundation, with an extra width that extends horizontally in the body of the dam, to constitute a horizontal barrier to upward migration of water seeping from the foundation. The first rows of panels were then set in place, with the geomembrane side facing the dam body and the concrete side facing the reservoir. The panels were shaped to allow easy placement and interlocking. After panels had been placed, adjoining panels were connected along their entire perimeter by PVC geomembrane strips heat-welded on the geomembrane of the panels.

The panels were then attached with watertight fittings to the steel bars that anchor them to the dam, and placement of RCC started. As the RCC lifts were being placed, the anchor bars were embedded within them, thus securing the panels to the dam body. Construction proceeded with placement of subsequent rows of panels, repeating the sequential steps described for the first row, until the dam body was completed and the construction of traditional concrete appurtenances could start.

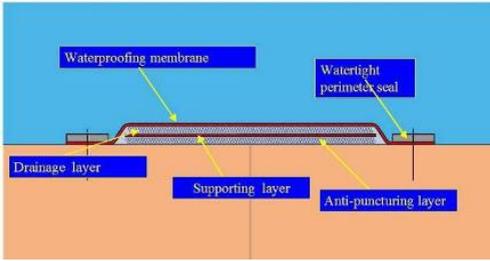
Figure 46. Schematic view of external waterstop.

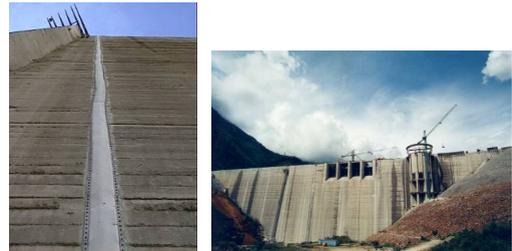
Figure 47. Detailed view of external waterstop at Porce II RCC Dam contraction joints, and general view of the dam.

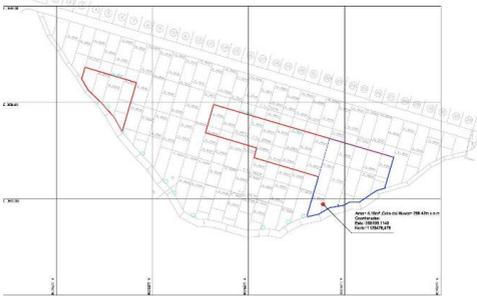
Figure 51. Turimiquire Dam: the critical areas to be waterproofed with the exposed PVC geomembrane system.

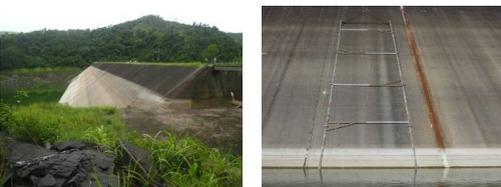
Figure 52. At left, upstream slope of Turimiquire Dam; at right, the anchorage profiles being lowered into the water at Turimiquire Dam.

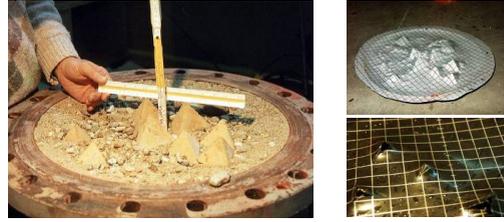
Figure 53. Real scale testing for puncture and burst resistance carried out by the US Army Corps of Engineers on 21 geomembranes confirmed the excellent performance of PVC in respect to all other types of geomembranes. PVC composite geomembrane (2.5 mm thickness, upper photo) conformed to the substrate and resisted to repeated cycles of loading-downloading at 1 MPa (100 m). HDPE (2.5 mm thickness, lower photo) did not conform and ruptured at 0.35 MPa at the first loading (Courtesy of the US Army Corps of Engineers – Waterways Experiment Station).

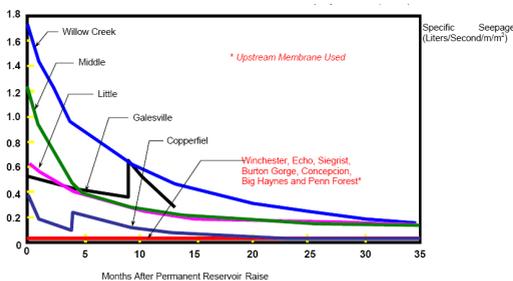
Figure 55. Leakage in roller compacted concrete dams with and without upstream geomembrane (Courtesy Ernie Schrader).
