FAILURE OF SEGMENTAL RETAINING WALLS DUE TO THE INSUFFICIENCY OF BACKFILL PERMEABILITY

Abdolhosein Haddad¹ & Gholamali Shafabakhsh²

Abstract: Segmental retaining walls (SRWs) (primarily those with precast concrete block facing) reinforced by geogrids or geotextiles are used extensively as retaining walls and bridge abutments in transportation networks in Iran. In spite of significant advantages of SRWs, like flexibility on soft foundations, seismic stability and their cost effectiveness, there are some cases of SRWs failure because of neglecting basic geotechnical engineering principles in wall details. In an attempt to identify possible causes for a 12 m height wall collapse, a comprehensive investigation was carried out including laboratory tests on the backfill, stability analyses on the as-built design based on the current design approaches and numerical slope stability analyses with pore pressure consideration. The investigation revealed that the inappropriate stability design and bad-quality backfill were mainly responsible for the collapse. Finally, practical significance of the findings from this study is discussed for future similar projects.

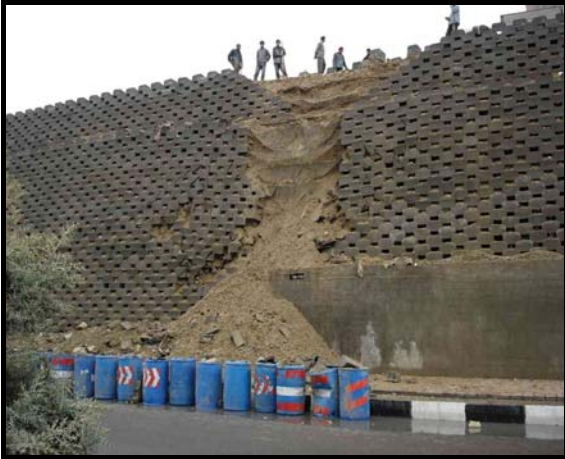
Based on site observations and engineering studies for each failed case study, the causes of failure generally can be distinguished as natural influences and professional mistakes. The wall failure occurred at the end of February 1999. The highest section of wall (12 m) failed during a heavy rainstorm. Numerous worldwide studies have reported that intense rainfall has been the major factor responsible for many slope failures including reinforced earth structures, Huang (1994), Rahardjo et al. (2001) and Pando et al. (2005). As seen in the photos taken after the collapse by the authors in Figure 3, the collapsed portion of the wall extended approximately to 10 m, resulting in a total slid volume of soil over 350 m³. In Figure 4 the geogrid reinforcements and cracked modular blocks near the sliding zone are shown.

Figure 3. Photo of collapse in the reinforced soil wall

In this study a comprehensive site investigation and slope stability analyses were conducted to investigate the causes of the collapse of a 12m SRW. Based on the forensic diagnosis of the observed SRW failure, intense rainfall was the most important natural influence to causing the SRW failure. However, inadequate planning, inappropriate as-built design, the bad-quality backfill soil with a significant percentage of fines, available at the site and poor construction workmanship are responsible for the SRW failure.

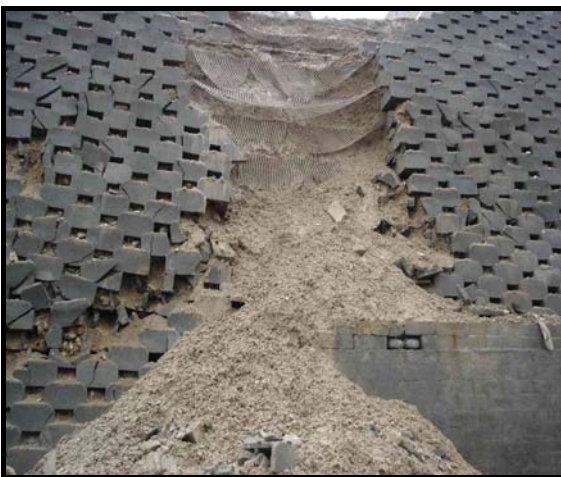
Figure 4. Wall failure-geogrid layers visible

The connection between the reinforcement and the facing of a SRW is an important component of the system that must be considered in both the design and construction of these systems. Also for tall SRWs or walls with complex geometry, global stability analyses should be carried out in design steps for various environmental conditions.

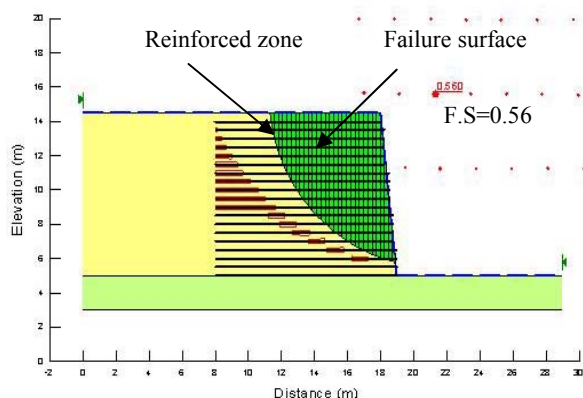
The results of the slope stability analyses are presented in Table 3. The safety factor of SRW was larger than 1.2 in case of the dry case and was less than the required safety factor for wet case (after of the rainfall and backfill saturation).

Figure 6. Failure surfaces obtained for wet case

Method	Safety factor of SRW	
	Dry Case	Wet case
Bishop	1.90	0.56
Spencer	1.88	0.69
