FAILURE ANALYSIS OF A REINFORCED SOIL SLOPE

Abstract: Failures of geosynthetic reinforced soil slope (RSS) initiated by intense rainfall have been often reported recently. These incidents were likely to be the effect of strength reduction upon wetting for unsaturated fill. This paper adopts a practical approach to evaluate the probable errors in analysis that are responsible for such failures. A case study for a collapsed highway RSS was conducted to verify the developed protocol. The results were consistent with those observed in the field. The rational procedures found in this research offer a quick and simple way to estimate the stability of RSS upon wetting.

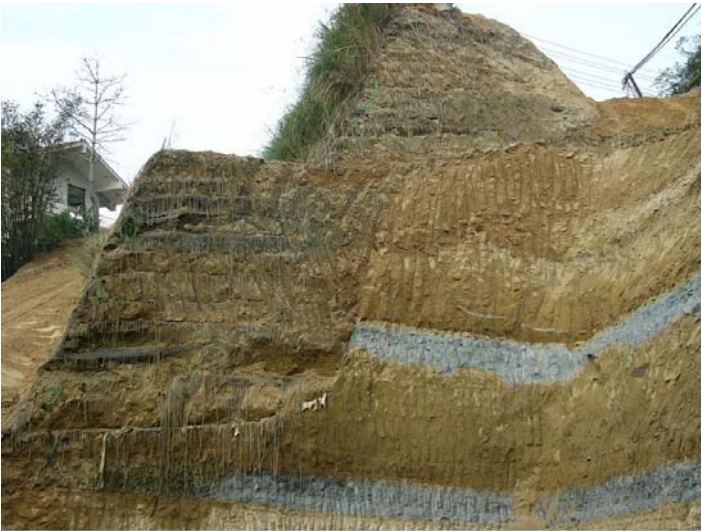
Figure 2. Geological formations at the site

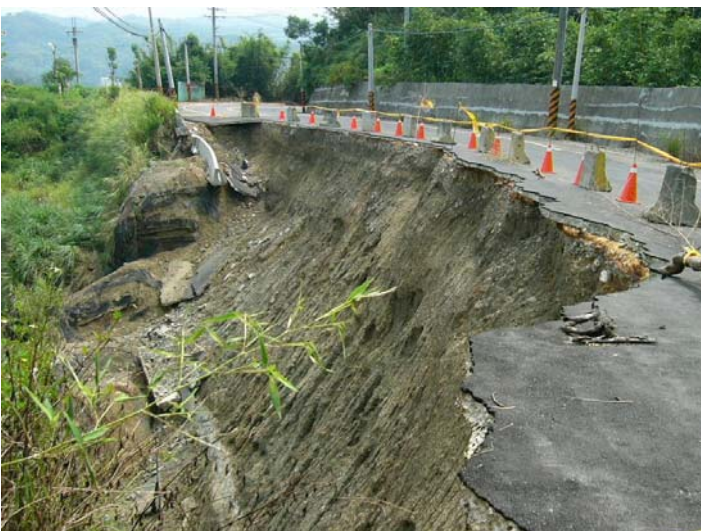
Figure 3. RSS totally collapsed during an attack of typhoon.

The site consisted of typical cut and fill construction for a 15-m wide highway winding through a mountainous area originally built in 2003. A 19-m in height, 3-tiered reinforced slope was used to support the widening of the highway as shown in Figure 1. The ultimate strength of the geogrid used was 200 kN/m. The geological formation observed at the site was predominantly yellowish fine-grained sandstone with thinly interbedded grey shale (Figure 2). Groundwater level was found at about 1m below the ground surface. The fill material for the RSS was yellowish sandy material. The sand was classified as poorly graded sand with silty clay (SP-SC) according to the Unified Soil Classification System (ASTM D2487). Table 1 presents its detailed physical properties. In 2004, typhoon Aere attacked Taiwan accompanied by enormous rainfalls. The reinforced slope totally collapsed during the storm and caused serious traffic interruption of the highway (Figure 3).

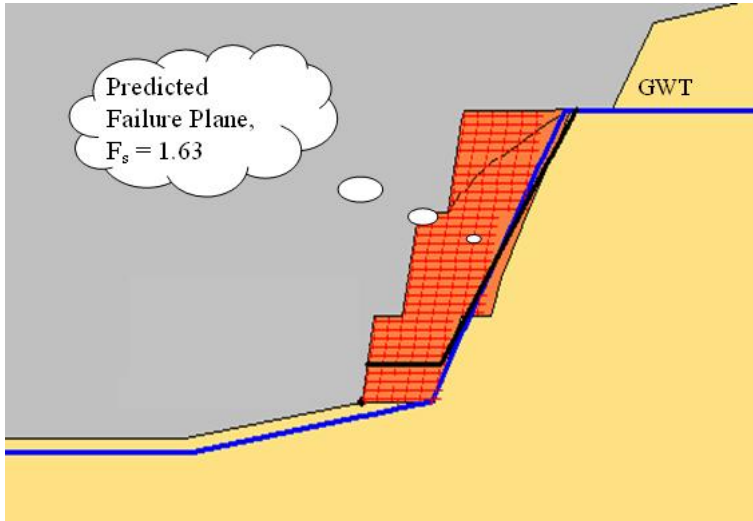
As shown in Figure 4, pre-construction stability analysis based on the traditional groundwater rising procedures indicated that the slope presented a safety factor of 1.63 for intense rainfall conditions. However, the RSS collapsed during an attack of typhoon with an enormous rainfall. Forensic study based on Wu and Tang (2006) showed that previous stability analysis was probably erroneous due to the ignorance of strength reduction for the unsaturated fill material.

Figure 4. Result of pre-construction storm stability analysis based on the traditional groundwater rising.

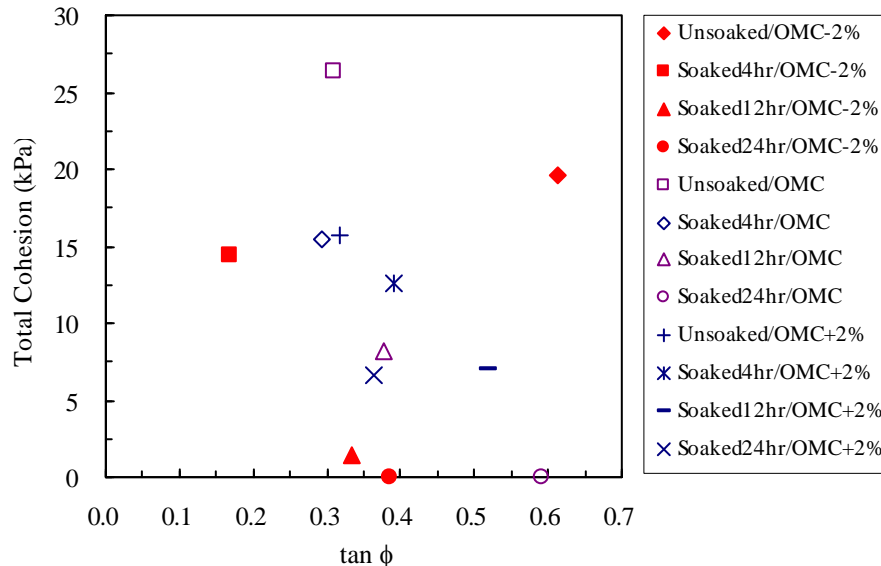
Figure 5 summarizes all strength parameters tested for samples compacted to 90% of maximum density with varying moisture contents. In general, the infiltration caused the total cohesion to decrease with the increase of soaking times. The cohesion had totally vanished after 24 hours of infiltration for samples compacted with less moisture contents (OMC and OMC-2%). The reduction was up to 100% in comparison with to its initial value before wetting.

According to Fredlund and Rahardjo (1993), the decrease of cohesion can be attributed to the loss of matric suction due to infiltration. Conversely, the friction angle increased with the increase of soaking time. It appears to be anomalous as research findings have indicated that friction angle is effectively independent of matric suction (Fredlund and Rahardjo 1993). Such phenomenon should be the effect of further consolidation of soil particles triggered after the hydrocollapse of soil sample. A longer consolidation promotes greater increases in the effective stress. It can be seen that samples compacted with less moisture content (OMC-2%) presented significant strength weakness upon wetting. It is logical to conclude that fill slope compacted dry-of-optimum will be more vulnerable to failure after intense rainfall. Rehardjo et al. (2003) and Chen et al. (2004) reported many landslides of man-made slopes coincided with such behaviours.

Figure 5. The effect of wetting on the reduction of strength parameters

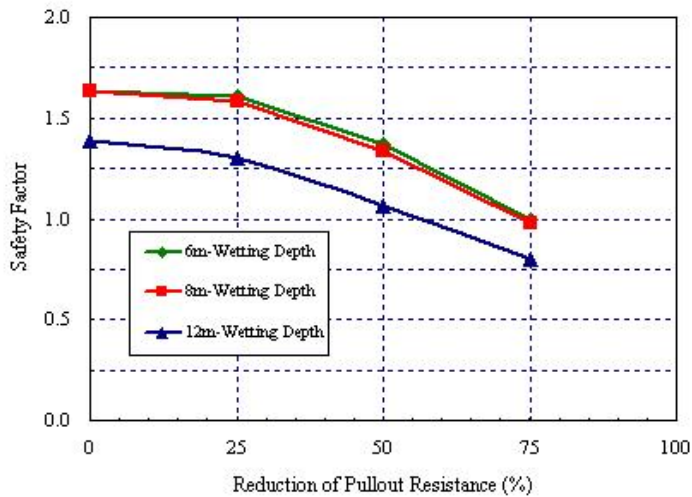
The safety of RSS was examined further using the protocols developed in this study. Strength parameters of the fill material were reduced in stages to simulate the effect of infiltration resulting from the downward movement of a wetting front. It can be seen in Figure 6 that the factor of safety (F_s) decreased with the increase of depth of wetting front. The reduction of pullout resistance of the reinforcement also presented significant negative effect on the F_s . The pullout resistance is a function of soil-geosynthetic interface shear resistance (Moraci and Recalcati 2006). FHWA (2001) recommended a pullout resistance factor (F^*) to be used as the correlation for soil and geosynthetic interaction. Based on its definition, a reduction of soil shear strength certainly causes F^* to decrease as well. The calculated factor of safety and the predicted mode of failure have shown a good agreement with what was observed in the field (Figure 7). The illustrated case study shows that sophisticated infiltration and slope stability analysis may not always be necessary for analysing rainfall induced slope failure. Rational results also can be available using traditional analysis with proper experimental simulations. Further studies are underway to verify the presented method.

Figure 6. The variations of factor of safety with the depth of wetting front and reduction of pullout resistance.

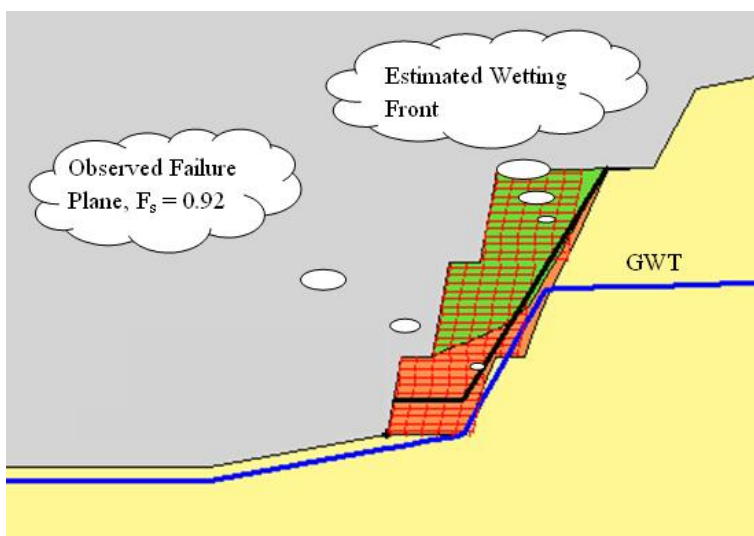
Figure 7. Result of stability analysis showing a wetting depth of 12-m caused the RSS to collapse.
