Installation of geosynthetics on an industrial dangerous waste landfill

Sobral, P.M.

Cascão, L.F.

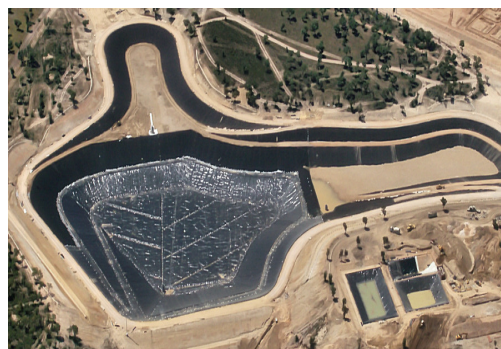
The landfill (Figure 1) is composed of three cells, with an approximated área of 80.000 m², with 25.000 m² of bottoms and 55.000 m² of slopes.

Figure 1. CIRVER Landfill

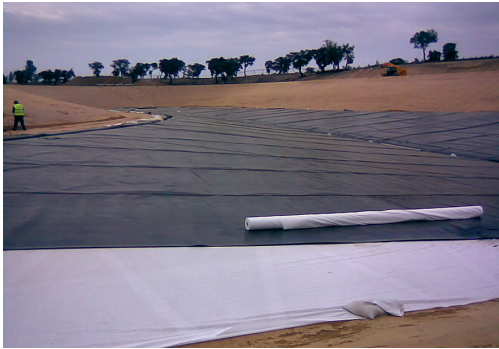
Seeing that half a meter of argil was applied above the natural field, the first layer of geosynthetics was a 150 gr/m² geotextile, wich express function is to protect the first layer of 2.0 mm HDPE geomembrane, corresponding to the second layer (Figure 2).

Figure 2. Bottom detail

Above this first geomembrane, was applied a 200 gr/m² conductive geotextile, in the same manner as, respective sensors and cables net, being those covered in all the bottom area with a drainage geosynthetic composed by a HDPE net, wich function is draining any liquid that may appears between the two geomembrane layers.

Then was applied a second layer of 2.0 mm HDPE geomembrane, superiorly protected by a 290 gr/m² geotextile, before being finally placed a mineral layer. The impermeabilization system in the cells bottom was composed by six geosynthetics layers, in addition to the sensors network.

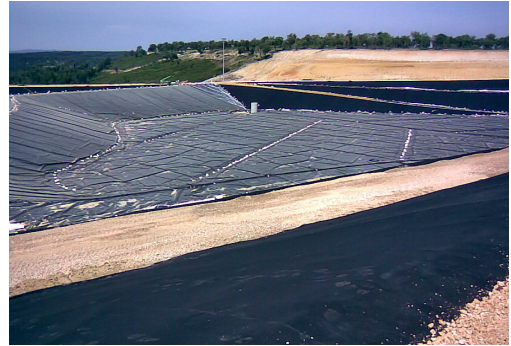
Finally, it was applied a 300 gr/m² black geotextile resistant to ultraviolet radiation, in order to protect and preserve the integrity of geosynthetics drainage that will be exposed to the sun during the time of operating the landfill (Figure 3).

Figure 3. Slopes protected by UV resistant geotextile

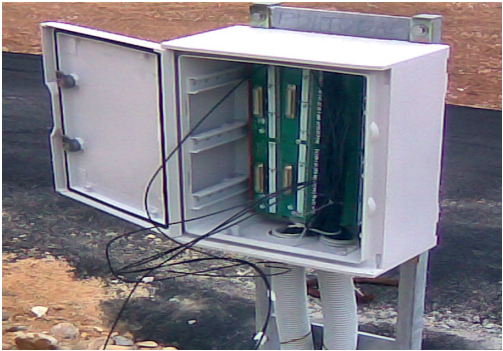
the landfill is divided into three large cells, several boxes (Figure 4) were installed to control, more specifically 7 units in the way of access around the site, cell 1 served by two checkboxes, cell 2 served by 1 checkbox, and cell 3 as well the largest of all, is linked to four checkboxes.

Figure 4. Leakage detection system checkbox

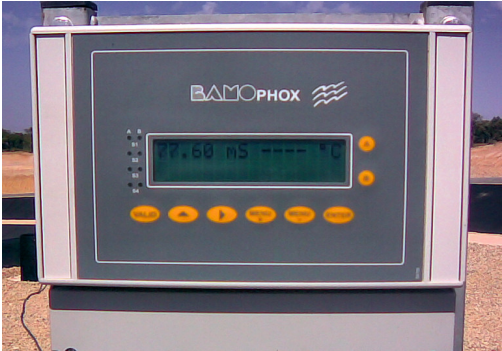
It is important to note that the leakage detection have an automatic alarm system, visible on the control panel (Figure 5) by any person, but it is not possible to locate immediately the fault in the geomembrane, appearing only one indicator light for alarm, that warns of a possible leakage. To locate the leak in the cell, it is necessary to use special software with a layout of the place in question, where all the sensors are deployed. Through analysis of the sensors network, the software will provide us with 2D and 3D, the exact location of the hole.

Figure 5. Control panel of the automatic alarm system

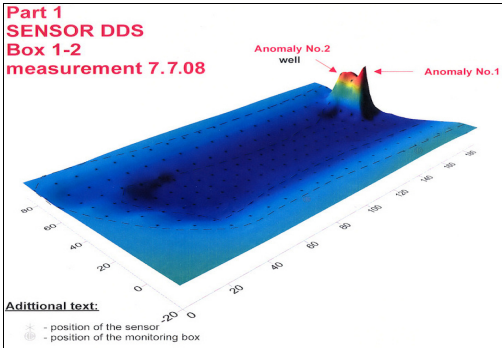
Here, we can verify on 2D (Figure 6) and 3D (Figure 7), the detection of a difference in electrical potential recorded by the system through sensors, which clearly shows the presence of some kind of damage in the geomembrane.

Figure 7. Anomaly location in 3D

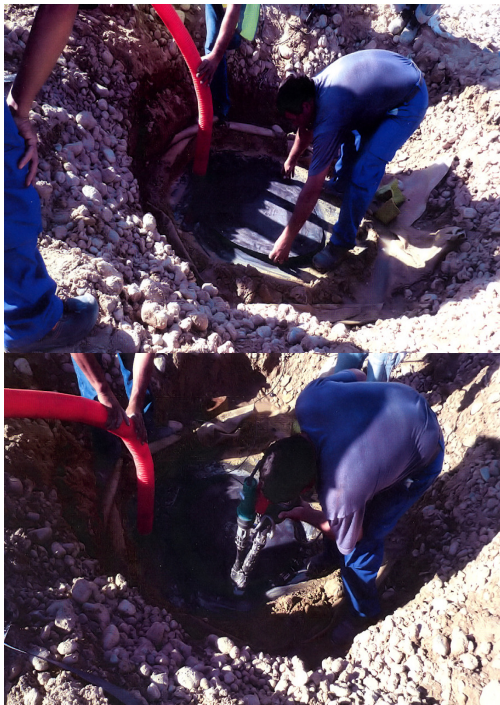
After the exact location of the anomaly, the mineral, geosynthetic drainage and geomembrane protection layers were removed, and the repair was made using a HDPE patch and extrusion welding (Figure 9).

Figure 9. Damage repair
