Landfilling biologically hazardous materials

P PHILLIPS, Geofabrics Australia Pty Ltd, Sydney, New South Wales, Australia
P.W HITCHCOCK, Robert Carr and Associates Pty Ltd, Newcastle, New South Wales, Australia

ABSTRACT: In April 1999, an outbreak of Newcastle Disease in the Mangrove Mountain area (NSW, Central Coast) led to the destruction of two million chickens. Landfilling of the chickens was identified as the only feasible disposal option and two landfill cells were constructed. A further cell was constructed for the disposal of manure and other waste from within the chicken sheds. Site selection was restricted due to the need for sites to be selected within the quarantine zone of the Mangrove Mountain Ridge and restrictions due to National Parks, and private properties. The geology encountered at the disposal sites was similar comprising permeable low strength Triassic aged Hawkesbury sandstone with a semi-confined aquifer at moderate depth. Groundwater is used extensively for domestic and commercial (mineral spring bottling) purposes and therefore a high degree of environmental protection was required. Double containment systems were used at the sites due to the sensitivit

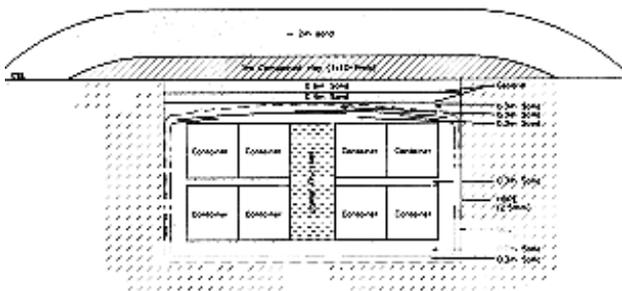
Figure 1. Cell design for Blood Tree Road, Mangrove Mountain.

- The containers were placed close to the wall of the cell with a central cavity so that collapse would be preferentially towards the centre and away from the composite lining system (see Figure 1)
- The HDPE was protected with cushioning geotextile to minimise impact of the container collision
- A 700mm thickness of sand was placed and compacted in between the base of the containers and the liner to reduce the risk of puncture from fatigued metal.

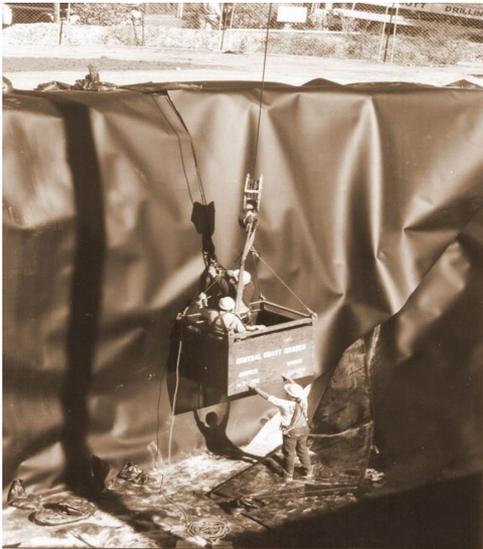
Figure 2. Installation of the HDPE

The completed excavation was lined with a composite liner composed of Geosynthetic Clay Liner (GCL) and a 2.5mm thick High Density Polyethylene (HDPE) liner and capped with GCL, HDPE and one metre of clay (refer to figure 2). A non-woven needle punched geotextile and natural materials (sand) were used to separate and protect these liners.

The GCL was made by non-woven geotextile sandwiching a layer of polymer enhanced sodium bentonite. The composite is held together by fibres needle punched and thermally locked to ensure high long-term shear strength.

The leak detection layer was made from 300mm of compacted sand was used between the two liners to ensure that any penetration of the upper liner did not impact on both liners.

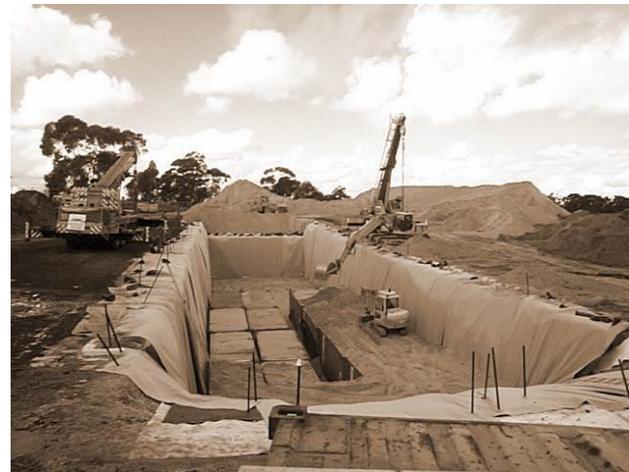
Figure 3. Containers being loaded into Blood Tree Road Cell.

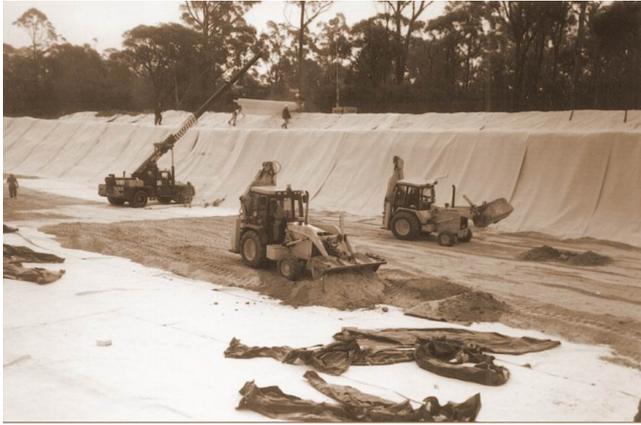
The cell was constructed by excavating a 75m square hole by approximately 8m deep into the sandstone bedrock. To maximise the useable volume all the walls were cut vertical. This cell was designed to dispose all the manure and litter from the 30 farms. Originally a composite liner system was designed (GCL/HDPE) but due to delays experienced in the installation and welding of the HDPE in the Blood Tree Road cell, was replaced by a secondary GCL on the base, walls and cap (refer to figure 4). This cell was excavated within 4 days and filled within a week.

Figure 4. Waratah Road Cell being lined using twin GCL wall and base.
