Large geotextile containers for coastal storm protection

ABSTRACT: The central coast of Vietnam is regularly ravaged by typhoons which develop in the South China Sea and move westwards during a typhoon season which extends from September to November each year. At Hoi An there have been several attempts at shore protection for beach front hotel developments using gabion structures and sand filled geotextile tubes (geotubes). These have failed to provide adequate protection mostly due to construction difficulties in the constant wave environment which prevails even outside of the storm season. In June 2009 work commenced on the construction of a seawall and groynes using large sand filled geotextile containers that when filled with sand weigh around 4.5 tonnes each. They are filled on land and used like large bricks to take advantage of the interlock and the high interface friction between the non-woven geotextile used for the geotextile containers. Wall construction commenced in July 2009 and the seawall was partially complete when some minor damage was sustained by the first storm in early September 2009. In late September the site was struck by typhoon Ketsana which made landfall

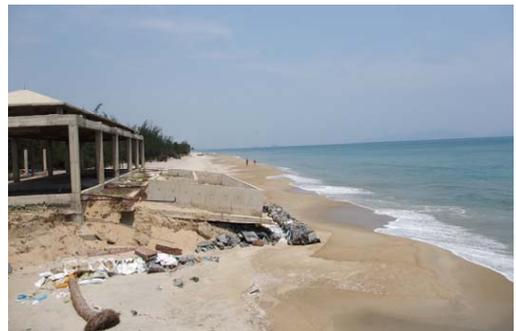
Figure 1 shows the state of the beach and structures in early 2009 with debris from previous work with gabions and geotubes evident.

Figure 1 – Early 2009

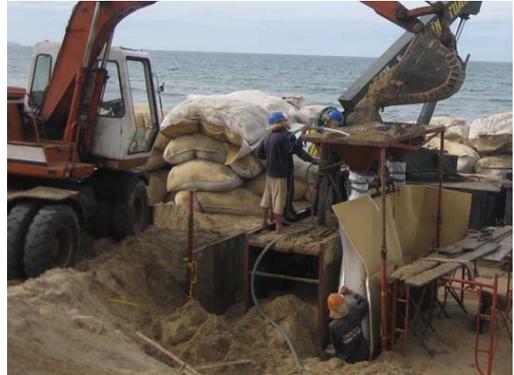
The geotextile containers were filled using local clean beach sand with a generous supply of water to help distribute and compact the sand, and achieve a nearly 100% full geocontainer. They were filled in a frame based on standard formwork components with a special hopper overhead. This can be seen in Figure 3.

Figure 3. Filling Frame

These geotextile containers were fitted with geotextile tubes which help to facilitate filling and

achieve a more secure closure after filling is complete.

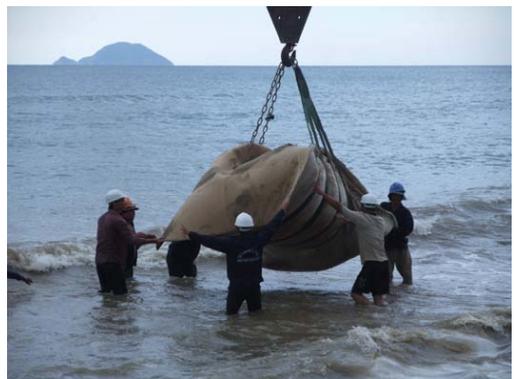
The geotextile containers were placed in position using both excavators and cranes with advantage being taken of the crane reach to facilitate placement of the geotextile containers without the machinery needing to enter the water. Figure 4 shows a geocontainer being placed in shallow water.

Figure 4 A geotextile container being placed in shallow water. Note poor slinging without a spreader frame which results in geotextile container being squashed.

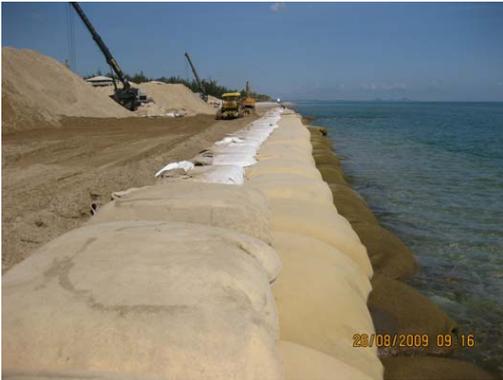
Placement of geotextile containers to form the seawall commenced in late July 2009 and by late August it had been built up to row 5. The partially built wall can be seen in Figures 5 and 6 – note the rapid colouration of the geotextile containers as the geotextile encourages marine plant growth.

Figure 5. Partially built wall – up to row 5

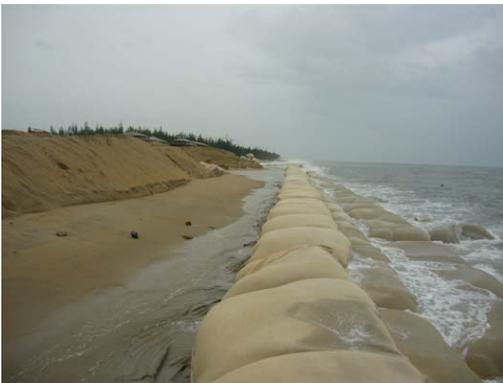
Figure 6 An early storm

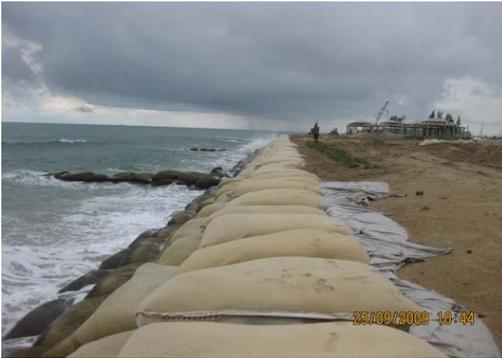
Figure 10. Partly built wall before typhoon

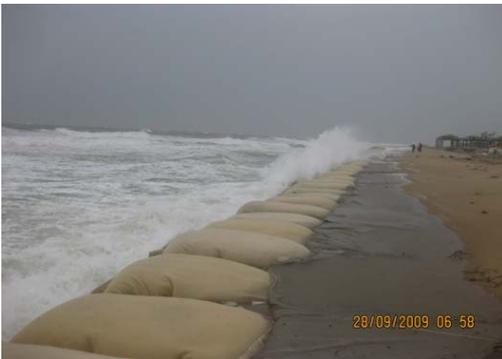
Figure 11. Partly built wall on the morning of the typhoon.

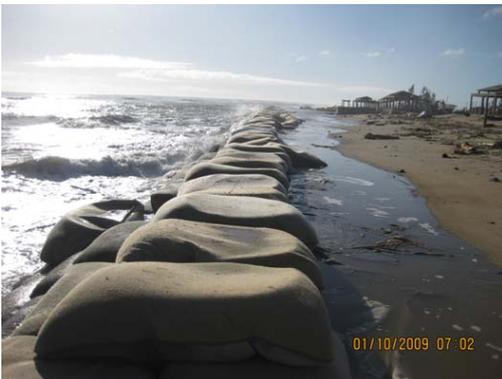
Generally the partially complete geotextile wall stood up very well with only a few geotextile containers shifting and no rupturing of geotextile containers. The geotextile containers that have shifted are able to be easily repositioned. The majority of this movement was due to overtopping of the partially completed wall.

Figure 12. Partly built wall two days after typhoon. Note shifting of a few containers.

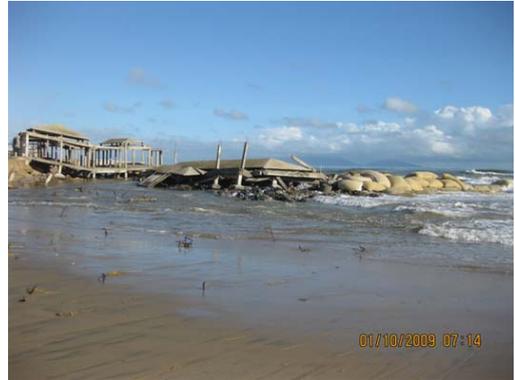
Figure 13. Collapse of structures in locations not protected by wall.
