SMOLTZYK, U. and MALCHAREK, K.
University of Stuttgart, Stuttgart, Federal Republic of Germany

Living Sheets on Steep Slopes

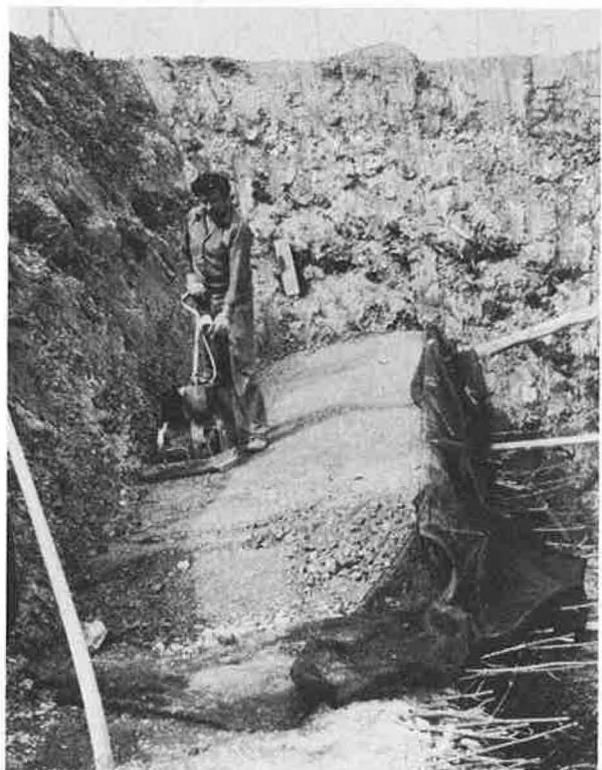
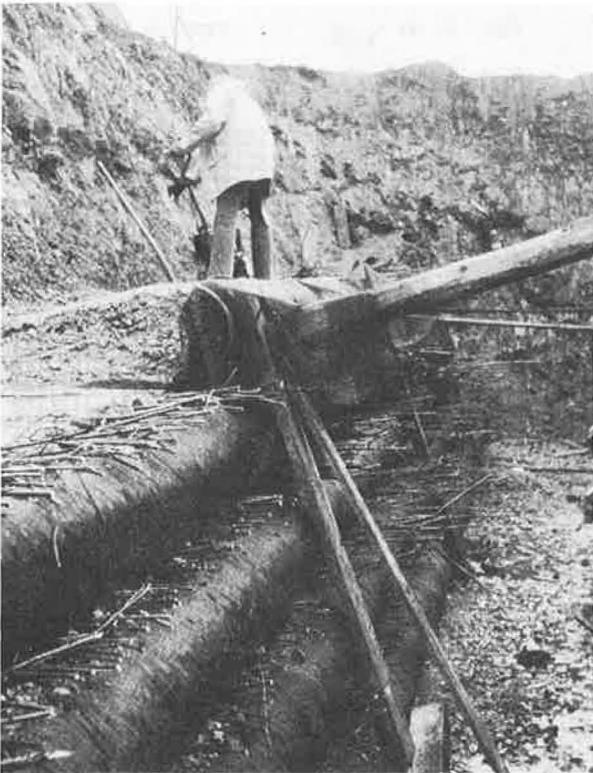
The installation procedure is illustrated in Figures 6 to 8. Formation of the bag shape was facilitated by use of a piece of half section pipe. Consolidation was effected by four passes of a small vibrator.

Fig. 6 IGB stability slope, partly constructed

Fig. 7 IGB stability slope, partly constructed

Fig. 8 IGB stability slope, partly constructed

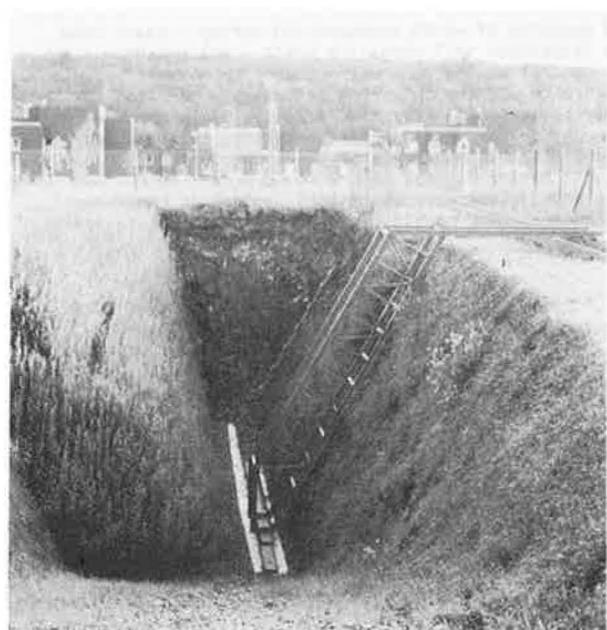
Fig. 10 Travelling framework for control measurements on the slope

wall. We therefore built ourselves a travelling framework, as seen in Figure 10, to enable us to take point soundings on the slope.

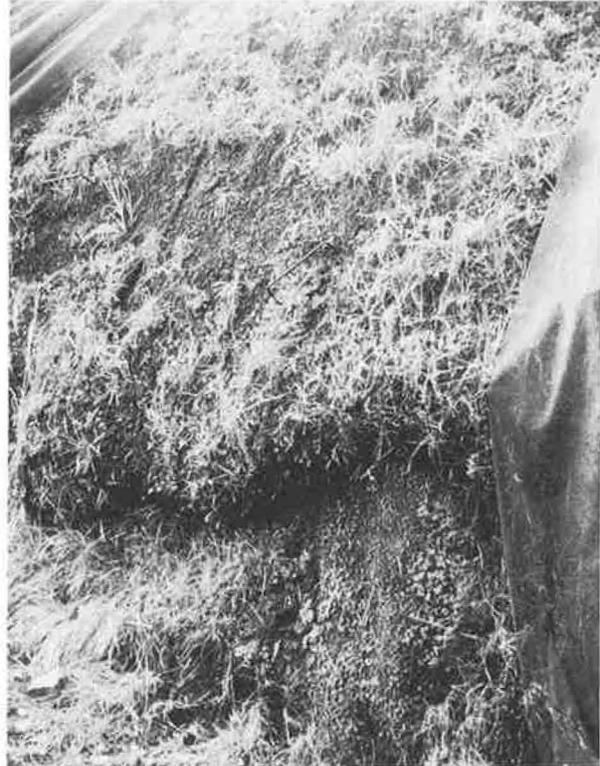
Fig. 12 Slips in control segment 3

Large differences were exhibited in the stability of the construction types, whilst in the IGB segment no measurable slips were recorded and the slope remained unchanged over a full summer-winter period, the surface of segment exhibited slipping and an example of this is shown in Figure 12. It became loosened through the considerable rainfall experienced in 1980. We see here a clear advantage of the solution using bags, which hold a sufficient volume of water for the use of the plants yet allow seepage to prevent the development of excessive water pressures behind the vegetation.

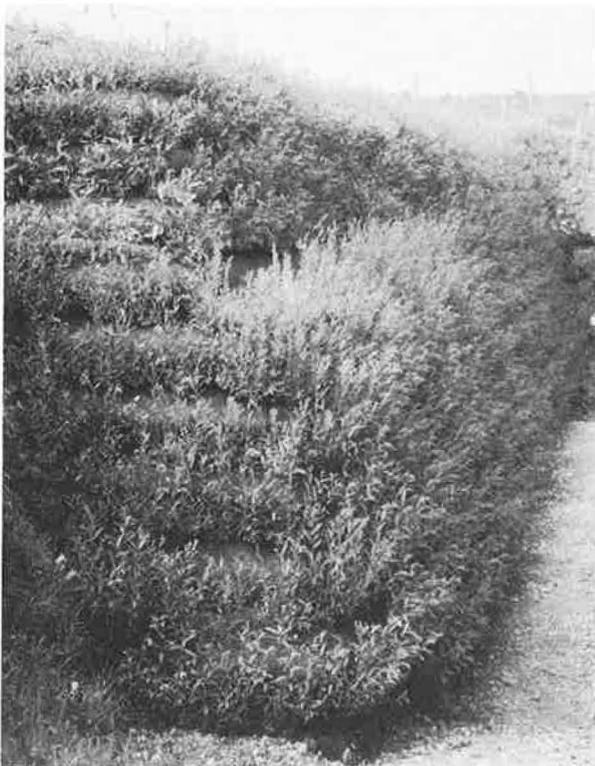
Fig.11 Condition of the IGB stability slope after two months

In spite of the fact that the planting was not carried out in the optimum season, the plants grew satisfactorily and after only two months had reached the stage shown in Figure 11, where generally the plastic fabrics were not visible outwardly.
