Long-term behaviour of a 13 m high reinforced steep slope

J. Vaslestad

Public Roads Administration, Oslo, Norway

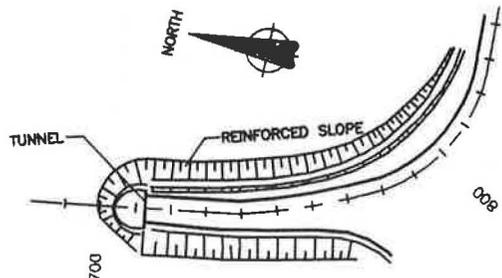
The total area of the reinforced slope is 1620 m². The length of the slope is 120 m and the maximum height is 13 m. The slope angle is 60°.

For aesthetic reasons and trying to lower the effect of the high slope, there is a terrace with a height of 2,5 m in the bottom of the slope. Trees were planted on this terrace for aesthetic reasons.

Fig. 1. Plan of the reinforced slope

A plan view of the reinforced soil slope is shown in figure 1.

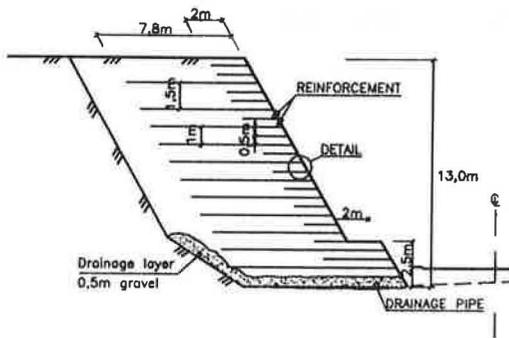
Fig. 2 Cross section of the reinforced slope

- Drainage layer of gravel with thickness 0,5 m in the bottom connected with the drainage system for the road.
- Horizontal drainage layers of gravel with thickness 0,2 m and 1,5 m vertical spacing.

- Backfill consisting of in-situ silty and gravelly sand.
- Organic vegetation soil with thickness 0,5 m in the outer layer of the structure. Seeds were included in this fine-graded soil (6 g/m^2).

- Vegetation mat consisting of wool and polyester in the front of the structure.
- Reinforcement. Woven polyester geotextile with tensile strength of 150 kN/m and length 7,8 m as primary reinforcement. Reinforcement spacing was 1,0 m except for the 2 upper layers with spacing 1,5 m. The same geotextile with length 2,0 m and spacing 0,5 m was used as secondary reinforcement.

A cross section of the reinforced slope is shown in figure 2.

The structure consists of the following elements (see figure 2 and 4).

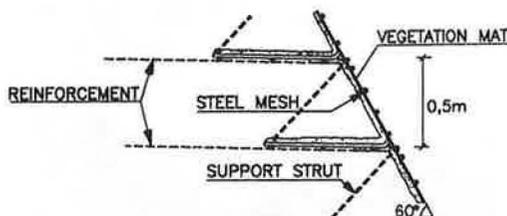
- Steel mesh. Commercially available lightweight steel mesh with height 0,5 m and 10 mm bars. The mesh was produced in units with length 2,0 m and welded on site. A similar steel mesh was used on a trial steep reinforced slope in Norway in 1987, Fannin and Hermann (1988).

Fig. 4 Detail of wall facing

The facing is shown in figure 4.

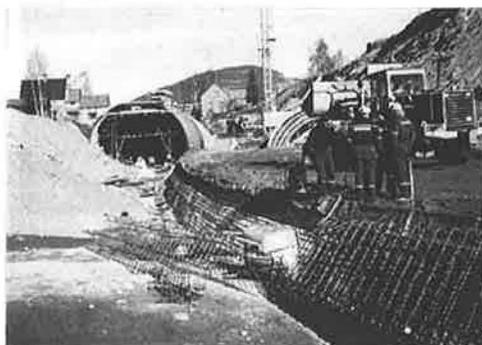
Fig. 5 Construction of the third lift

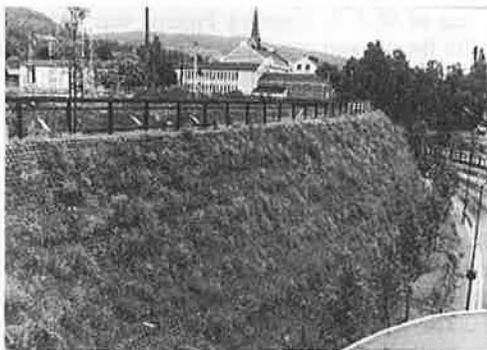
Fig. 7 Spread vegetation in the first 1-2 months.

The vegetation in the first 1-2 months after construction consisted mainly of weeds with large parts without vegetation, see figure 7.

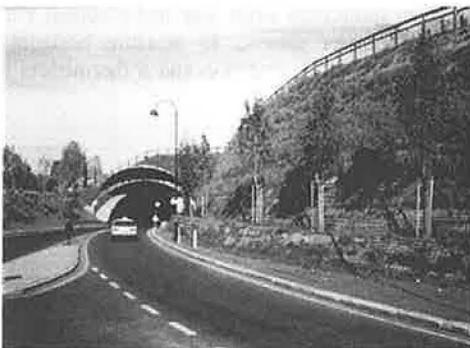
Fig.8 Vegetated slope

The weeds were cut and later the vegetation gradually improved and became more even, see figure 8.

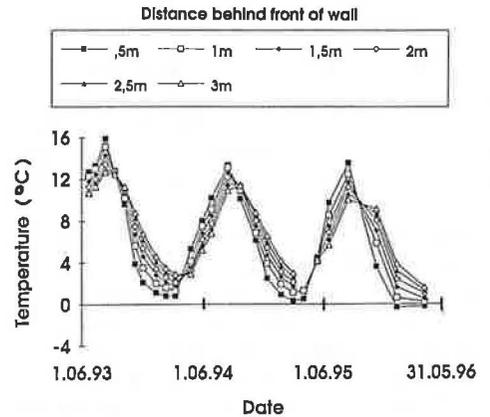
Fig. 9 Temperature measured in the soil in the reinforced structure

The temperature measurements are shown in figure 9. The temperature within the reinforced soil follows an annual cyclical pattern.

A maximum temperature of 16°C was measured in the summer 1993 and a minimum temperature of -0,5°C in the winter 1996.

In the summer the difference in temperature is about 4°C from 0,5 m to 3,0 m behind the front. The difference in temperature in the winter is about 3°C from 0,5 m to 3,0 m behind the front.

measure the temperature distribution in the front of the structure. The thermistors are placed 5 m below the top of the slope, and with horizontal spacing 0,5 m behind the front. The inclinometer channel is placed 3 m behind the facing of the slope.

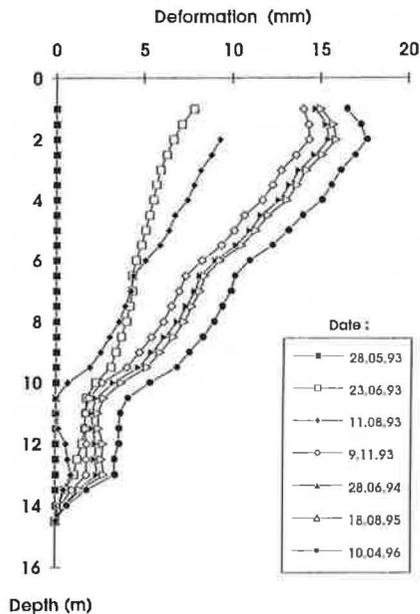
Fig. 10 Horizontal deformation after the end of construction

Horizontal deformations after end of construction are shown in figure 10.

A maximum horizontal deformation of 18 mm is measured 1 m below the top of the wall.

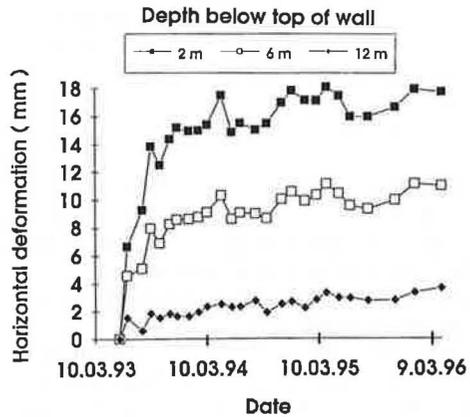
The major part of the deformations in the top of the wall (14 mm) occur within the first 6 months after the end of construction, see figure 11.

Fig. 11 Horizontal deformations, annual variation

The horizontal deformation also show an annual cyclical pattern as shown on figure 11.

The horizontal deformations are largest in the spring time (the thawing period) and smallest in the summer and autumn.

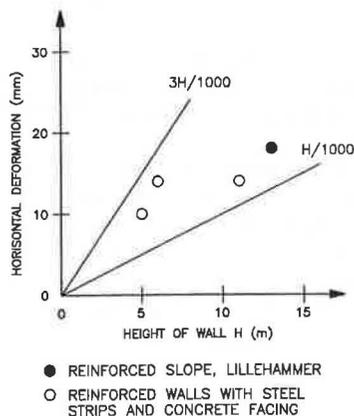
Fig. 12 Long-term post-construction horizontal deformations on reinforced earth walls in Norway

Fig. 12 shows that the long-term deformation of the reinforced slope and walls lies between H/1000 and 3H/1000.

Measurement of long-term post-construction horizontal deformations were made on four reinforced earth walls in Norway, figure 12.
