Performance of synthetic rubber sheets for surface lining of the upper pond in Yambaru seawater pumped storage power plant

J. TAKIMOTO, Yuncan Hydropower Project Office, Electric Power Development Co., Ltd., Lima, Peru
Y. KANEKO & M. KASHIWAYANAGI, Engineering Dept., Electric Power Development Co., Ltd., Tokyo, Japan
F. TATSUOKA, University of Tokyo, Tokyo, Japan

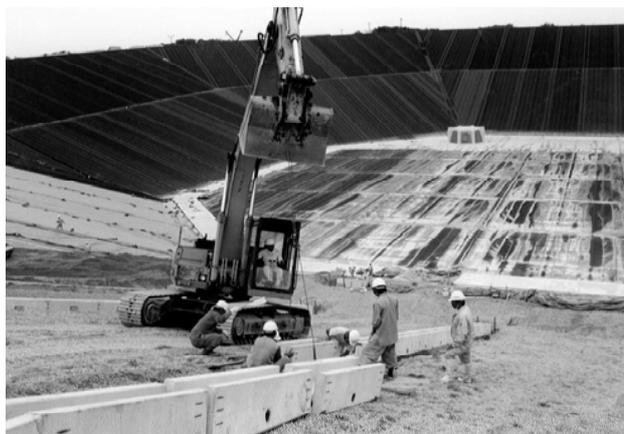
Photo 2. Construction of sheet connection structure

The concrete blocks for the sheet connection structures were produced in not only an outside existing factory but also at the construction site. The standard concrete block has a length of 2.0 m and an approximate weight of 680 kg. Photo 2 shows the installation of a sheet connection structure. Each block was placed on a mortar bed that had been placed to render a flat surface. After confirming perfect fitting to the mortar bed, the block was anchored into the transition layer. Then the filling concrete was cast-in-place inside the recess of the block.

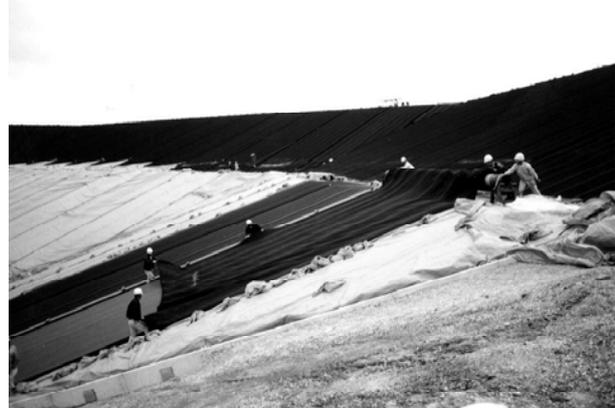
Photo 4. Rubber sheet installation

The main rubber lining sheets, cushion fabric, cover sheets and damping materials had been cut to the specified width in the factory. Rubber sheets wound on a steel roll and cushion fabric wound on a cardboard roll were delivered to the construction. As shown in Photo 4, to install the cushion fabric and the rubber lining sheets on the slope sections of the pond, a roll of cushion fabric and rubber lining sheet was placed at the crest of the slope. First the cushion fabric then the rubber sheet was manually pulled out from the respective roll step by step toward the toe of the slope. To install the cushion sheets and rubber sheets on the flat bottom sections of the pond, two thirds of the total rolled length of sheet was first spread out from the roll and then it was arranged at place from left to right. In this installation work, it was essential to prevent undulation, wrinkling and spot formation in the cushion fabric and main lining sheets so that too large residual tensile stress was not introduced in them. It was also necessary to avoid excessive expansion and contraction in the rubber lining sheets as a result of large temperature changes.

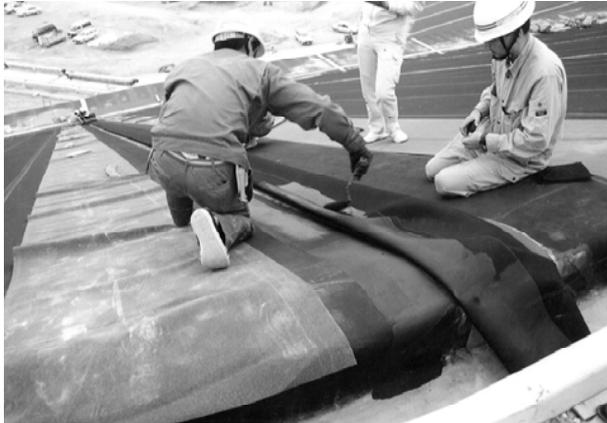
Photo 5. Cover sheet bounding work

sheets, was bonded to the main rubber lining sheets at the site. As a highly reliable adhesive bonding was essential as the common practice, an adhesive tape that consisted of a naturally vulcanised butyl rubber-type adhesive was used, as shown in Photo 5. The edges of the cover sheet were protected by using a reinforcement tape. At locations where the rubber lining sheets were covered with cover sheets, the surface of the rubber lining sheets was first made as flat as possible and the sealing was made reliable by using a sealing material.

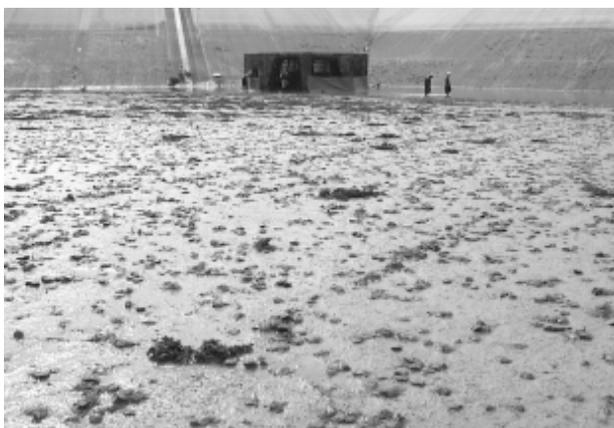
Photo 7. Marine life form accretion

The subsequent inspection performed in October 2000 was a diving survey after the water level of the upper pond was lowered to a level of 132 m. For the fourth inspection, however, the water was totally removed so as to perform a visual survey (see Photo 7).

Although the amount of marine life forms tended to increase year after year, there has been no evidence that the surface of the rubber lining sheets had suffered from any damage or deterioration as a result of this marine life form accretion. It was found however that the presence of shell accretion on the sheet surface may raise a particular problem during maintenance and inspection work; i.e., the shells may damage the lining sheets when operators tread on the shells or when equipment is rolled over them. A possible solution would be the use of shoes provided with cushion material soles so as not to damage the lining sheets.
