Performance testing method of geotextile for interlocking block pavement

ABSTRACT: Geotextile has been recently introducing a part of ILB pavement because of expecting to increase its durability. The use of geotextile for ILB pavement between upper base course and cushion sand under ILB prevents the cushion sand loss into the base course. The loss often causes the change of ILB position, damage of ILB, and pavement surface unevenness. This paper first described the effect of geotextile on ILB pavement through the field research and full-scale type of accelerated pavement testing, and concluded that "Roller Compacter Testing Method" was the most optimal laboratory testing method.

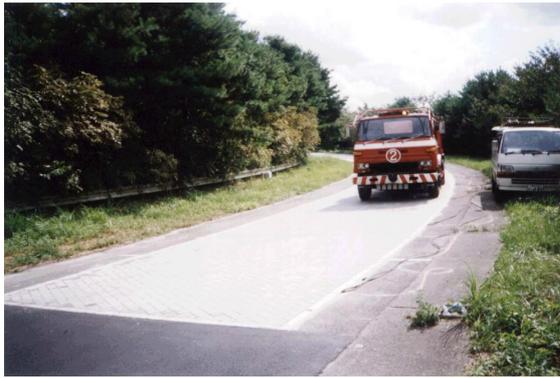
Figure 3 Full-Scale Accelerated Pavement Testing

ing truck of 200 meters diameter and 5 meters width, and automatically controlled three trucks shown in Figure 3.

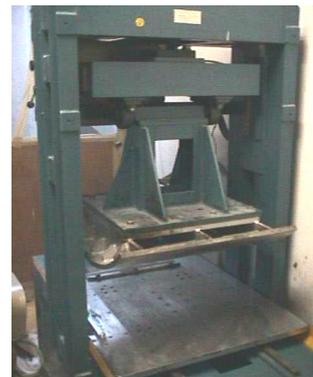
(a) Roller Compactor

Figure 6 Laboratory Testing Machines

Figure 6 illustrates the general views of each test machine. Wheel tracking (WT) test is originally a testing method for asphalt pavement. Roller compactor (RC) is a machine to make specimens for asphalt mixture of highway pavement. Table 2 shows the specifications of each testing method and Figure 7 illustrates the cross-section of each specimen. Subgrade is replaced by rubber base.

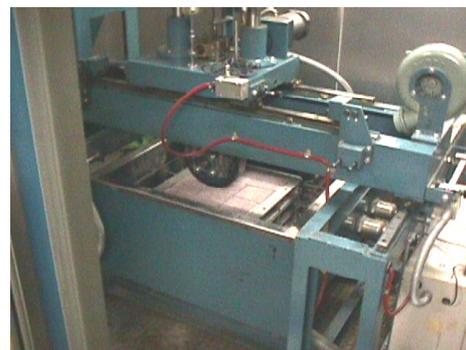
(b) Wheel Tracking Test Machine
