Post-construction behaviour of two high geogrid-reinforced soil retaining walls for Fujisan-Shizuoka airport

ABSTRACT: For Fujisan-Shizuoka Airport, which opened to service June 2009, two high geogrid-reinforced soil retaining walls, 21.1 m and 16.7 m-high, were constructed to preserve natural environment consisting of forest and steep swamp areas in front of the walls. These areas are to be buried in the backfill if gentle-sloped embankments were constructed. As the walls support the east side of the runway of the airport, it is required to ensure minimum residual displacements and a high stability of the walls during heavy rainfalls and severe earthquakes. Well-graded gravelly soil was selected as the backfill and compacted very well to an average degree of compaction higher than 95 % based on the modified Proctor. A systematic and comprehensive drainage system was installed inside and at the bottom of the walls. The deformations of the walls during and after construction were monitored, which showed very small deformation during and after construction. The recorded tensile strains in the geogrid also indicated a high stability of the walls. This case history shows that very sti

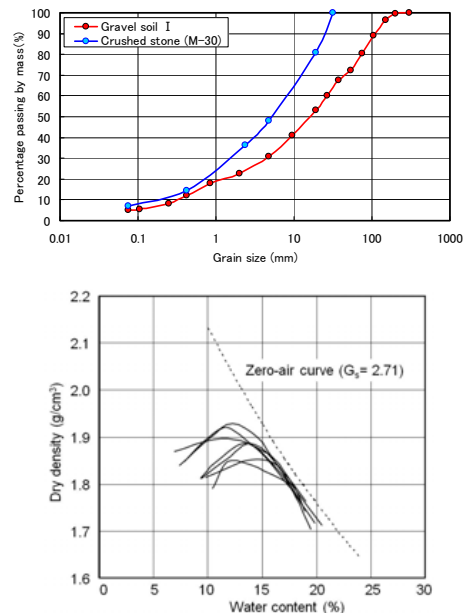
Fig. 6. a) Grading curves; and b) compaction curves (modified Proctor) of the main backfill

The backfill of the main body of the walls was well-graded gravel from a nearby ancient riverbed that has tectonically heaved to above the sea level (gravel soil I, Fig. 6a), which composes round large particles and sub-angular fine particles. The design shear strength parameters of the backfill were an angle of internal friction equal to 35 degrees and a

A vertical 50 cm-wide zone composing gravel of graded crushed stone from a quarry (M-30, Fig. 6a) was arranged immediately behind the wall face to smoothly discharge toward the bottom of the wall face the water from the drainage geosynthetic strips as well as permeated rain water.

Radio Isotope method, performed eleven times at each place per an area of 1,000 m². Fig. 8 shows the histograms of the D_c values in the reinforced zone. The mean D_c values in valleys 1 and 2 were 98.0 % and 97.5 %, respectively, with standard deviations of 2.85% and 2.75% (i.e., a coefficient of variation equal to 3 %). These values fully satisfy the specified allowable lower limits (Table 1) and indicate that the backfill was compacted very well. The water content was also controlled during construction not to exceed 16 %, which is slightly wetter than the optimum water content (Fig. 6b).

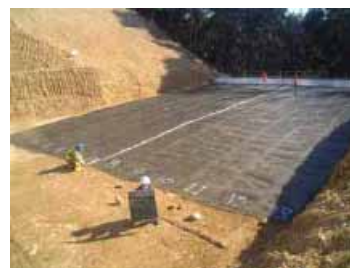
Fig.7. Installation of geogrid layers

Different types of geogrid made of Aramid fibre coated with HDPE having design tensile strengths ranging from 20 to 87 kN/m were used to reinforce the major part of the backfill. Fig. 7 shows a geogrid layer placed on the compacted lift of the backfill. Installation damage to the geogrid when the reinforced backfill is compacted using 10 ton-class vibrating roller compactors was evaluated by performing tensile loading tests of the samples of the aforementioned three types of geogrid retrieved from the backfill reinforced with geogrid layers as the actual walls in test compaction tests. It was found that the installation damage can be ignored.

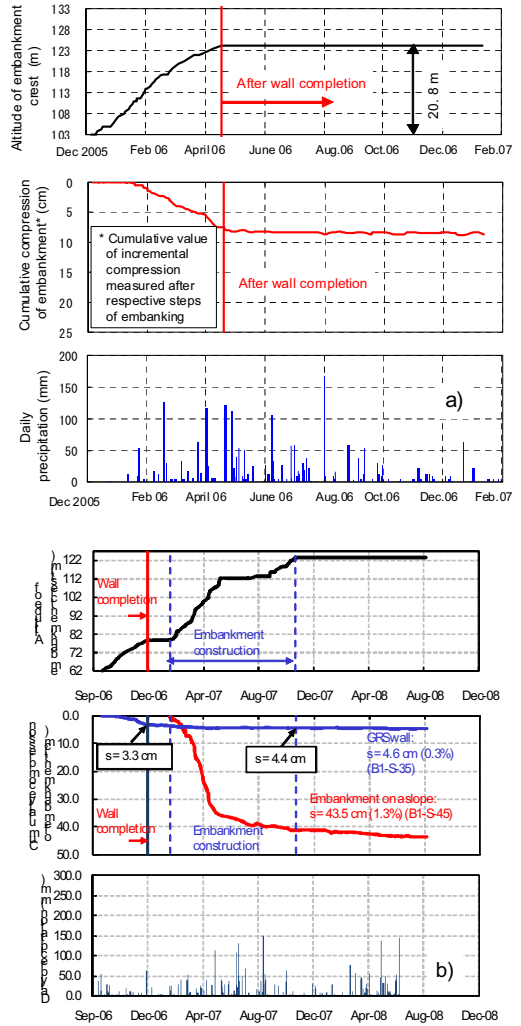
Fig. 9 a) Deformation of the wall and embankment on a slope, valley 1; and b) deformation of the wall, valley 2

The performance of the two GRS walls is presented in Figs. 9 and 10. The total vertical compression of the geogrid-reinforced backfill during construction is only 0.3 % (the wall in valley 1) and 0.5 % (the wall in valley 2) of the respective completed wall heights. Furthermore, the post-construction residual compression of the two walls was negligible. In particular, the deformation during a number of heavy rainfalls was negligible. This very high performance was due largely to the fact that the reinforced backfill was compacted very well (Fig. 8). On the other hand, relatively large compression took place during and after construction in the embankment constructed on a slope in valley 1 (Fig. 5a). This is due likely to that the backfill was not reinforced, therefore the compaction work was relatively difficult, and a larger compacted lift (i.e., 40 cm) was employed, despite the use of heavier compaction machines (a 18 tonf-class vibratory compactor). In particular, compaction efficiency is generally higher when the backfill is reinforced than when not, because lateral yielding of the reinforced backfill when subjected to heavy compaction load is better restrained. This high wall performance can also be attributed to effective drainage systems arranged inside and at the base of the backfill.

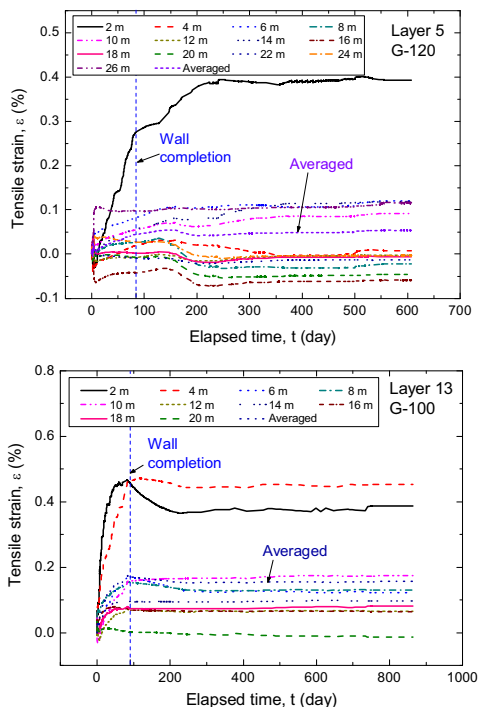
Fig. 11 shows the time histories of tensile strain at a 2 m-interval in representative geogrid layers (i.e., fifth layer in valley 1 and 13th layer in valley 2). The tensile strain increased at relatively high rates during wall construction. The largest strain at the end of wall construction was about 0.5 %, observed at 2 m from the wall face, which was much smaller than the strain at rupture in tensile loading tests of the geogrid (i.e., 4 %). This trend of geogrid strain indicates that there exists no sign showing the global failure of the walls. In the wall in valley 1, the increase in the strain continues by the end of construction of the embankment on the slope, which is consistent with the displacement at the wall face (Fig. 10). More details of the tensile strains in the geogrid and their analysis to estimate the tensile forces are reported elsewhere (Kongkitkul et al., 2010).

Fig. 11. Tensile strains in representative geogrid layers
