Serviceable life of geotextiles in various environments

Lucyna Niespodzińska
Maritime Institute, Gdańsk, Poland

Eugeniusz Dembicki
Gdańsk Technical University, Poland

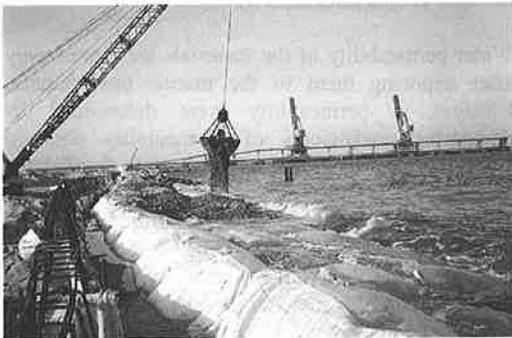
Fig. 1. Exposure site of the geotextile A and B (Table 1) to the marine environment in the North Harbour in Gdańsk.

Because fabrics have higher strength though lower permeability, a new type of fabric made from polypropylene fibres (Table 1, It. 8, 9) was made for use in structures. Polypropylene fabrics were used in marine environment both above and below water surface. This fabric was used for the located below water surface core of the coastal breakwater in the North Harbour in Gdańsk. The core was made in the form of multi-chamber geotextile segments filled with sand, Fig. 1 replacing the inner part of the breakwater's rubble mound. After two years of exposure in the sea, fabric taken from the structure for testing had unchanged strength parameters.

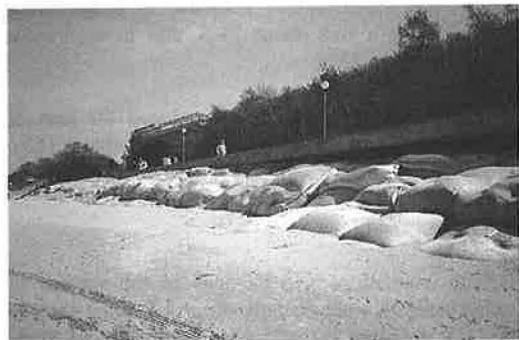
Fig. 2. Exposure site of the geotextile A and B to the marine environment (above water) in structures located on beach at Kołobrzeg.

Fabrics used in structures located on the beach to protect dunes against running up storm waves (Fig. 2), were made using stabilisers which prevented degradation of the fabric when exposed to UV radiation. After two years the fabric did not change its strength parameters, even though during storms a large part of the structure became uncovered and was exposed to sunlight.

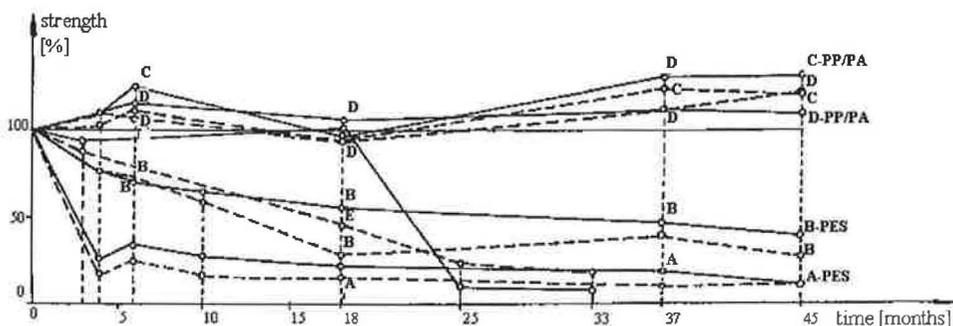
Fig. 3. Textile strength as a function of geotextile degradation in sediment - when extended longitudinally

Strength parameters and accompanying elongation under breaking load 1 were tested. In Fig. 3 results obtained for five kinds of geotextile materials are presented.

geotextile A - of PES; geotextile B - of PES - natural fibre waste blend; geotextile C - of PP and PA filament as the weft on a jute warp; geotextile D - of PP and PA blend; geotextile E - made of fibre glass.

From data presented on Fig. 3, it can be seen that the postsoda sediment environment causes significant degradation of material A and B - as indicated by the decrease of tensile strength after exposure. Also material E is degraded, and from a very brittle material in primary state, it becomes more

ductile (elongation grows) after exposing it to the sediment.

The strongly alkaline, calcium environment of postsoda sediments causes significant degradation of polyester materials, which means that geotextiles containing polyester PES have to be discarded.

Positive changes occur in materials C and D, the strength and elongation of which increase after exposure to the sediment. The postsoda sediment environment, containing large amounts of calcium carbonate, does not cause any degradation of geotextiles made of PP, PA and jute fibres.
