HUGO, F.

STRAUSS, P. and SCHNITZER, O.

The Control of Reflection Cracking with the use of a Geotextile. A Ten Year Case History**Controle des lézardes causées par réflexion en utilisant une natte géotextile—Un historique de dix ans**

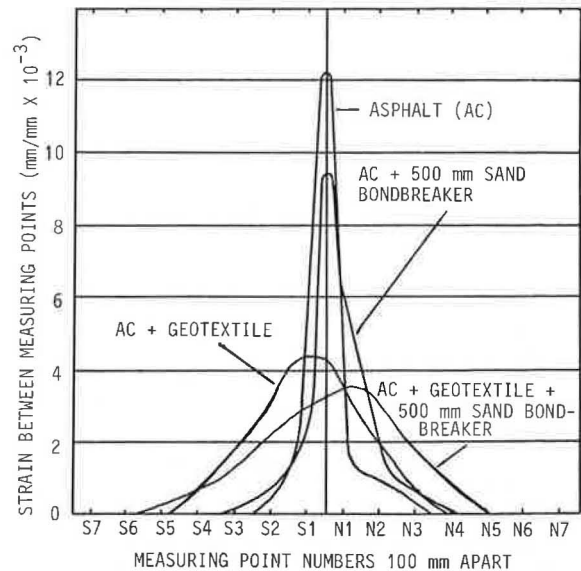
- 6 Figure 1 indicates some results of this experiment. At a crack width of 2 mm it can be seen that for the AC overlay alone the strain at the joint was 3,5 times that of the overlay consisting of reinforced AC with bondbreaking. Also the strain at the crack in the reinforced overlay without bondbreaking was 2,8 times lower than that in the unreinforced overlay. Bondbreaking alone reduced tensile strains by approximately 25%. Movement at the joint was distributed over a much larger area with the reinforcing and bondbreaker.

FIG. 1: STRAIN PATTERN FOR DIFFERENT TYPES OF OVERLAYS AT CRACK OPENING OF 2 mm

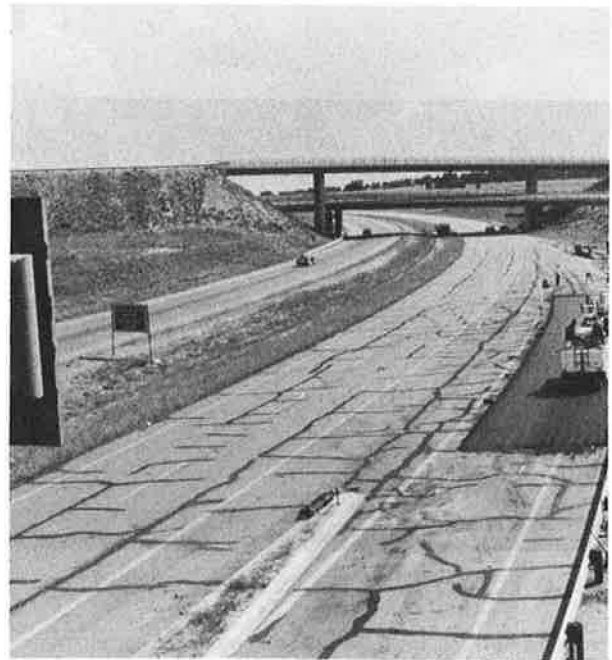
Fig. 4 General View of Site during Construction of Test Section

- 1 In general the crack pattern was strongly related to the underlying cracked CTB. (Compare figures 4 and 5).
- 2 Two types could be distinguished, viz.
Type 1: conventional true vertical reflection cracks extending from the top down into the CTB, and
Type 2: randomly spaced, short discontinuous cracks orientated similarly to *Type 1*.

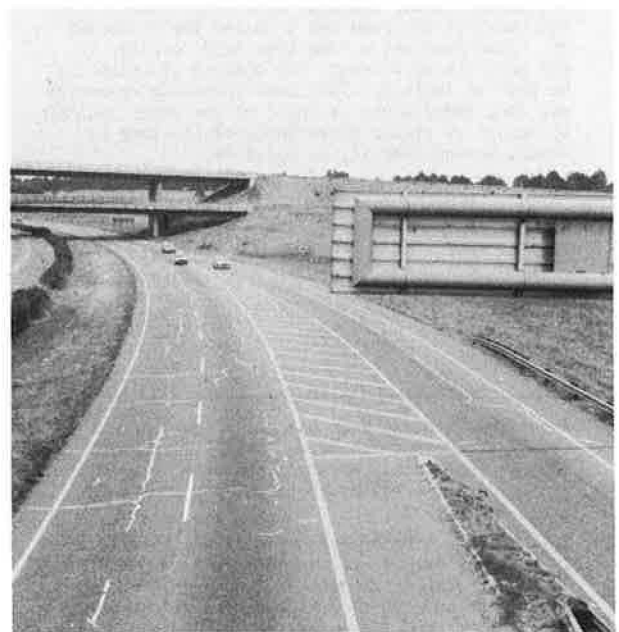
Fig. 5 Cracks demarcated with Lime during a Survey February 1982

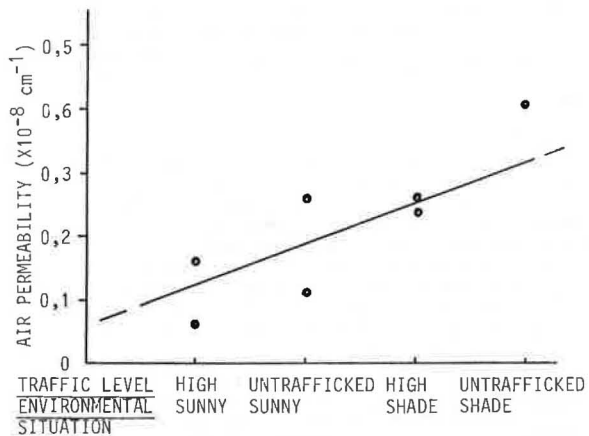
FIG. 7 : INFLUENCE OF THE ENVIRONMENT AND TRAFFIC ON PERMEABILITY

Deflections have so far been related to the structural performance of the stabilised base. Another important aspect that also needs consideration, is the performance of the gap graded asphaltic concrete overlay. Cores were analysed and it was found that the physical properties of the asphalt had changed due to traffic and environmental influences. In particular the permeability and density were affected. This in turn affected the stiffness. The capability of the mix to sustain deformation has thus deteriorated somewhat which could have caused the greater incidence of cracking. Results are shown in Figures 6 and 7 and Table 6.
