The first mining-landfill capping in Italy

ABSTRACT: The Rigoloccio mine in Tuscany was closed after more than 70 years of activity. The entire area has been reclaimed. The site morphology has been modelled, a capping system has been designed and a proper “green reclamation” has been developed. During construction a failure occurred on a limited portion (3%) of the slopes and it was the case of making a full set of analyses to understand the problem. The final results achieved are excellent and the solution has been used to new ongoing sites.

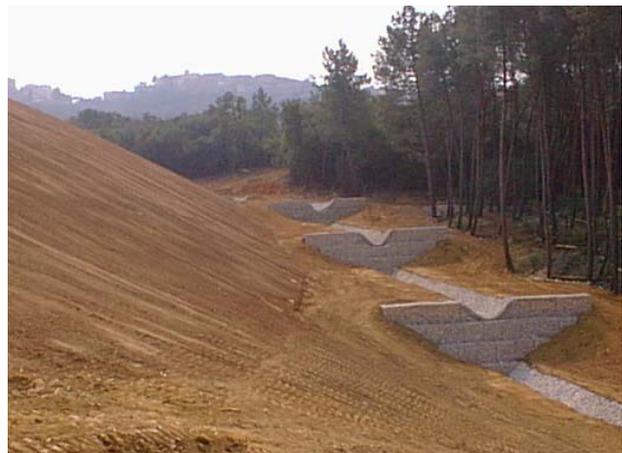
Figure 1. Reno Mattresses lining and bridles built at the toe of the slope of the capping.

To solve these problems the torrent bed was lined with Reno Mattresses and six bridles done with double twist steel mesh gabions were built in the steepest and most erosive portion of the torrent (Figure 1).

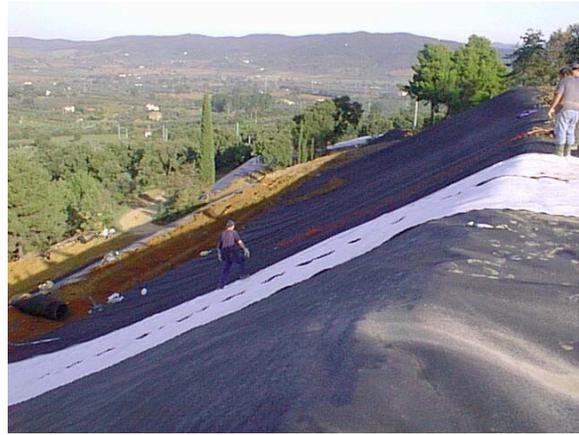
Figure 3. Typical cross/section of the geosynthetics capping layers (geomembrane – drainage composite – reinforced mat).

The geocomposite was laid in between the drainage composite and the vegetative soil layer in order to reduce as much as possible the costs (increased from the initial forecast by the need of a soil reinforcement). The drainage composite had only one geotextile-layering filter instead of two as originally designed. Figure 3 shows the final solution.

The slope length was not constant and the strength required from the analysis calculation exceeded in some sections what available; in these sections the reinforcement was doubled to satisfy the equilibrium. Where the slope high exceeded 15 meters,

the reinforcement was doubled for a length of 11 metres from the top of the slope.

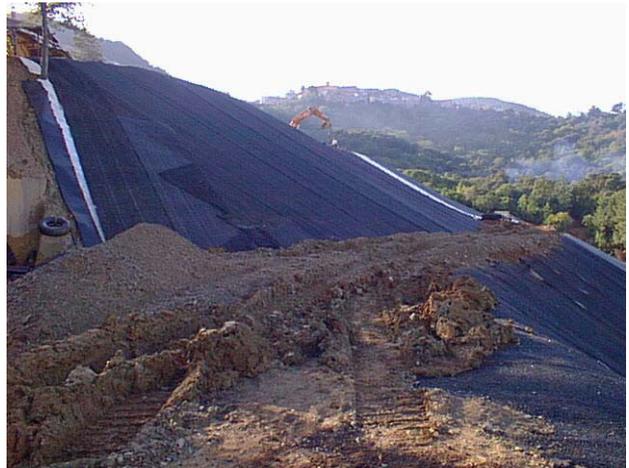
Figure 4. Soil ballast layer placed at the toe of the first slope in the intermediate berm.

Special care was due to the second slope anchorage to the intermediate berm. A layer of approx. 10 cm of soil was placed on top of the drainage geocomposite in order to improve the friction performances between the reinforcement composite and the drainage layer. On the reinforced mat was then laid a thick layer of vegetative compacted soil. The thickness of the layer placed on the intermediate berm ranged from 120 to 150 cm according to the slope height: 150 cm were used where the slope high was over 15 metres (Figure 4).

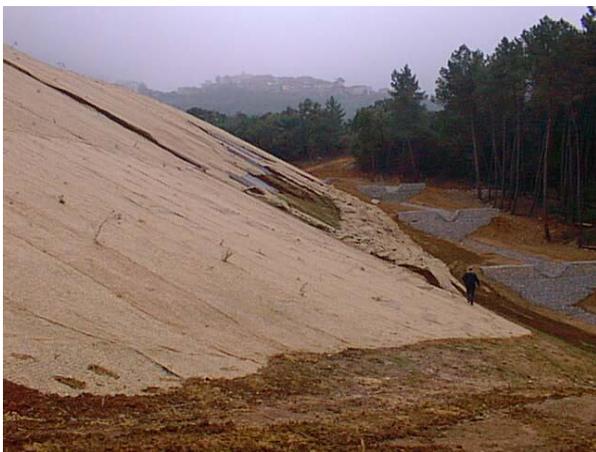
In spite of a geosynthetics package accurate design (ultimate state analyses had been done to check and verify the different package layers), the reinforced mat had a break in a small area – 500 sqm (Figure 5) on a full covered area of approx. 18.000 sqm. This happened after some heavy rains occurred during Spring 2000. The causes of this collapse have been deeply investigated with accurate back-up analyses before taking any action. The conclusion was that the collapse was possibly due to several factors like:

- The thickness of the layer that was deeper than supposed to be in the design stage ('in situ' investigations reported a thickness of the soil layer 30-40% thicker than supposed to be as showed in Figure 6).
- A decrease of the friction angle below the design value (set as usual to 12 degrees) due to the heavy rains occurred in that period.
- A possible increase of the weight of the soil due to his cohesive component.

Figure 5. General view of the collapsed area

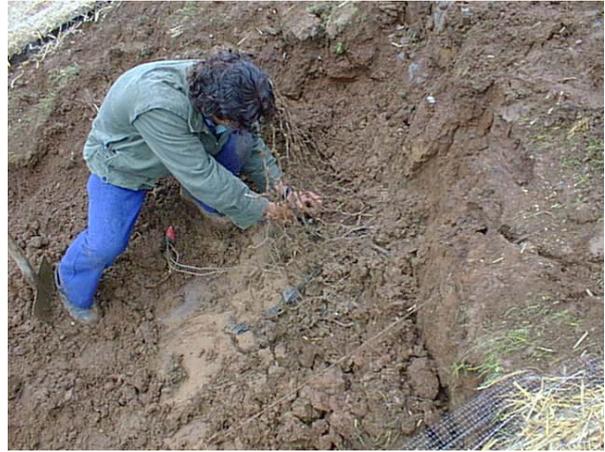
Figure 6. View of the broken reinforced mat

The collapse of the mat occurred – in most of the sections - exactly at the end of the additional reinforcement confirming that the collapse was due to a lack of mechanical strength and – in few other sections – at different points in the middle slope length. A back-analysis at the break location confirmed the initial evaluations. More difficult was to understand the few breaks occurred at the middle of the mat (probably due to bad connections of different mats).

Established that the problem was not in the geosynthetics itself or in the design philosophy and that the solution was correct, the materials have been replaced.

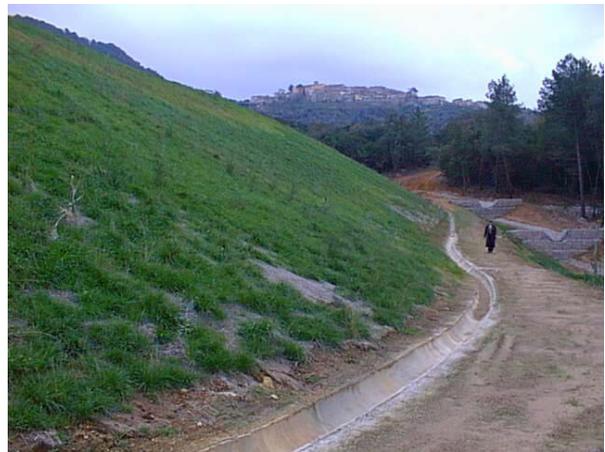
Figure 7. The collapsed area after the rebuilding.

In order to increase the safety of the most critical sections the length of the secondary reinforcement was increased for the whole length of the slope from bottom to toe. To reach the toe it was also necessary to build a ramp; the construction of this embankment reduced the free length of the slopes and increased the safety factor of the new sections. So doing the slope integrity has been quickly re-established (Figure 7).

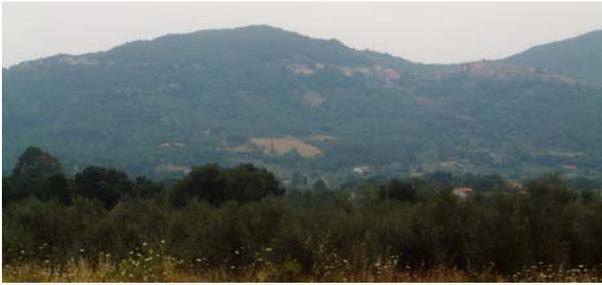
The final results (Figure 8) achieved was excellent and the same solution has been applied in the design of a second landfill to be recovered in the same area.

Figure 8. Panoramic view taken from the close motorway of the reclaimed area.
