The use of spunbonded geotextile in railway track renewal St. Petersburg-Moscow

E.S. ASHPIZ, University of Transport Engineers, Moscow, Russia
R. DIEDERICH & C. KOSLOWSKI, DuPont de Nemours, Luxembourg

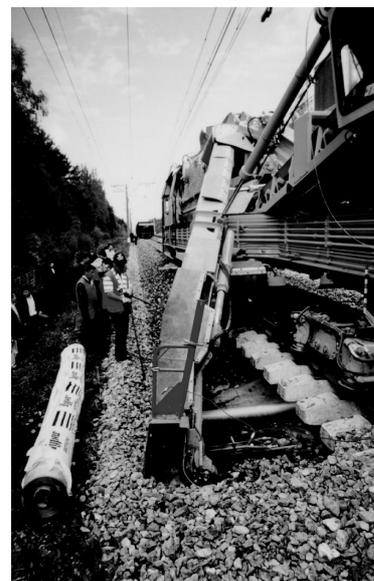
Figure 2. Track renewal with specialised equipment

The line renewal operations were done during 8 hours daily. After that, the line was opened again for traffic. Crushed stone cleaning and geotextile laying were performed using specialised equipment without removing the track. The geotextile was laid on the top of the old ballast and covered with cleaned crushed stone without additional protective layer.

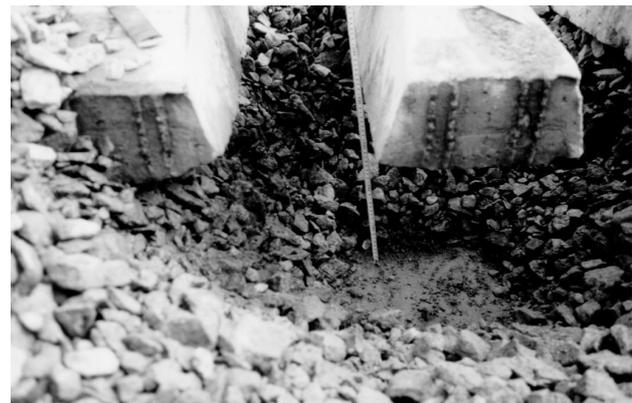
Figure 3. Excavation from under the track

After 5 years of service life the track was opened on several sections in order to determine the performance of the geotextile. Samples were excavated and tested to determine area weight, breaking load and water permeability.

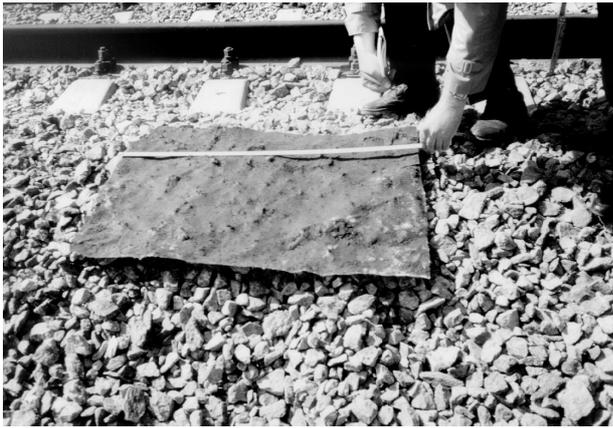
Figure 4. Excavated sample of geotextile with some old ballast

Some contamination of the geotextiles was noticed after extraction. Tests of the un-cleaned geotextile with ballast showed that the water permeability of the whole structure decreased only 1.5 times. The conditions found on the track at various sections confirmed that the existing decrease in water permeability of the geotextile did not affect humidity conditions of the structure as most part of incoming water is drained in the ballast layer on top of the geotextile. During extraction it was found that the moisture content of the ballast under the geotextile was 1-2% less than above the geotextile.

It was clearly visible that the contamination was mainly coming from the top of the structure due to abrasion of ballast and rain falls. Only minor contamination was found on the bottom part of the geotextile.
