Thick and abrasion resistant geotextile for use under the ballast in railways structure

NANCEY A., BIDIM Geosynthetics S.A., France
 IMBERT B., ROBINET A., SNCF, France

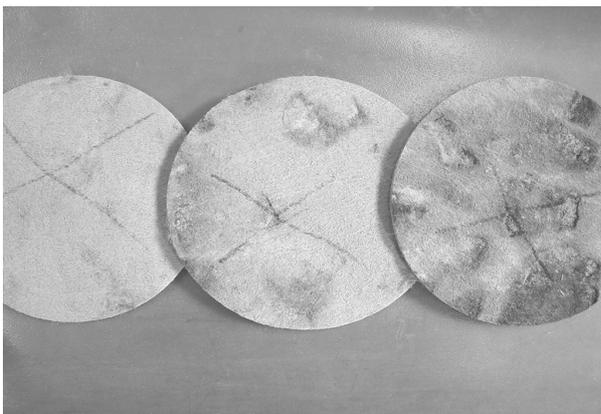
Figure 5 : Samples excavated after 200 hours

- During the excavation of the geotextiles after the third phase of 20 hours, a larger quantity of fine soil was observed for the wet sample
- The central area of the geotextile is more marked than on the side. This is due to the heavier loading under the concrete foot. Figure 5 shows specimen coming from different areas on the same sample after 200 hours.

- Not any hole or tear has been observed on the different extracted specimens.
- The prints made by the ballast were more or less important depending on the duration of the stresses. The geotextile removed after 200 hours was logically more marked than those having stressed during 20 hours at the vibrogir.

- For the geotextiles removed after a long duration (80 hours to 200 hours), a light worn can be observed, traduced by several abrasion marks and some filaments partially dissociated from the layer. But generally, the samples were still in a good condition.

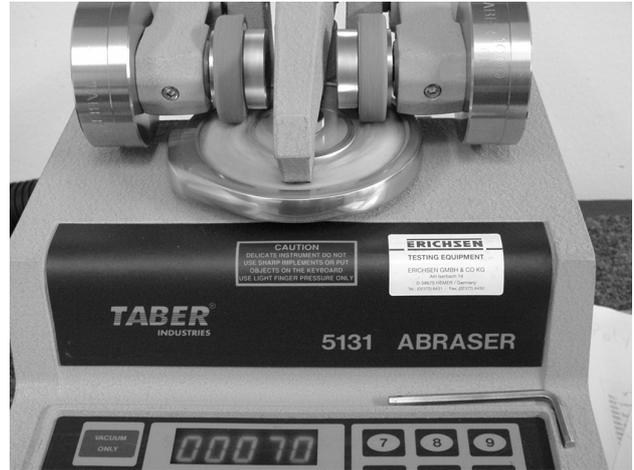
Figure 6 : Abrasion test device

- the pyramid puncture resistance following the French standard NF G 38019. This test should allow to measure the puncture resistance of a geotextile in similar conditions than if it was submitted to the stress of the ballast. The size of the pyramid piston is closed to the size of the stones.
- an abrasion test realised following the standard ASTM D – 3884. The geotextile is submitted to abrasion by a rotative system until his destruction. The number of revolutions reached by the sample constitutes the result of the test.
