Two major geogrid reinforced rockfall barriers in northern Italy

ABSTRACT: The paper describes two interesting examples of geogrid reinforced rockfall barriers designed and constructed in Italy, in the Alps region close to the France border.

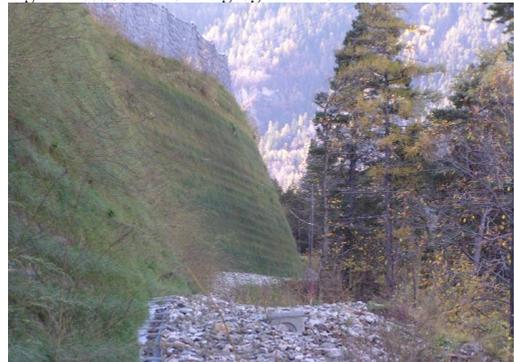
Fig. 2: downstream picture of the barrier

The protection structure designed was consisting in an embankment reinforced with extruded HDPE geogrids (Table 1), with faces inclined at 70°, using wrap around technique with steel mesh formworks at the face. The barrier was 340 m long with a maximum height downstream up to 16.00 m and a maximum height upstream of 7.00 m; the width at the crest was kept equal to 2.50 m in order to allow the subsequent installation of a 3.00 m high steel mesh barrier, capable to absorb a maximum energy of 2000 kJ (Fig. 1 and 2).

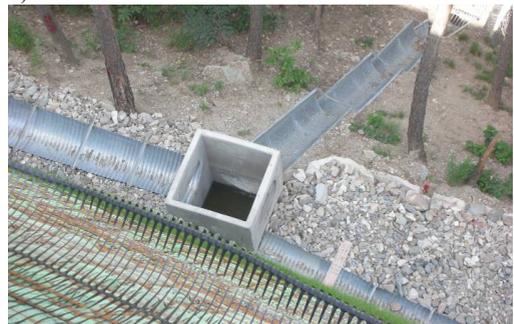
Fig. 3: steel gutters and collection boxes - downstream face.

The construction of a soil embankment acts as a dam capable to stop or divert the superficial runoff. This could lead to possible problems in case of heavy rainfall; an accurate drainage systems was then designed and constructed. At the base of the whole upstream side of the barrier a stainless steel gutter was laid; drainage of the water was ensured through drainage geocomposites laid at 20 m interval along the excavations surface. The water collected was reaching the downstream face in stainless steel ditches at the base of the downstream face (Fig. 3).

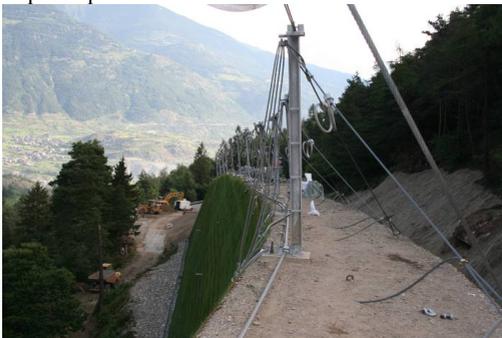
Fig. 4: Installation of the steel fence on top.

The design and construction of the steel barrier on top too was extremely challenging. Clearly a conventional steel barrier with ropes connected to the upstream side was not feasible, as the distance between the top of the embankment and the slope was excessive. A system with anchorages and brakes directly laying on the crest of the embankment was necessary. Several systems with such a fixing device exist; however, the efficiency of the anchorage system is something that needs to be tested and proven, as the anchorage bars or ropes are inserted in a “re-constructed” soil and not in a natural soil. To verify the efficiency of those anchorage a full scale pull-out test was decided. Both a steel bar, 32 mm diameter and 6.00 m long, grouted and a steel rope with the same length and grouted were showing a pull-out resistance well exceeding three tons, although the test was done in a position very close to the face of the embankment. Those tests were giving adequate guarantees that the complete system (geogrid reinforced barrier and steel barrier) could guarantee the required protection.

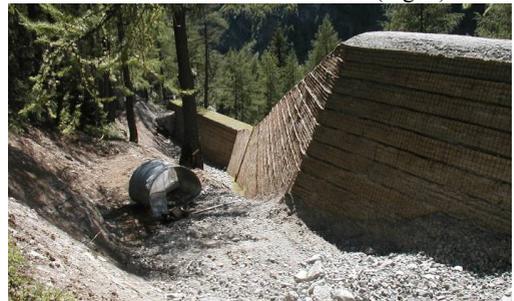
Fig. 5: Construction of the barriers at Rhemes.

The analysis of the size and dimension of the previously felt and of the possible future boulders was showing a high percentage of rocks smaller than 6 m³, but also fewer blocks (2% on the total amount) with dimension up to 15-16 m³. The analysis of the possible trajectories for the smaller boulder were giving as a maximum impact energy a value of 4000 kJ, value covered without problems by the test and the certifications of the rockfall barriers used. Barriers were built between 2002 and 2003 (Fig. 5).

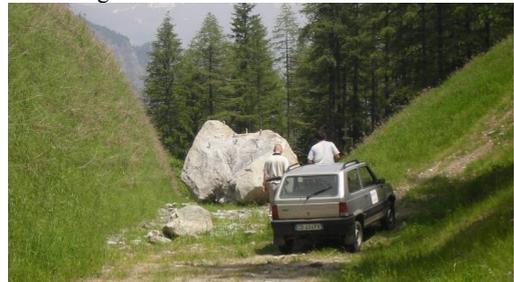
Fig. 6: Boulder, 35 m³, reaching the lower level of barriers.

Unfortunately, during an event occurring in 2008, among some smaller boulder two big boulders, respectively 35 m³ (Fig. 6) and 30 m³ (Fig. 7) were falling from an area slightly below the expected one (altitude 1900 m) and after a trajectory that nobody could witness, were reaching the position of the barrier hitting the same.

During an inspection of the site a few days after the event it was possible to verify that the impact was causing minor damages to the structures and that they were still capable to resist further impacts without need to provide important repairs.

Once it was clear that the road, the electric line and the town were safe, it was possible starting to define a remediation system, and it was possible to try to run a sort of back-analysis of the event to try to guess the possible type of energy to which the barrier were subjected. With a simple calculation based on the transformation of the potential energy into kinetic energy (without dissipations) considering the masses of the two boulders (79 and 92 tons) and the difference in altitude (355 m for the barrier hit by the 35 m³ rock and 310 m for the other one), this was leading to unrealistic values of both the impact velocity and the kinetic energy (83 m/sec, 276,000 kJ and 78 m/sec, 241,000 kJ). Obviously the no-dissipation assumption is not realistic. A sensible hypothesis on the reduction of the velocity due to rebounds, impact against trees or other rocks could be done; assuming that the speed at the moment of the impact is 20% the one obtained before (around 16 m/sec for both cases), we have impact energies of 11,000 and 9,600 kJ, that seem to be absolutely realistic.

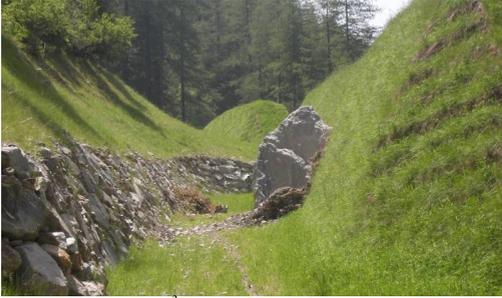
Fig. 7: Boulder, 30 m³, reaching the upper level of barriers.

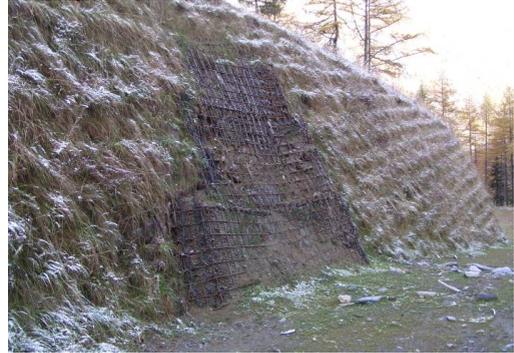
Fig. 8: Repair of the upper barrier.

As said before, these event were a good opportunity to define a possible remediation system after the impacts. As said before, the damage was minor and the maximum excavation depth was limited to 200-300 mm; in these situations it is necessary to prevent the washout of the soil from the area where both the geogrid at the face and the vegetation are missing, and where the geometry can be overhanging. In this situation it is necessary to fill the holes with soil, compacting it as much as possible, for example with the backhoe; for the upper part, where overhanging can occur, it can be necessary using a new steel mesh formwork at the face with a geogrid inside as a formwork to keep the soil in place. The finished surface should be protected from erosion during the period between the end of the work and the growth of

the grass, for example by using geomats or biomats, or hydroseeding the face.
