## Vittel road platform waterproofing

**ABSTRACT:** The Vittel (France) bypass which was constructed in 1995 is located within the protection area of the well known mineral water named Vittel. In order to meet the requirements of the french regulation for the protection of the ground-water, the road platform was lined with a geomembrane lining system. The design, the installation, the quality control and the quality assurance related to the installation of the lining system are described in this paper.

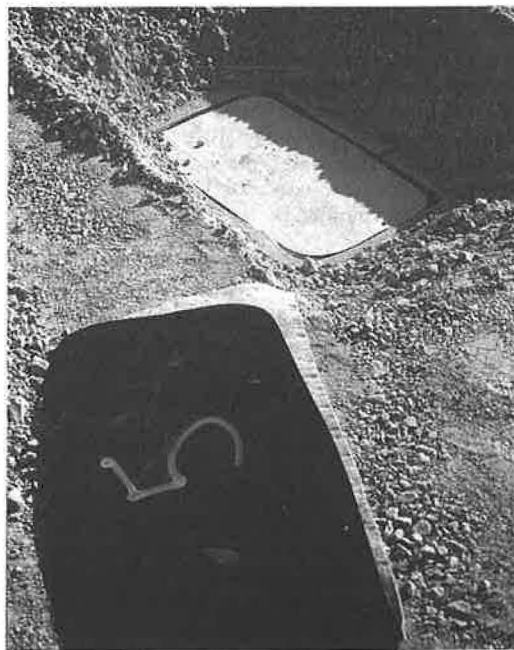
Photograph 1. Sampling of geomembrane on the pilot test. Vittel bypass.

After the placement and the compaction of the upper granular layer, the soil was carefully removed in order to evaluate by a visual inspection the damages of the geomembrane. A preliminary visual inspection was performed and ten samples of geomembrane (1 to 2 m<sup>2</sup>) were cut for a detailed visual inspection and evaluation of damages (Photograph 1).

Each sample was inspected by the Project Manager Quality Assurance Team. A first classification was so achieved. The samples of geomembranes were then passed to the laboratory of the Project Manager Quality Assurance Team. A detailed visual inspection was performed by a technician who did not participate to the pilot test, and who reported the number of damages, their sizes and deepness. A final selection was thus performed.

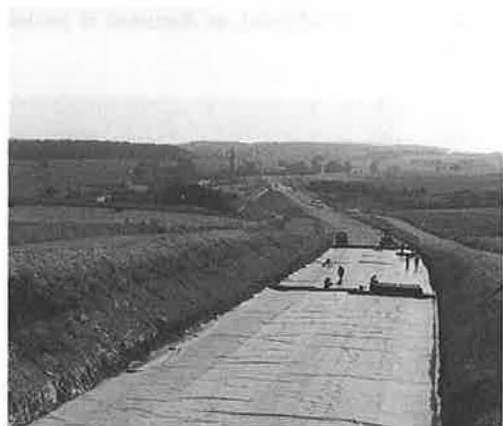
Photograph 2. Installation of the lining system on the Vittel bypass.

Geosynthetics, which were delivered on site as rolls, were unrolled along the road axis (see Photograph 2). Four rolls of geotextiles and three rolls of geomembrane were so usually installed within the width of the platform.
