Sustainable rehabilitation of a highway slope failure with geosynthetics

ABSTRACT*:* This paper presents a novel solution by taking into account of safety and sustainability to cope with a damaged slope. The rehabilitation consists of a piled supported reinforced concrete protection wall and a reinforced soil slope (RSS) with geosynthetics. Such approach is not common; however, the experience described herein has shown that the reported composite retaining structure meets all the site criteria. RSS demonstrated competent safety and significant carbon footprint reduction compared to those of traditional reinforced concrete structures. RSS also successfully made a vegetated terrain that has presented a natural appearance and provided an aesthetic and eco-friendly environment for the site. Based on field observations, the slope is stable and safe to date. It is a valuable and sustainable solution particularly for those sites that have a major concern with basal instability due to scouring effect.

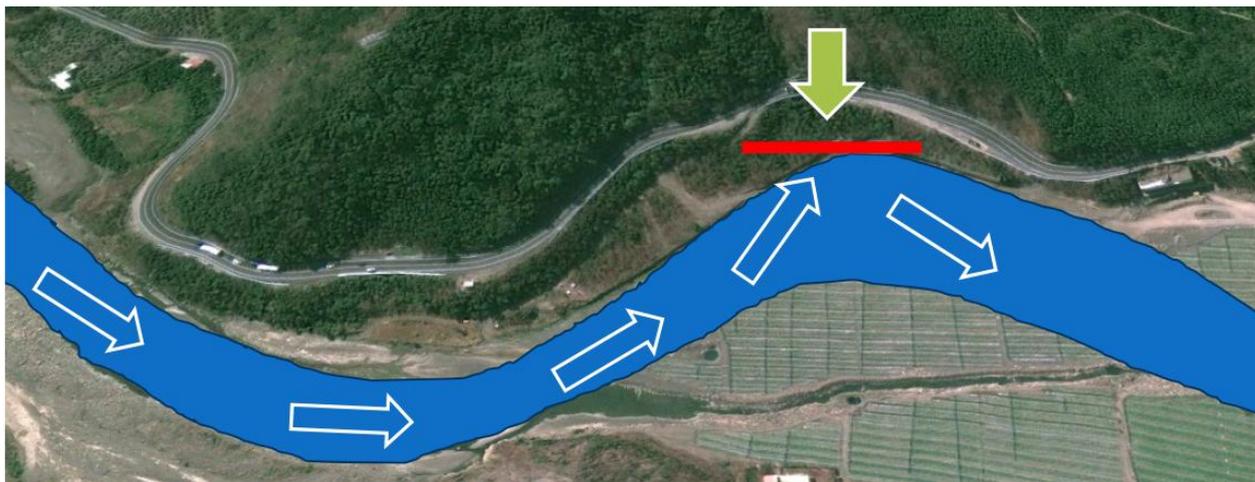
Route 9 is the most important arteries in southern Taiwan with world-famous natural scenery along the line. In August 2013, Typhoon Kongrey hit the island with heavy rainfall and caused numerous infrastructure damages in these areas. As shown in Figures 1~2, the site reported herein located at Sta. 470k+500 where its downslope was totally collapsed due to the riverbank breach which was smashed by the rushing flooding of the adjacent River. The in-situ drainage system also was found insufficient to accommodate the enormous overflow came from the upper land of the site. The highway was seriously disrupted and the rehabilitation was immediately necessary to resume the normal livelihood of residents and minimize the loss of local tourism productions.

Figure 2. Severe scouring smashed the riverbank and caused disruption of the highway.

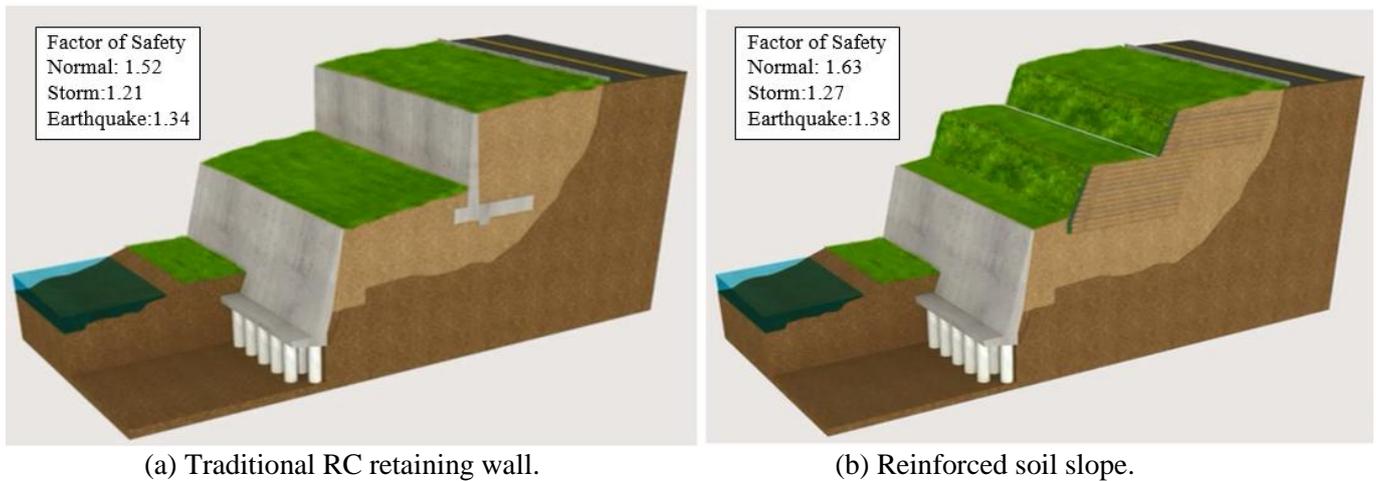
Figure 3. Proposed design schemes and their safety evaluation.

verse effect of concrete structures, the designer proposed to use geosynthetic reinforced soil slope (RSS) to replace the upper retaining structure (Figure 3b). As can be seen in Figure 3, both design schemes presented comparable safety condition. RSS has been successfully used worldwide for the past decades to stabilize slopes with high merits in sustainable and eco-friendly environment (FHWA 2009).

The traditional solution for the case reported herein would be simply building a staged cast-in-place reinforced concrete (RC) retaining walls and then backfilled in layers with qualified imported materials to the elevation of the pavement. However, it would be the same as before, the retaining wall on a shallow foundation would most likely be destroyed again by violent floods. Pile foundations, therefore, must be used to support the structure so that it can stand firmly on the steep slope and provide sufficient protection for river scouring (Figure 3a). Although sustainability and management of carbon emissions are the required missions for this project, stability must be warranted to assure public safety. To improve the ad-

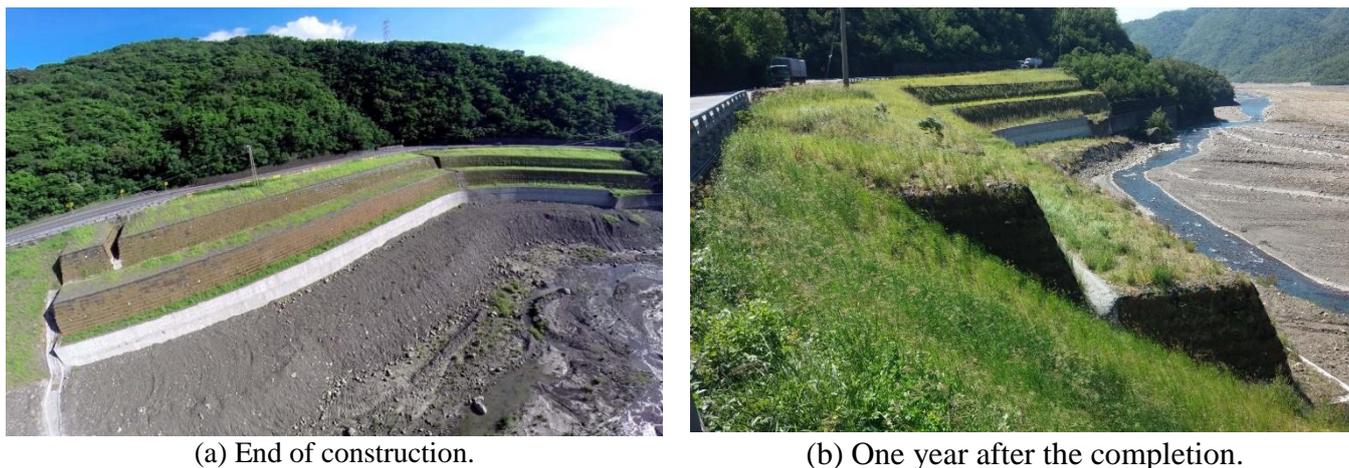
(a) End of construction. (b) One year after the completion.
Figure 6. Completion of the rehabilitation.

After four months of construction, this project was successfully completed in May 2014. Since then it has been through a number of typhoons attacks and by far still remaining in good condition (Figure 6). Although it has always experienced heavy traffic, no evidence has been observed for deterioration or instability. Vegetated slope presents natural appearance and provides an aesthetic and eco-friendly environment for the site. As many other similar projects already in use, the rehabilitation has been proved successful.
