# Durability of a 13-Year Old Test Embankment Reinforced with Polyester Woven Fabric

G. H. Troost, G. den Hoedt, P. Risseuw & W. Voskamp  
Akzo Nobel Geosynthetics bv, Arnhem, The Netherlands

**ABSTRACT:** In the summer of 1980, a geotextile-reinforced steep earth dam was built, using a polyester woven fabric. The purpose was to investigate construction techniques and greening and protection systems. The dam, with an overall length of 50 m, was built with 2:1 and 4:1 slopes, using partly sand and clay as fill.

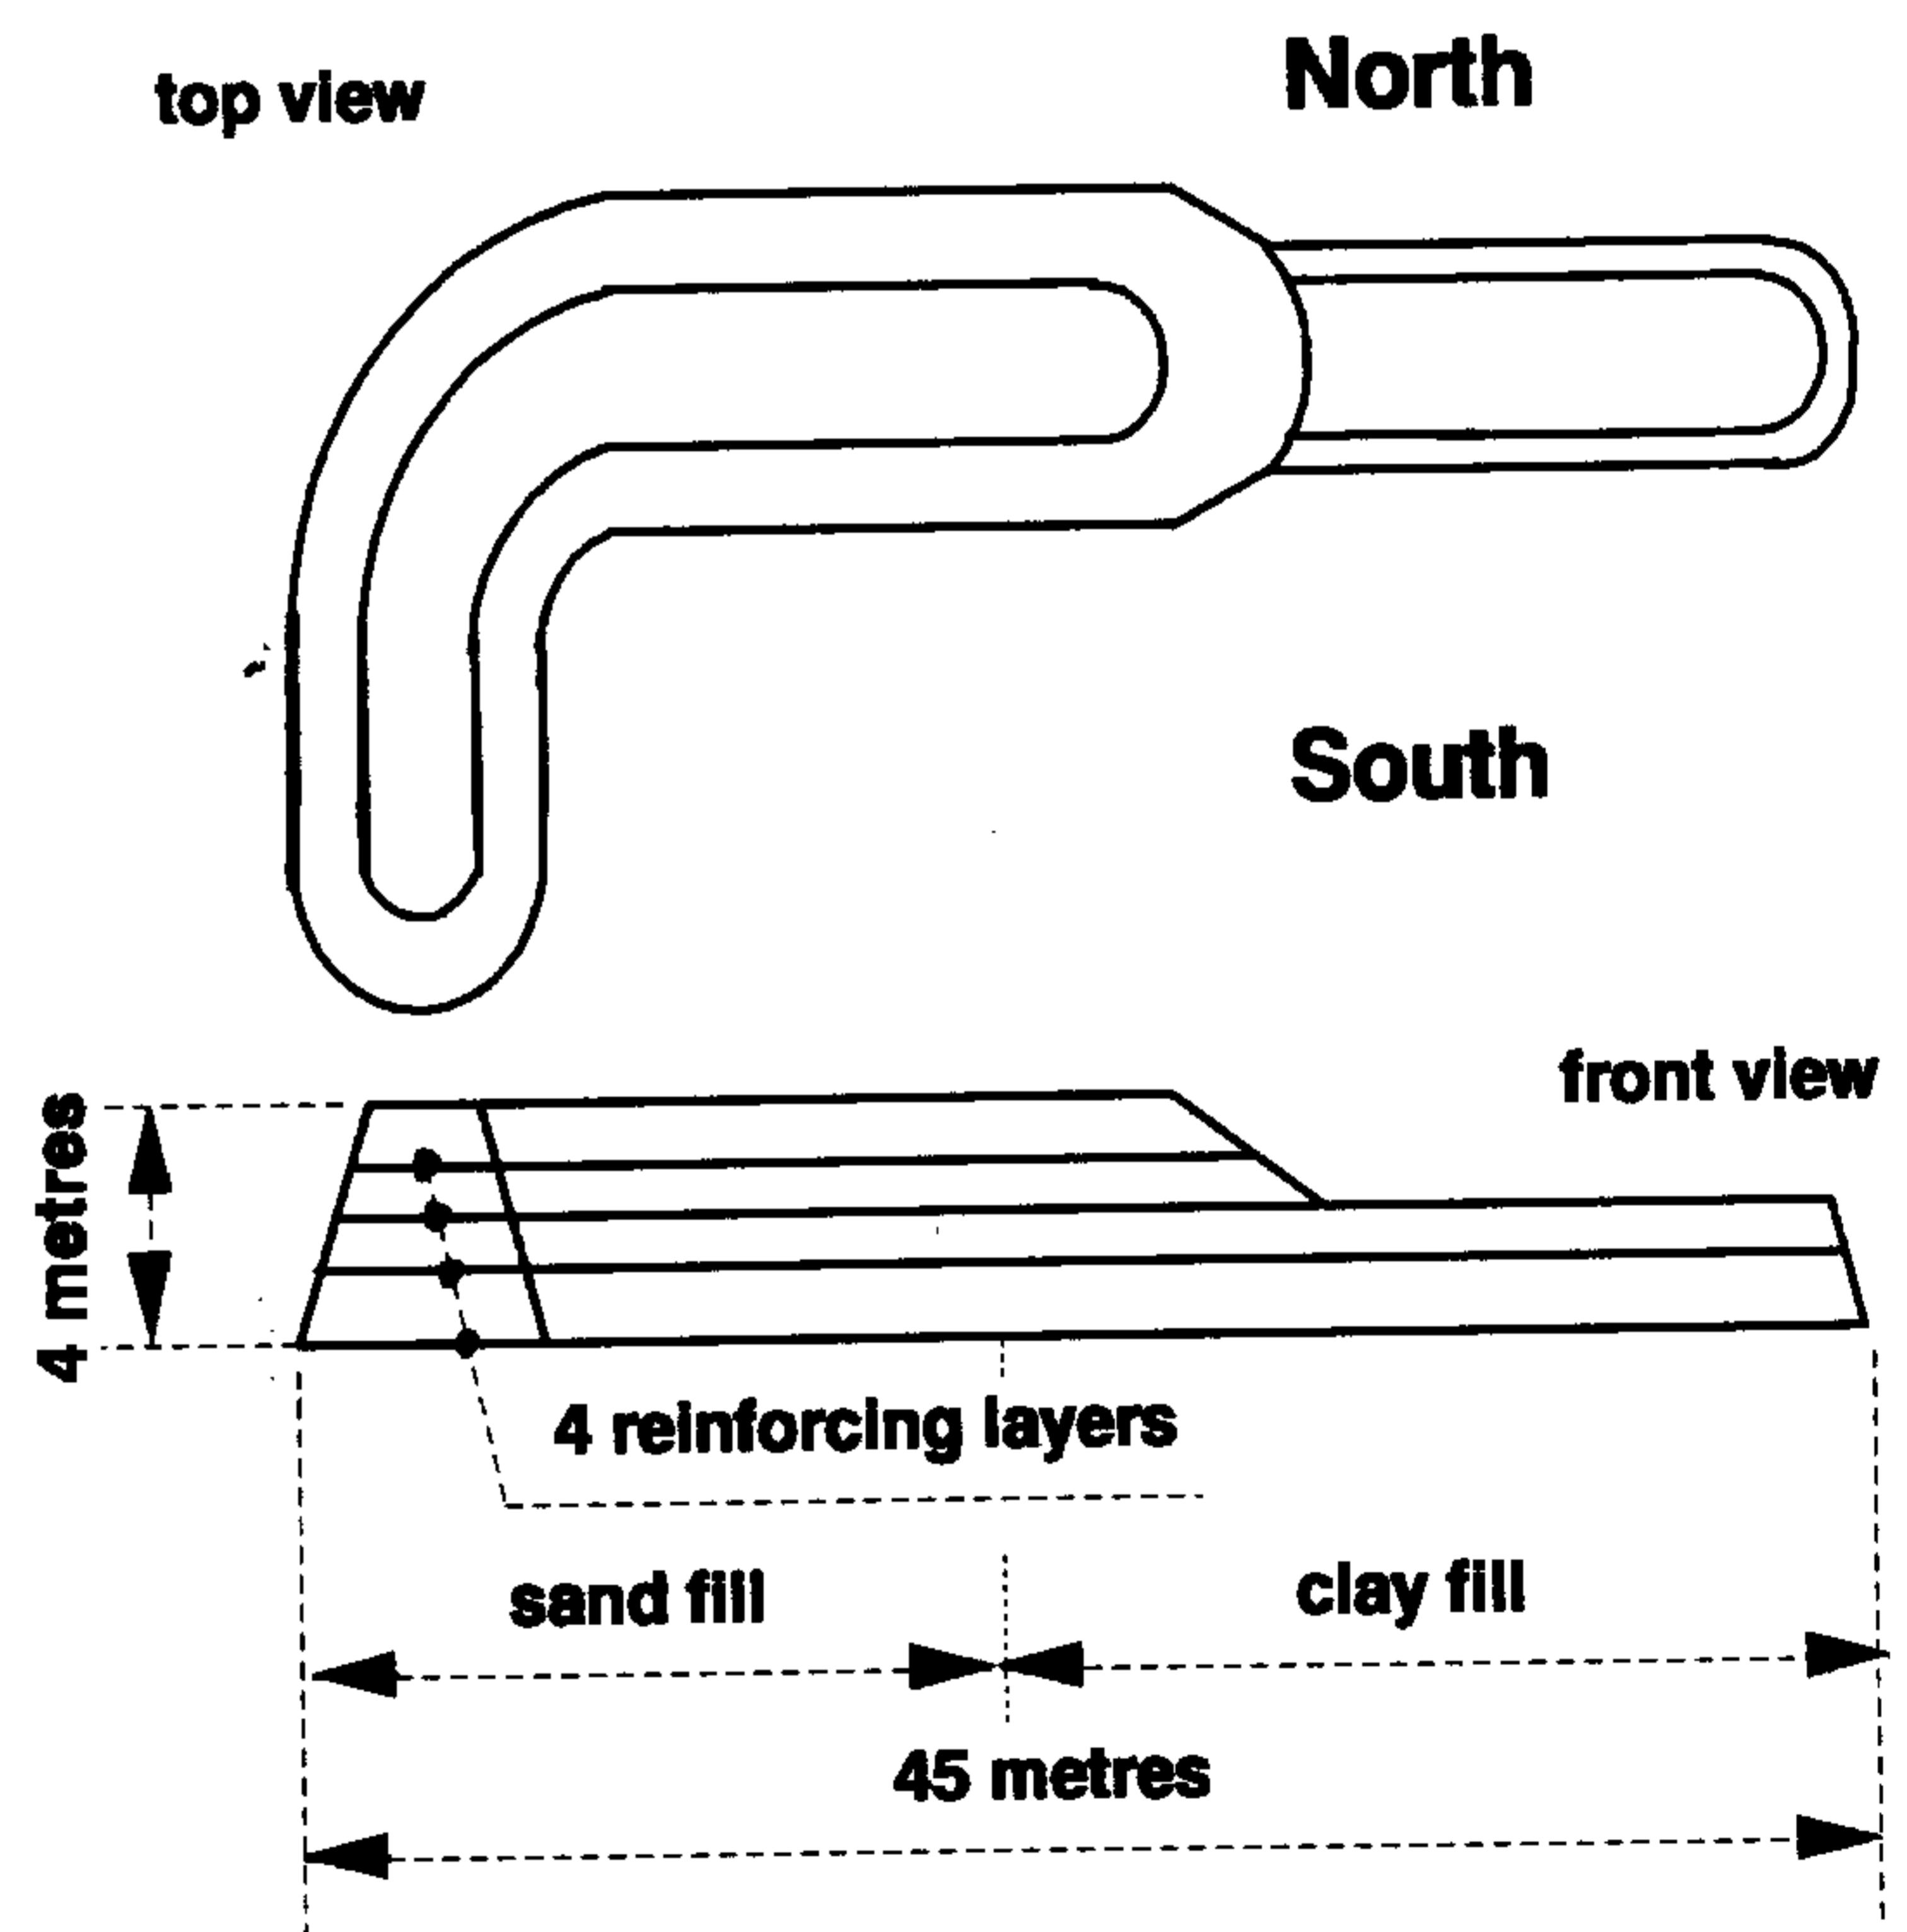
Fig.1 Design and shape of the dam

Figure 1 shows the design of the dam. The 90° bend in the dam was made to test the feasibility of providing an emergency path through such a dam in the event of its use along a highway without adversely affecting the dam's function as a noise-abatement barrier. The base width of the dam section with 2:1 slopes was 5 m; in the section with 4:1 slopes it was 3 m.

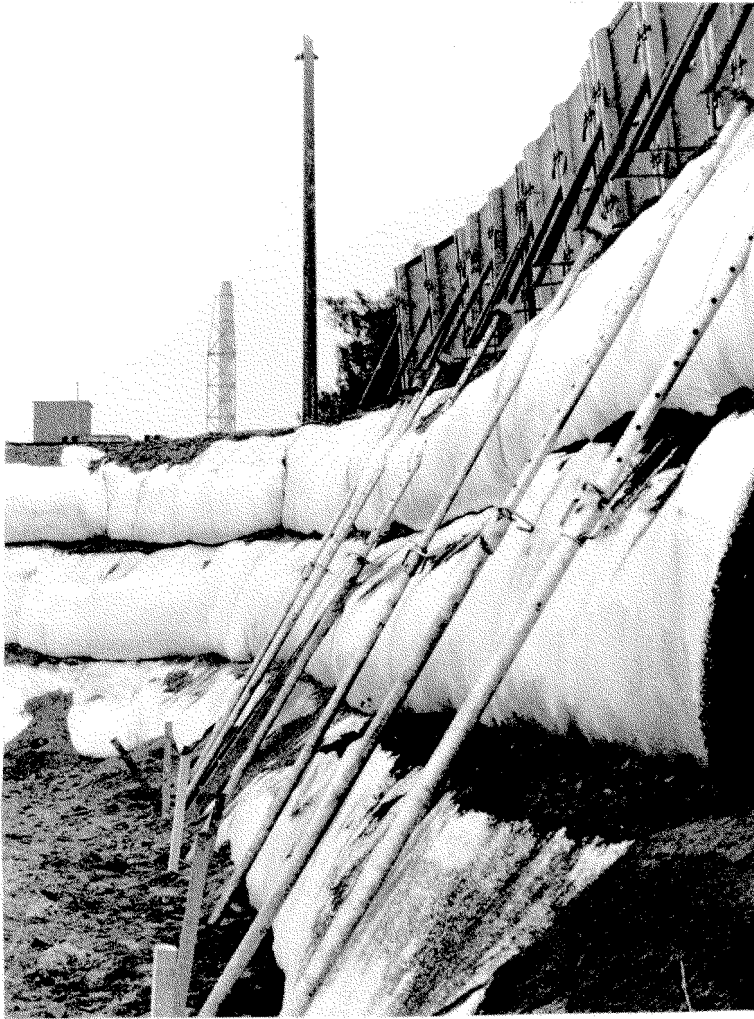
Fig.2 View of dam under construction

The dam was constructed in 1-metre-high layers, as shown in Figure 2.
