## APPLICATION AND MONITORING OF A COMPLEX SOIL REINFORCED STRUCTURE NEXT TO FAULT ZONE

### ABSTRACT

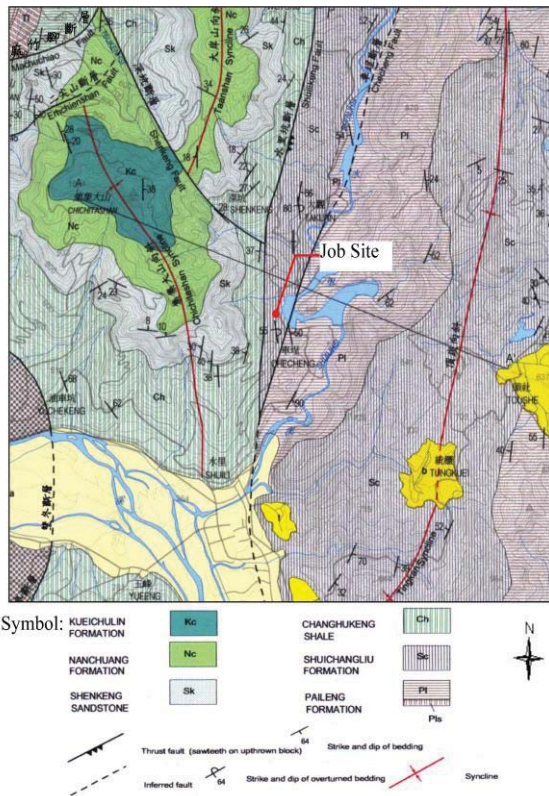
Fig. 3 Regional geological map (Central Geological Survey, MOEA)

The regional geologic map shows that there are several fault zones cuts through the job site area, rock mass is fragile and weak. It was assumed that the layer at landslide area was affected by fault, see Figs. 3 and 4. According to the on site boring hole results: 0m to 5m is colluvial soil, 5m to 35m is crushed stiff shale rocks and more complete stiffer shale rocks distributes at 35m to 60m. Groundwater level is between the colluvium layer and crushed stiff shale rock layer. Moreover, fault gouge is also mixed in the crushed shale layer, as Fig. 5. Table 1 shows the soil properties of each layer.

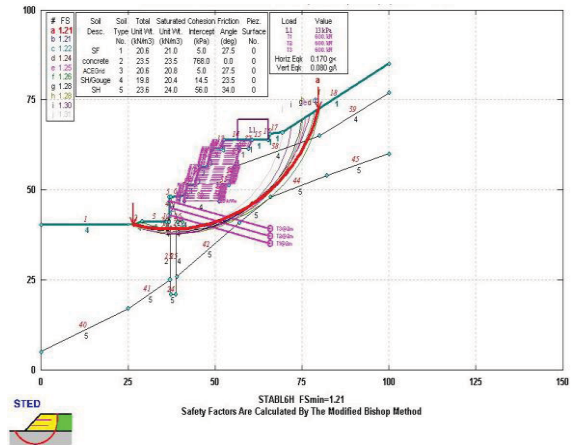
Fig. 8 Stability analysis (Earthquake mold)

Mold	Normal	Heavy Rainstorm	Earthquake
Factor of Safety	1.57	1.12	1.21

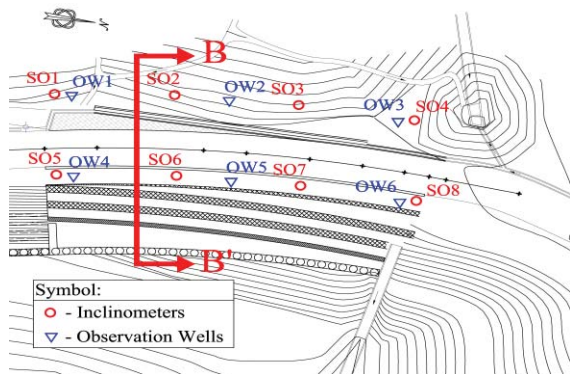
Fig. 11 Monitoring configuration

Surrounded by many fault zones, the geology at site is very fragmental and groundwater concentrates on fault gouge easily. To monitor long term deformation of the structure, 8 inclined tubes and 6 groundwater observation wells were installed on upper slope and reinforced zone of the structure for one-year monitoring of slope displacement and variation of groundwater level, see Fig. 11. Data of maximum displacement, maximum accumulated displacement and displacement rate are shown in Table 3.
