## A FAILURE CASE STUDY ON REINFORCED SOIL SLOPE OF A 220KV SWITCHING STATION

G. Xu<sup>1</sup>, Y.M. Shang<sup>2</sup>, T. Mei<sup>2</sup>, R.S. Tang<sup>2</sup>, and K. Gao<sup>1</sup>

### ABSTRACT

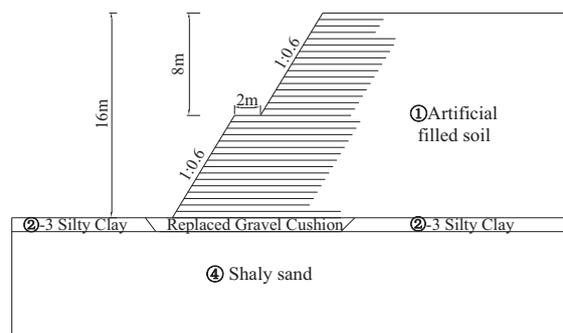
Fig. 6 Calculation model of the reinforced slope.

In order to analyze the stability of the original design, limit equilibrium methods, such as Bishop simplified method, Janbu simplified method, Spencer method and Morgenstern-Price method (Chen, 2003), are utilized to calculate the safety factor of the slope. The dimensions of the calculation model are 27m × 43m (Fig. 6). Material parameters of each layer are illustrated in the previous section. Software package Slide 6.0 (Rocscience, 2012) released by Rocscience Inc. and the Mohr-Coulomb strength criterion are employed in the calculation.
