# Mechanically stabilized earth (MSE) wall failures due to hydraulic situations

George Koerner & Robert Koerner  
*Geosynthetic Institute, Folsom, USA*

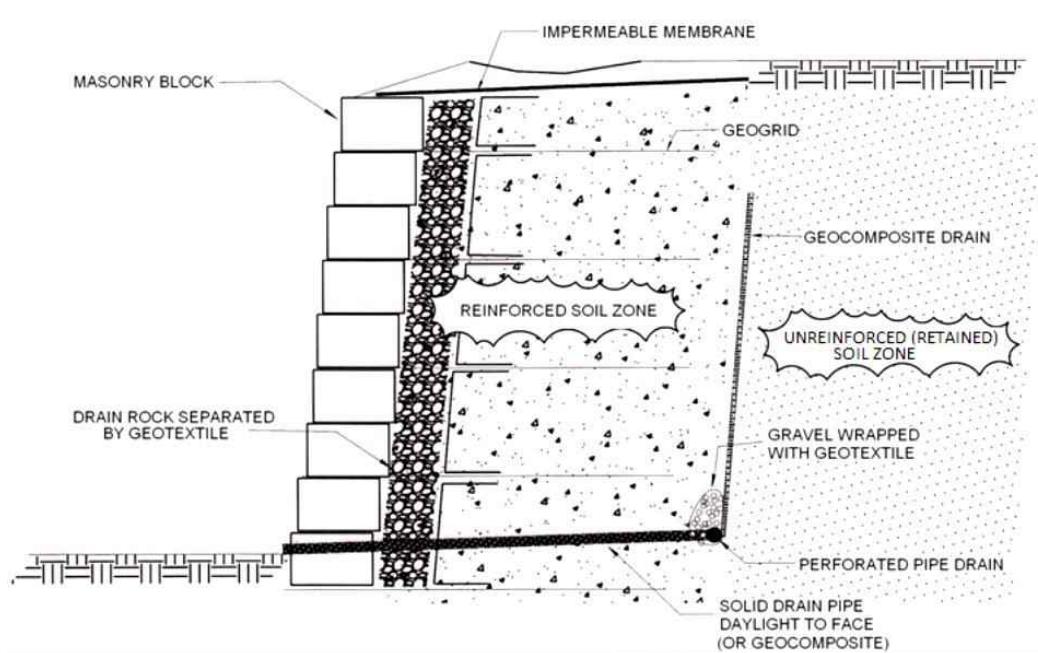
In light of the 220 (73%) cases that used fine-grained soil backfill (with the large majority having poor-to-moderate compaction) four distinct drainage locations must be designed accordingly. These are addressed individually in the paper, see Figure 5. Of course, use of sand and/or gravel backfill would largely solve the problem from occurring, but cost differences appear to dominate most decisions. It is estimated that cost savings using on-site fine-grained soils, versus quarry purchased granular soils, represents 50 to 75% the cost of a given wall. Thus, there exists the necessity of providing front, back and base drainage as well as a hydraulic barrier at the upper ground surface. These four topics follow.

Figure 4. Front, back and base drainage layer locations as well as impermeabilization of the top surface. (Compl. TenCate Geosynthetics, Inc.)

Located immediately behind the wall facing system is a layer of gravel for the purpose of eliminating water flow through the masonry block, gabion or other wall facing; recall Figure 5. This gravel layer is typically 300 mm thick and actually fills in hollow block voids if they are used. The accumulated water flow is gravitationally transmitted to the toe of the wall and exits either by periodically spaced weep-holes through the toe of the wall, or is collected by a drainage pipe to exit at the ends of the wall. *Absolutely essential is that the gravel layer must be separated from the fine-grained backfill soil with a geotextile filter; see Koerner and Koerner, 2017*). This filter layer must be wrapped around each soil lift between the individual layers of reinforcement. That said, it is generally omitted, not from a cost motivation, but from an construction inconvenience perspective. The obvious reason for such a filter is that individual silt or clay particles coming along with water from the reinforced soil zone will eventually contaminate the lower portion of the front drainage gravel causing toe failures as shown in Figure 6.

Since most facing types of MSE walls have a gravel leveling pad beneath them, a practical design procedure is to simply extend this gravel layer beneath the entire reinforced soil zone so as to “connect” with the back drain. Again recall Figure 5. The geocomposite back drain would be embedded into this gravel base drain for expulsion of the collected water. Obviously, the upper surface of a gravel base layer must be protected using a geotextile filter. If a drainage geocomposite is used for the base drain it is simply a continuation of the back drain but bent into a 90° configuration. Alternatively, the core of the geocomposite back drain can be wrapped around a perforated drainage pipe and the collected water can be transmitted to the ends of the wall, see Figure 7a. Lastly, the geocomposite back drain could be attached to closely spaced transmission pipes beneath the reinforced soil zone. This attachment detail is obviously important, see Figure 7b.

As again seen in Figure 5, the upper ground surface must be adequately sealed against rainfall and snowmelt such that it cannot enter into either the reinforced soil zone or front drainage layer. The barrier material is sometimes seen as a clay liner but (in the authors opinion) it is not the preferred material. Drying in warm seasons and backfill settlements will cause cracking of the clay which is not reconstituted when moisture returns during wet periods. Far better is to use a geomembrane or geosynthetic clay liner, or even both in the context of a composite barrier.

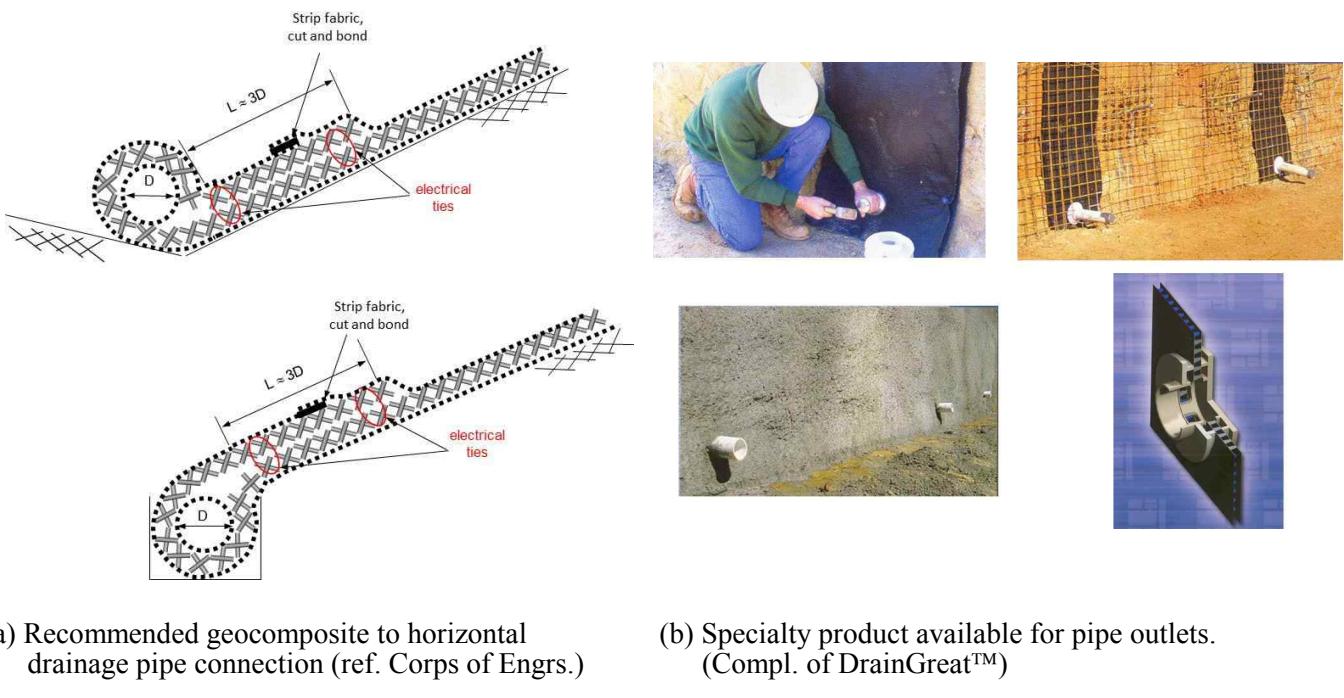
(a) Recommended geocomposite to horizontal drainage pipe connection (ref. Corps of Engrs.)

(b) Specialty product available for pipe outlets.  
(Compl. of DrainGreat™)
