Exhumation of geotextiles from a geosynthetic reinforced bridge abutment after 17 years of service

Maxwell Koerner, George Koerner & Robert Koerner
Geosynthetic Institute, USA

Keywords: MSE wall, GSRBA wall, geotextile installation damage, geotextile durability

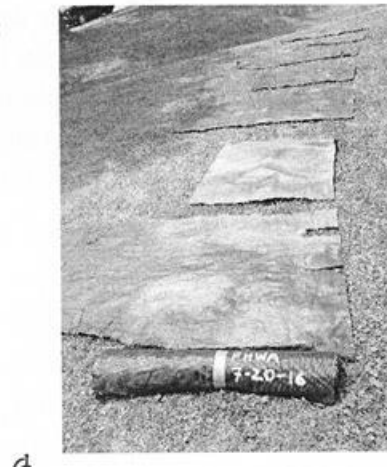
Figure 8. Exhumed and cleaned geotextiles

The images below document the exhumation process of the geotextile from the stone backfill and masonry block units. The excavation site was located 21 m away from the edge of the abutment in order to avoid disturbing the soil surrounding the GSRBS's tunnel, located 4.5 m away from the same edge. Six layers of textile were exhumed from the surface, amounting to a total excavation depth of 1 m. See Figures 3 through 6 detailing the process. Due to the staggered arrangement of the masonry blocks, the size of the geotextile cut from each layer became progressively smaller as the excavation progressed. The width of the topmost layer (layer 1) was about 1 m, while the bottommost layer (layer 4) was only 0.5 m (Figure 7). After digging down the six layers and removing the textile sample, a roll of TenCate Mirafi HP770 was used as replacement material, and the hole was backfilled with the same AASHTO No. 57 gravel. Upon return from Virginia, the exhumed textiles were carefully cleaned, to remove any large particles of dirt that remained on the textile, and subsequently conditioned and prepared for testing (Figure 8).

After analyzing the accumulated data, the 30% average decrease in overall strength, resulting in a reduction factor of 1.43, is accredited to damage that occurred during the installation and backfill of the geotextile.

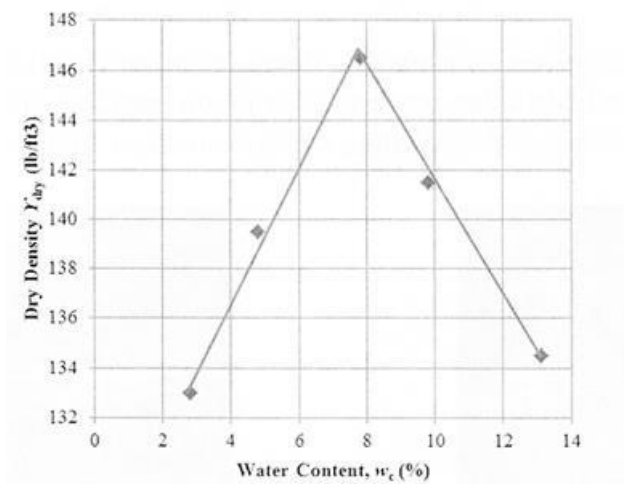
Figure 12. Procter compaction test results.

Along with testing the properties of the textile, the properties of the AASHTO No. 57 stone backfill surrounding the textile were also investigated in order to shed light on the cause of the loss of strength of the geotextile. The stone was mined from a local quarry. The FHWA supplied a sieve analysis of the aggregate from when the wall was built, and a Procter compaction test was performed with samples of the soil obtained from the excavation. These analyses were conducted to obtain a better understanding of the in-situ condition of the diabase soil, which was believed to be compacted at greater than 95% of optimum dry density. The results are shown in Figures 12 and 13 respectively.
