Coupled hydro-mechanical analyses of a multi-tier geosynthetic-reinforced soil slope subject to rainfall infiltration

ABSTRACT: This paper presents a case study and numerical investigation of a failure of a geosynthetic-reinforced soil slope with marginal backfill subject to rainfall infiltration. The investigated slope is a 26 m high, 4 tier geogrid-reinforced slope constructed for stabilizing the existing highly weathered and fractured sandstone road embankment. Contrary to the backfill recommendations in design guidelines, locally available low plasticity silty clay (CL-ML) with over 60% of fines, was used as backfill in the reinforced zone. The GRS slope first experienced excessive deformation after seasons of typhoon and heavy rainfall from 2010-2013. The measured settlement and horizontal deflection at slope crest were 140 and 80 cm from June to December 2012. Although an immediate remedial action had been taken, the slope final collapse was caused by two sequential typhoon events with total accumulated rainfall of over 600 mm in August 2013. The failure mode was identified as the compound failure which had the failure surface partially cut through the reinforced zone at the

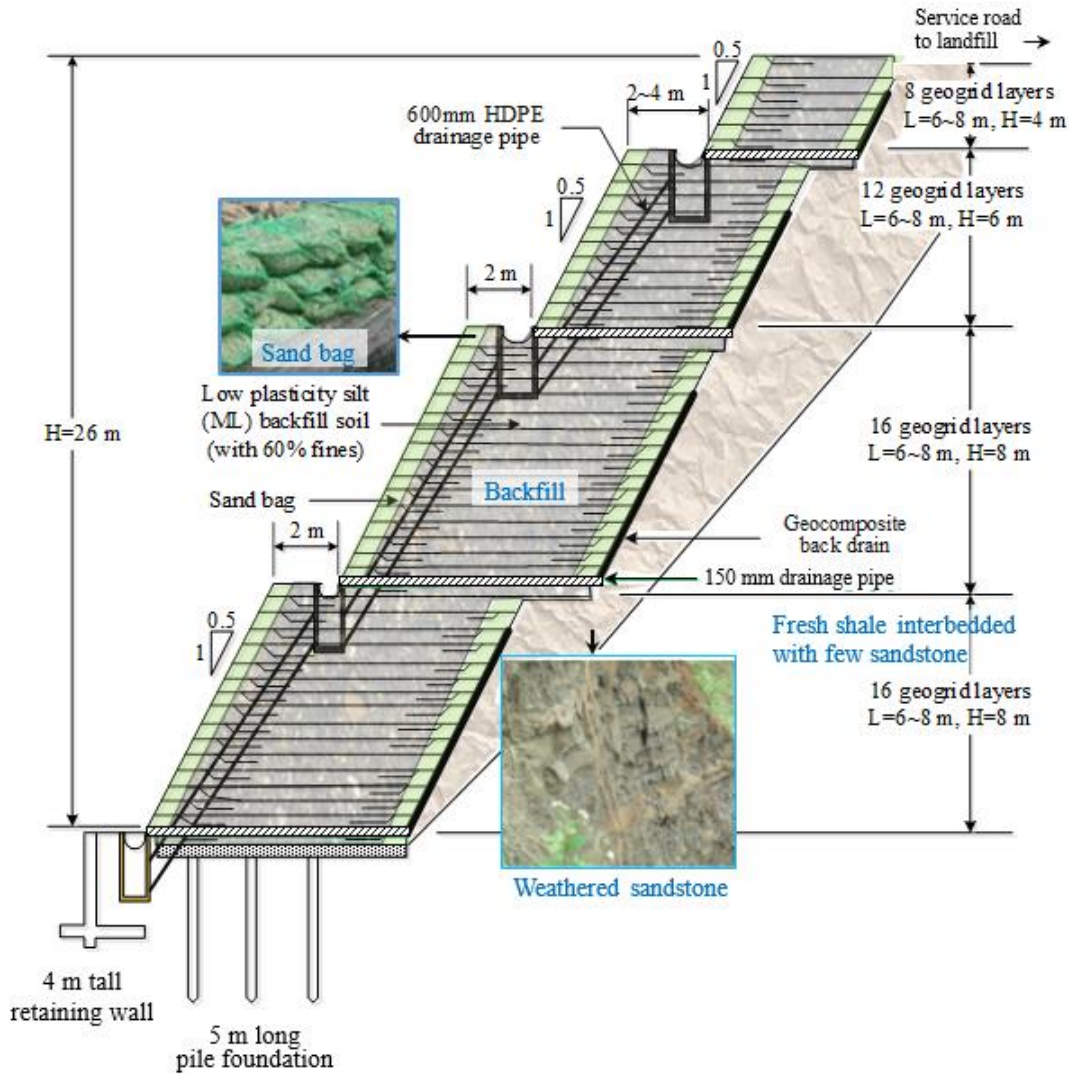
The multi-tier (GRS) slope investigated in this study was constructed 2010 to stabilize unstable slope on a road side that provided traffic access to a landfill in mountainous area in Dali District, Taichung County, Taiwan. As shown in Figure 1, wrap-around geogrid reinforcements with sandbag at front and rear were used. Locally available, low draining soil (with 60% fines) from weathered sandstone was used as backfill material (Figure 1). This could have been as a result of attempting to reduce cost and environmental impact associated with transportation of recommended backfills to construction site and disposal of excavated in-situ soils. A scrutiny of the original design revealed that as proposed by design guidelines limit equilibrium analysis (LE) was carried to check both the internal and external stability of the GRS slope. During design, phreatic surface was assumed to be at the middle between retained weathered layer and the slope surface and no attention was paid to soil hydraulic conductivity.

Figure 1 Layout and design details of multi-tier geosynthetics-reinforced soil slope

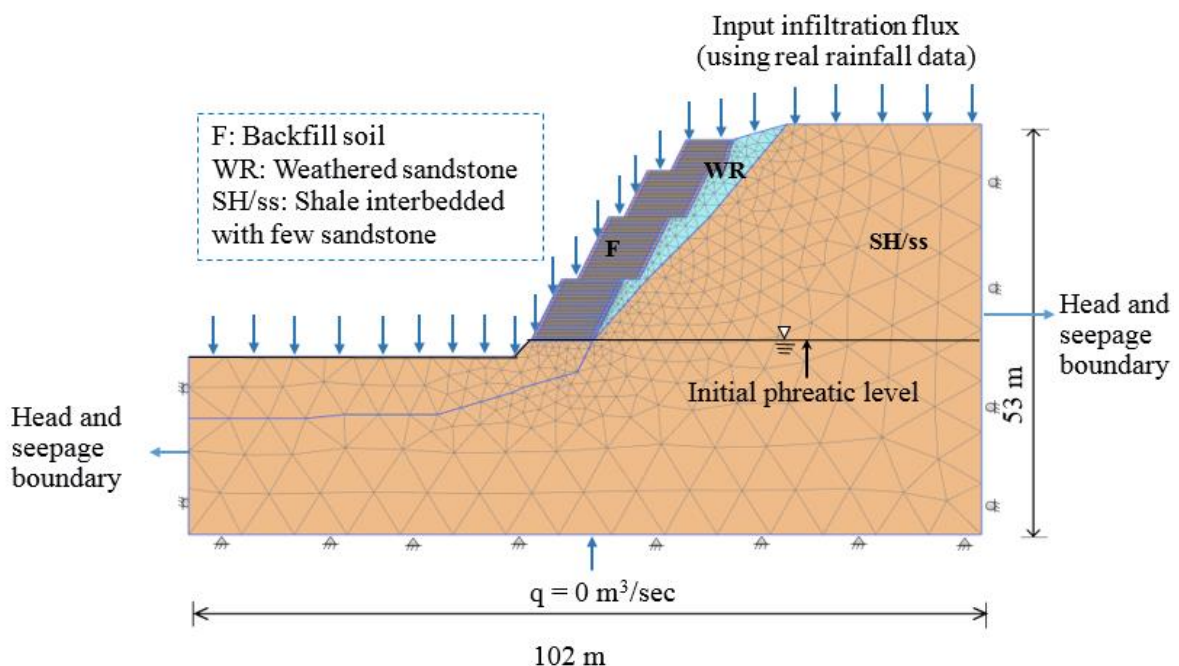
Figure 5. Numerical mesh and boundary conditions
