Repairs underwater of a HDPE liner by using a bituminous geomembrane of a density more than 1

ABSTRACT: A case of history will be given of a gold mine in Spain, the Tailing reservoir (TMF) waterproof with HDPE presented various defects (around 256) The mine asking extension, repairs on these defects were requested by the authorities to be fixed to obtain the necessary authorizations to operate and manage the installation.

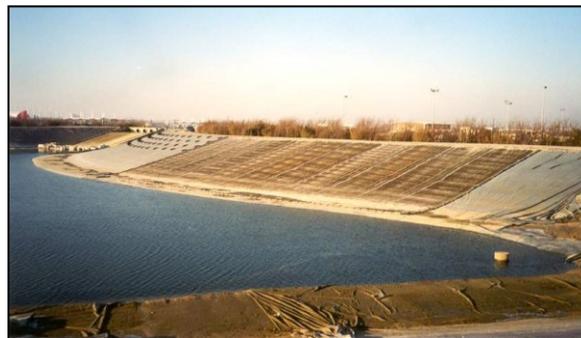
3.4.1 Joint PVC/BGM

Other example Joint PVC/BGM with bituminous mastic for repairing PVC exposed in Avery windy region, Tunnel under the Channel (storage of polluted water)
