Case study on deformation of reinforced soil wall using geo-textiles

Hijiri Hashimoto, Takahiro Yamanashi & Hirochika Hayashi
Civil Engineering Research Institute for Cold Region, PWRI, Japan

ABSTRACT: When an unsoundness reinforced soil wall was built by some kind of factors, it is necessary to elucidate the mechanism by a detailed field work how deformation occurred, and we must take the measures that a similar phenomenon is not generated in future. This paper is findings to grasp factor of deformation of the geo-textiles reinforced soil wall which did be large deformation. The data which used of the subsidence of a history at the time of the construction, a physical characteristic, the bowling investigation into used laying earth on the ground materials, the rain and ground water level after the construction, the reinforcement domain pass, and is a change at time. We considered factor of deformation of the geo-textiles reinforced soil wall to a base by these data. The point concerned was the topography condition that the rain and melting snow water concentrated on a reinforcement soil wall, and, as a result of investigation, there was it in the environment where the ground wat

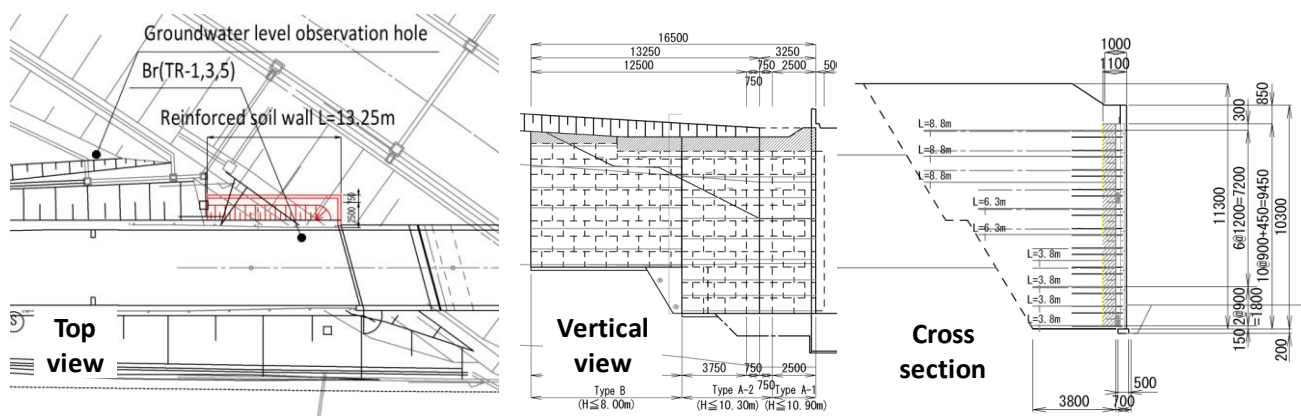
Figure 1. Top, vertical, and cross-sectional views of the reinforced soil wall.

Figure 1 a), b), and c) are the top, vertical and cross-sectional views of the reinforced soil wall. The reinforced soil wall was attached to an abutment that straddles a branch road (cut section) constructed halfway up a hillside in a hilly area. We were constructed using a reinforcing material of 3.8m in length with vertical intervals of 0.9m, the middle 2 layers were constructed using a reinforcing material of 6.3m in length with vertical intervals of 1.2m, and the top 3 layers were constructed using a reinforcing material of 8.8m in length with vertical intervals of 1.2m. Reinforcing materials with three different strengths were used. The tensile strengths of the reinforcing material for the bottom, middle, and top layers were 90kN/m, 72kN/m, and 49kN/m, respectively. For Type B, the bottom 3 layers were constructed using a reinforcing material of 3.0m in length with vertical intervals of 0.9m. The middle 2 layers were constructed using a reinforcing material of 5.0m in length with vertical intervals of 1.2m, and the top 2 layers were constructed using a reinforcing material of 7.0m in length with vertical intervals of 1.2m. Reinforcing materials with three different strengths were used for Type B, too. The tensile strengths of the reinforcing material for the bottom, middle, and top layers were 90kN/m, 60kN/m, and 37kN/m, respectively.

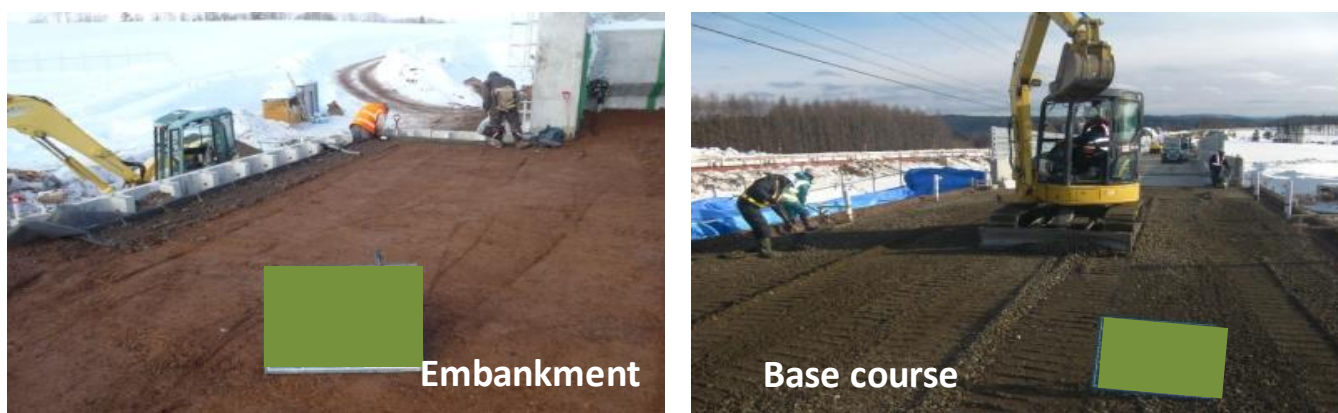
Figure 2. The embankment and the base course under construction.

The embankment in question was constructed in two stages in FY 2012. Figure 2 shows the embankment being constructed and the base course being constructed. The first stage of construction, in which the embankment was constructed up to the wall height of 3m, was done in 10 days from mid to late July 2012. The second stage of construction, in which the rest of the wall height up to 10m was constructed, was done in 9 days from late December 2012 to early January 2013. The machine for rolling compaction was a 200kN-class vibrating roller. The completion thickness for each layer was 30cm. The construction work was not done during the period from December 29, 2012 to January 6, 2013.
