Reinforcement of an old retaining structure using soil containing fine particles and multifunctional geocomposite

Alain Nancey & Anna Le Faouder

TenCate Geosynthetics France, France

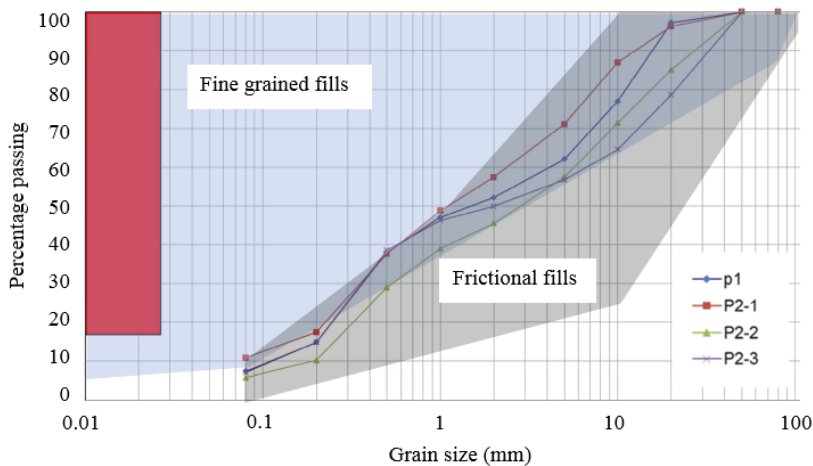
Figure 5. grain size distribution and typical grading envelopes for frictional and fine-grained fills.

Grain size distribution of the different samples are reported on Figure 5 showing also limits defining frictional fills and fine-grained fills (Lawson 2005). This light brown clayey gravel seen on figure 6 and taken from the old embankment, is exactly in the overlap zone between frictional and fine-grained fills confirming that this material could be frictional and moisture sensitive. That means that it was possible to use it as a fill material on this site but taking care of the water content during installation and compaction of the material.

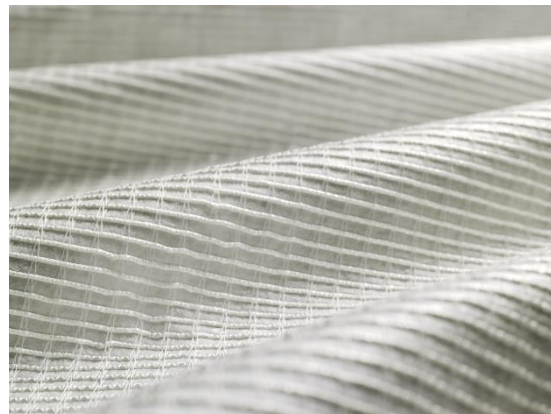
Figure 8. reinforcement geosynthetic

Because of the type of fill described above, the consultant chose a high strength geocomposite made of multi-filaments polyester yarns stitched on a continuous filaments nonwoven (figure 8). During compaction of the fill, the nonwoven allows the reduction of the pore pressure and provides a protection of the high strength yarns insuring the reinforcement function.
