# CASE STUDY ON A LARGELY-DEFORMED GEOTEXTILE-REINFORCED SOIL RETAINING WALL INDUCED BY RECENT HEAVY RAINFALL IN JAPAN

J. Hur<sup>1</sup>, and S. Shibuya<sup>2</sup>

#### ABSTRACT

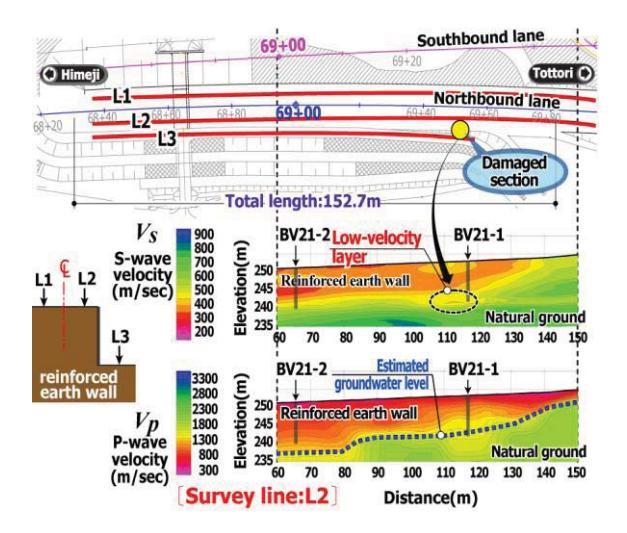
Fig. 6 Results of HR-SW survey

The HR-SW survey was carried out to figure out the 2D profile of the elastic wave velocities, i.e., S-wave and P-wave velocities ( $V_s$  and  $V_p$ ) of the fill, together with the foundation. Fig. 6 shows the profiles of  $V_s$  and  $V_p$  with depth for the 160m long survey line L1. In general, the Vs increase with depth, since in-situ overburden stresses increase with depth. However, a low-velocity layer was observed for V<sub>s</sub> near the severely damaged section at BV21-1 (n.b., elevation: approximately 240m, distance: 110~115m). The decrease in  $\mathrm{V}_{\mathrm{s}}$  strongly suggests some reduction of the magnitude of stresses at the deformed section. On the other hand, the dashed curve in the profile of  $V_p$  represents the boundary associated with  $V_p = 1500$  m/s, noting that the specific condition of  $V_p = 1500$  m/s is applicable to saturated soil. Accordingly, it may be surmised that the state of soil behind the damaged panels is close to saturation.

A noticeable decrease in V<sub>s</sub> near the deformed section was indicated by the HR-SW survey. Therefore, a down-hole PS-logging was carried out to directly measure the profile of Vs with depth. Similarly, RI-logging using the Gamma Ray attenuation technique was performed for profiling the variations of wet density,  $\rho_t$ , and the natural water content, wn, with depth. Fig. 7 shows the profiles of  $V_s,$  N-value,  $\rho_t,\ \rho_d$  and  $w_n$  at three locations of BV21-1, BV21-2 and BV21-3, respectively (see Fig. 4). As seen in Fig. 7, the horizontal layer over the depths roughly from 10m to 13m for the length between BV21-1 and BV21-2 is seemingly soft by showing higher water content with the relatively low values of  $V_s$ , N-value, and  $\rho_d$ . The supposed soft soil layer corresponds to the portion characterized by the low-velocity from surface wave survey. Meanwhile, both of  $V_s$  and N-value appear relatively larger for the soil layer improved by cement-mixing (i.e., the portions for the first and second remedies, see Fig. 4).

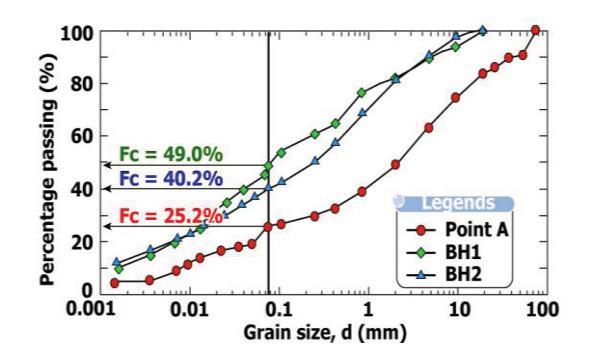
Fig. 8 Grain-size distribution

soil at BH1. On the other hand, the soil at point A on the slope may be regarded as sourcing for the filling. Fig. 8 shows the grain size distribution of these three samples. It is obvious in this figure that the soils from BH1 and BH2 are much finer in grain size by showing the fines content,  $F_c = 49.0\%$  and 40.2% for BH1 and BH2, respectively, whereas  $F_c = 25.2\%$  at point A.

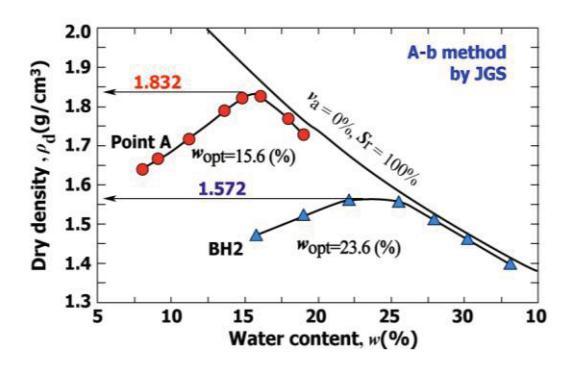
Fig. 9 Compaction curves

Figure. 9 shows the compaction curves of two samples at point A and BH2. The maximum dry density,  $\rho_{d\mbox{ max}},$  of the BH2 sample was far smaller than the other sample (n.b.,  $\rho_{d max}$ =1.572 g/cm<sup>3</sup> for the BH2 sample and  $\rho_{d max}=1.832$  g/cm<sup>3</sup> for the other), whereas the optimum water content was higher (n.b., wort=23.6 % for the BH2 sample and w<sub>opt</sub>=15.6 % for the other. It should be mentioned that the entire fill was constructed by using the same method. In addition, the controlled value for the density was set to  $0.9\rho_{d max}$  based on the compaction curve similar to that of the sample at point A. It is now almost certain that the soft soil layer with larger amount of fines, and having lower values of Vs, Nvalue and  $\rho_d$  is responsible for the damage of the wall as shown in Fig. 2.

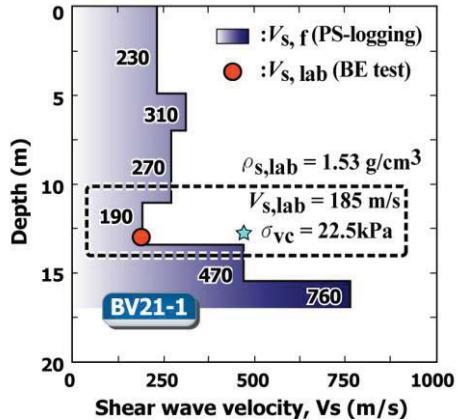
Fig. 10 Comparison of V<sub>s</sub> between PS-logging and BE test in the laboratory (Jung et al, 2010)

As shown in Fig. 10, the  $V_{s,lab}$  from the BE test almost coincided with  $V_{s,f}$  at the relevant depth when the sustained  $\sigma_v$  of the laboratory sample was 22.5kPa, noting that the  $\sigma_v$  of 22.5kPa accounts for approximately one-tenth of in-situ overburden pressure at prescribed depth. In an attempt to obtain the shear strength at the damaged section, the constant-pressure DST (for the details of apparatus, see Shibuya et al., 2005) was performed.

Once the hammock state was reached inside the wall, the overburden stress corresponding to the hammock state in the fill will be dramatically reduced, which in turn would bring about some decrease of the shear resistance between the geotextile and the surrounding soil. The notion is strongly supported by the results of laboratory tests that the estimated  $\sigma_v$  at the deformed section was as small as one-tenth of the supposed  $\sigma_v$  (see Fig. 10).

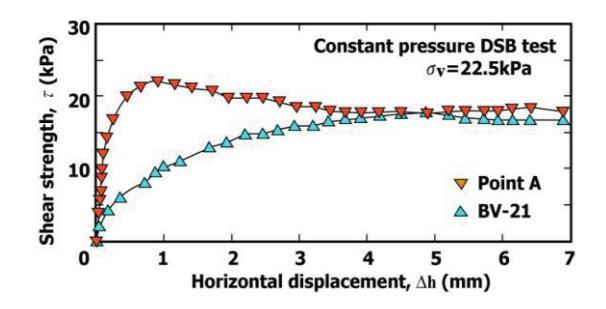
Fig. 11  $\tau$ - $\Delta$ h relationships in constant pressure DST

The relationship between the shear stress and the horizontal displacement is shown in Fig. 11, in which similar result of the sample from point A is also shown for comparison. The maximum shear stress,  $\tau_{max}$ , of 17kPa was very small for the sample at the damaged section, bearing the overburden height of the embankment of about 10m in mind.

The stress-displacement curve exhibited no peak for the sample, whereas it showed a higher strength for the other sample comprising less fines.

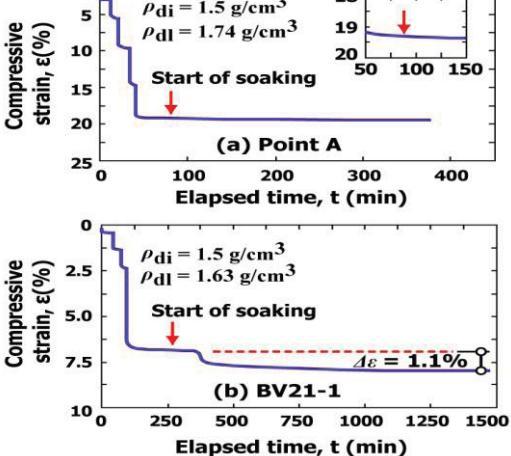
Fig. 12 Results of soaking test at v =200kPa

According to the results of site investigations performed, the soil at the damaged section is currently saturated (see Fig. 6). This means that the initially unsaturated soil at compaction is soaked gradually possibly due to seepage flow into the fill. Soaking test was, therefore, carried out in an attempt to examine the deformation behavior during the process of soaking. The results of soaking test are shown in Fig. 12. On soaking, the sample at the deformed section exhibited a considerable amount of settlement with time to reach the compressive strain of 1.1 % over a period of one day. Conversely, no volume change was observed for the other sample.

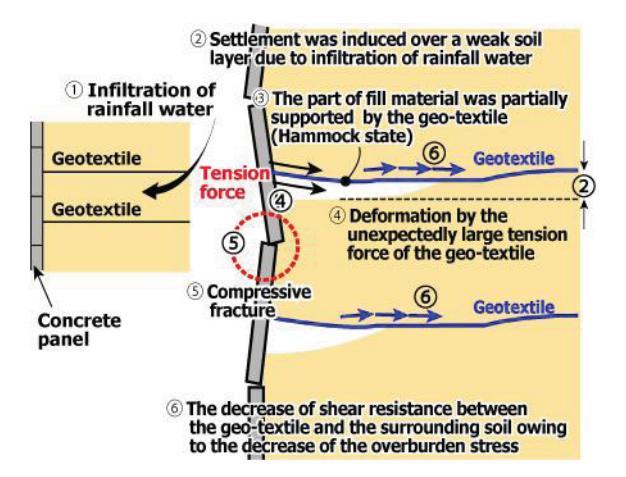
Fig. 14 Mechanical behavior of a largely-deformed reinforced earth wall with geo-textile

Based on this observation, the background as well as the mechanical interpretation for the damage of the wall can be postulated as an image shown in Fig. 14. It may be described such that:

- a considerable amount of subsidence took place over the 3m-thick weak soil layer in the lower part of the reinforced earth due to seepage of rainfall water,
- ii) the weight of the upper fill was partially supported by the geo-textile hooked on the concrete panels, and
- iii) the concrete panels associated with the hammock state were severely damaged by the unexpectedly large downwards compression force triggered by the tension force of the geotextile.

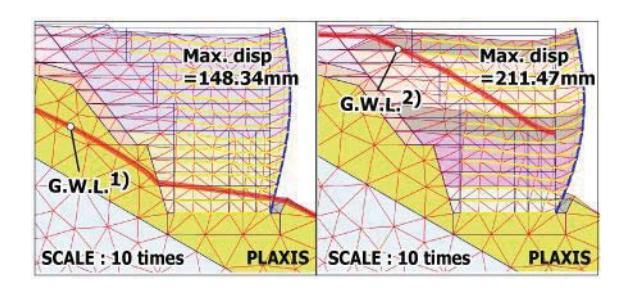
Fig. 18 Deformed meshes due to the increase in a water level

Figure 18 shows how the reinforced earth wall was deformed according to the increase in the ground water level. The maximum amount of displacement with and without rain is 211.5mm and 148.3mm, respectively. This observation demonstrates that the infiltration water permeating the reinforced earth wall has a strong influence on the movement of the wall.

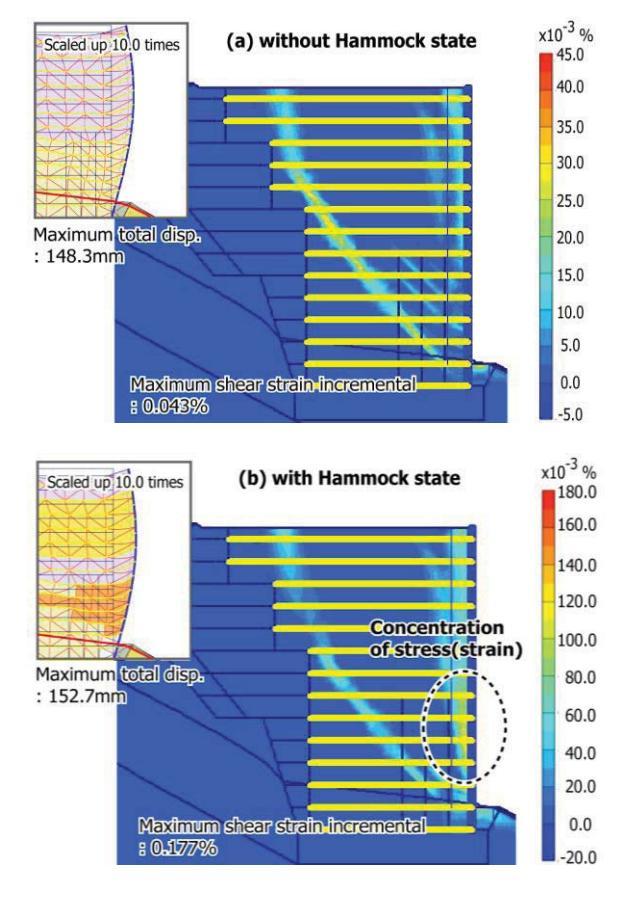
Fig. 19 Incremental shear strains in the fill, together with the deformed meshes near the wall facing

Figure 19 shows the results of an analysis performed for two cases, i.e., the case of normal geotextile and the other case of geotextile in the condition of Hammock. Based on the observation, the hammock condition was assumed over the lower part of the wall comprising the soft soil layer. The effect of Hammock was significant in that large deformation was observed near the wall by showing the maximum shear strain increment almost ten times that of the normal condition.

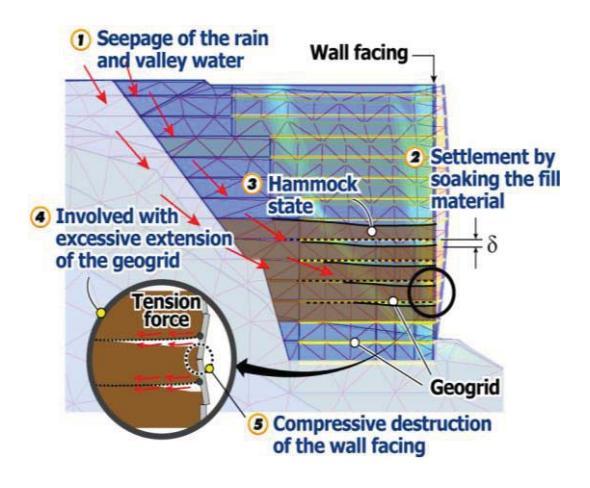
Fig. 20 Sequence for the development of wall damage

As well depicted in Fig. 20, the large deformation of the wall may be induced with the sequence of events in the following. First, the filling

materials with a high compressibility existed on some layers inside the backfill. Second, rainwater and the water in a valley infiltrated into the layers, which in turn induced compression settlement. As a result of the generation of settlement in the weak soil layer, so-called 'Hammock state', in which the weight of the upper filling was partially supported by the geotextiles, was gradually formed. This condition generated high tensile force to the geotextiles, which in turn induced stress concentration on the concrete panel connected to the high-tensioned geotextiles. As a consequence, a type of compression failure took place on the concrete panels.

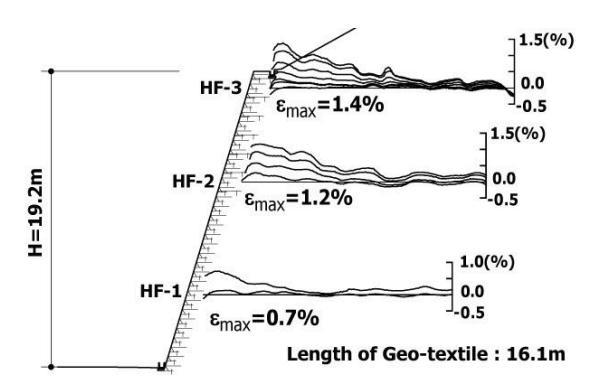
Fig. 29 Measured extensional strain of geotextile

And then, Fig. 28 shows the variation of the horizontal and vertical displacements with time at several points over the facing. Large displacements were observed at No.50, for which the horizontal displacement exceeded 16cm and the settlement reached to 24.4cm over the middle part of the wall (T-5 and T-16). As indicated in Fig. 29, the extensional strain of the geotextile was observed at three levels, HF-1, HF-2 and HF-3.

Note that the strain in each geotextile was large at the portion close to the wall facing. This tendency may be attributed to the combined effects by the tensile force associated with the horizontal displacement of the wall and by uneven vertical displacement near the wall facing with metal frame. The strain increased from bottom to the top by showing the maximum strain of 0.7%, 1.2% and 1.4% at HF1, HF2 and HF3, respectively. It should be mentioned that the strain of 1.4% at HF3 accounts for 70% of the strain level corresponding to the upper limit of the safe domain (i.e., 1.987%).

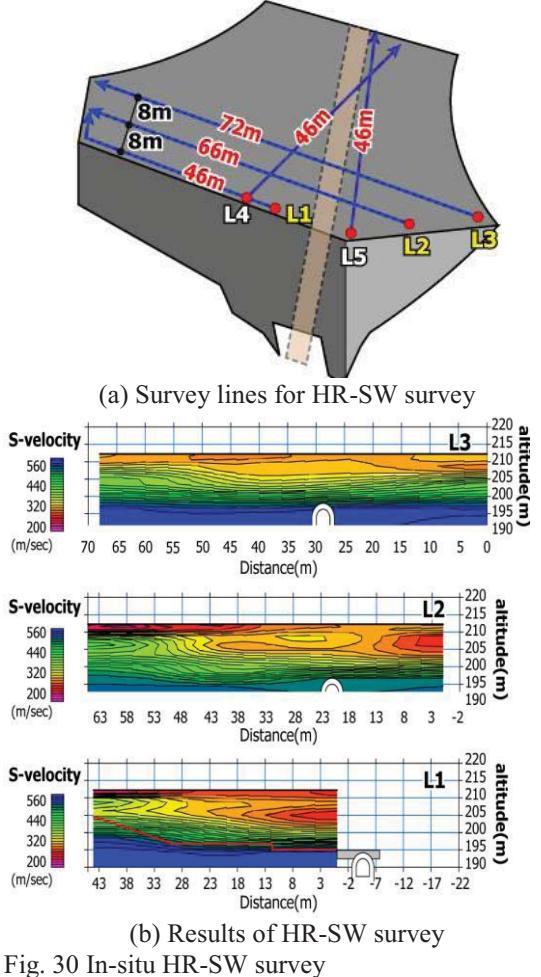
As can be seen in Fig. 30(a), a HR-SW survey along five survey lines was performed. Fig. 30(b) shows the 2D profile of S-wave velocity obtained from the survey. As a result of the survey, the existence of relatively low-velocity layer showing about 200m/s of S-wave velocity was found at the level around an altitude of 205m of the survey lines L1 and L2. In addition, the borehole sounding was carried out at two locations of K-6 and K-7. As a result, a loose layer was found at the middle of the filling (GL.-8~-11m).

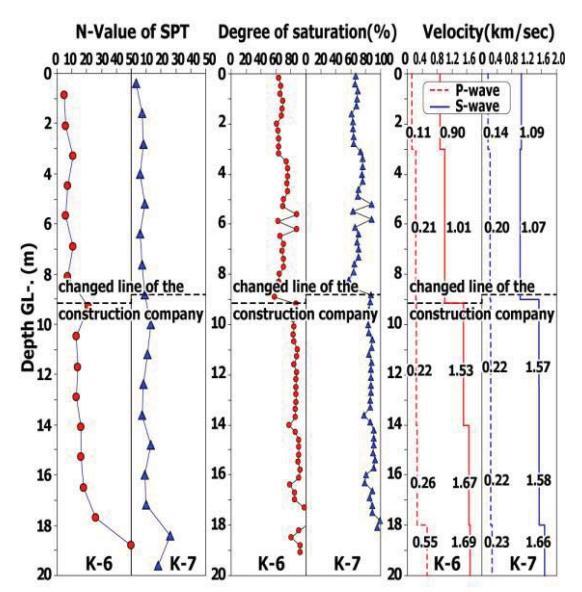
Fig. 31 Variations of N-value, degree of saturation and PS-velocities with depth

Figure 31 shows the results of both the SPT N-value and the PS-logging. Note that the SPT N-value was relatively low (N=3~11) over the upper part from GL.-0 to GL.-9m. In the meantime, N-value from GL.-9m to the bottom was about N=7~21. Despite that the N-value at the lower part of the wall was relatively high compared to that at the upper part, a tendency for N-value to increase with depth was not observed. The degree of saturation from the upper part of the filling from GL.-0 to GL.-9m ranged from 57.8% to 76.3%. Meanwhile, the degree of saturation at the lower part of the filling was higher from 77.4% to the full saturation. A noticeable change in terms of the degree of saturation was found at an altitude of 205m.

It should be mentioned that at this level, the construction company in charge was changed.

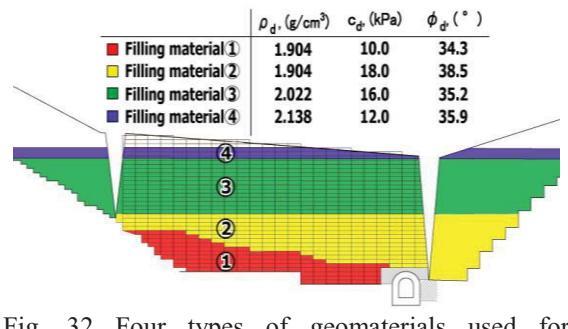
Fig. 32 Four types of geomaterials used for construction

As indicated in Fig. 32, the reinforced soil retaining wall was constructed using the local soils that could be classified into four different origins. The density control for the compaction work during construction was set to be over 90% of the maximum dry density from the compaction test in the laboratory.

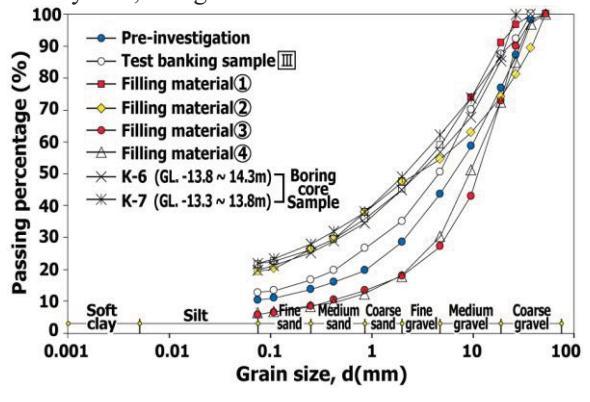
Fig. 33 Comparison of grain size distribution curves

Figures 33 and 34 show the results of grain size distribution curves and the compaction curves from different origins. The particle size distribution curves exhibited a considerable scatter. The filling material (1), the filling material (2), and core samples (K-6 and K-7) contain a relatively large amount of fine-grained particles. Meanwhile, the maximum dry density of the filling material ① and the filling material ② is 1,904kg/m<sup>3</sup>, whereas the filling materials ③ and ④ exhibit the maximum dry density of 2,022 and 2,138kg/m<sup>3</sup>, respectively. Compared to filling materials (3) and (4), the filling materials (1) and (2) exhibit lower dry densities and higher water contents. In addition, the compaction curve of filling material 2 exceeded zero air void curve on wet side, indicating serious errors for the interpretation of the test result. It should be mentioned that the on-site compaction work was carried out by assuming a single compaction curve from the filling material ① with the maximum dry density of 1,904kg/m<sup>3</sup>.

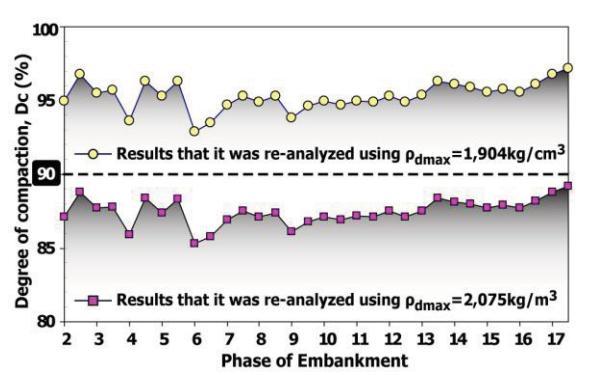
Figure 35 shows the results of revised in-situ degree of compaction,  $D_c$ . When the value of 2.075g/cm<sup>3</sup> of the maximum dry density of soils from boring cores (i.e., K-6 and K-7) was applied, the in-situ degree of compaction was 87% being lower than the prescribed lower limit of  $D_c=90\%$ . Accordingly, a soaking test was carried out to examine the deformation behavior on wetting.

Fig. 35 Revised in-situ degree of compaction, D<sub>c</sub>

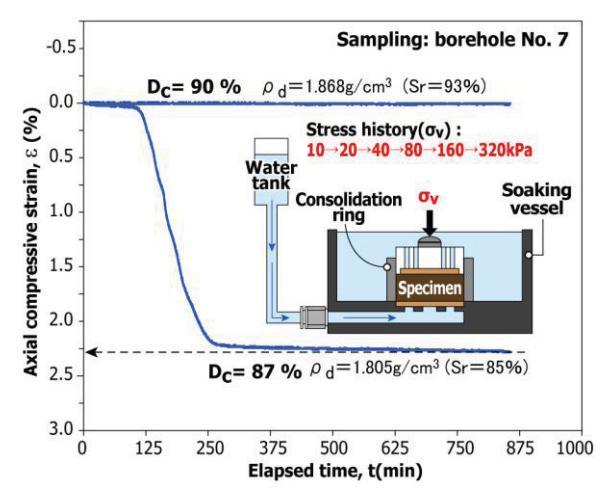
Figure 36 shows the result of the soaking test using two specimens from the boring While the sample with  $D_c=90\%$  had no prompt volume changes, the other sample with  $D_c=87\%$  showed a considerable amount of immediate settlement at 125 minutes after the soaking. A sort of collapse behavior may have been observed for the sample with  $D_c=87\%$  due to the loss of matric suction. These results imply that the sample soil ① and ② used for the density control of the field compaction work was by no means a representative soil for the whole fill by showing a lower value in terms of the maximum dry density. Moreover, the soil when compacted loose with  $D_c=87\%$  showed a collapse on soaking.

Fig. 36 Results of soaking test at  $\sigma_v$ =320kPa

Therefore, it may be surmised that a considerable amount of settlement occurred over the loosely compacted soil layer at the lower part in the event of rainfall and/or the attack of seepage flow

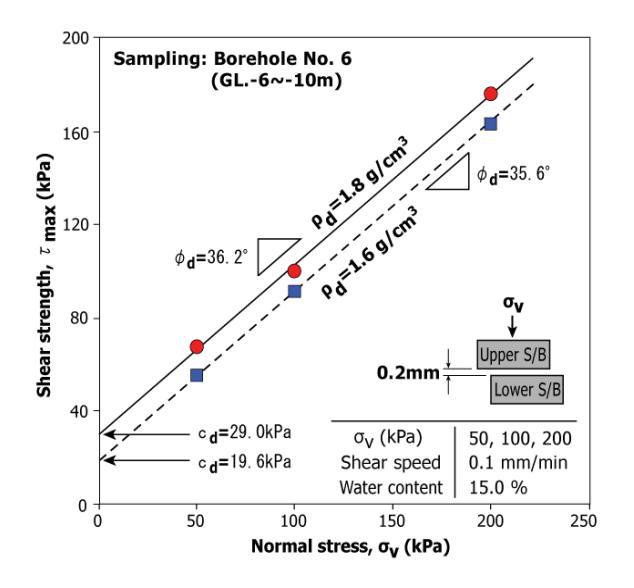
from the rear side of the fill. Figure 37 shows the results of DST using boring core sample K-6. In the DST, two samples with the dry density of  $1.6g/cm^3$  and  $1.8g/cm^3$  were prepared. Note that the internal friction angle ( $\phi_{ds}$ ) was as high as about 36 degrees regardless of the density. In the meantime, the sample with the dry density of  $1.8g/cm^3$  showed a higher value of cohesion. It may be surmised that the degree of compaction of the cited soil does not influence much the strength, but the deformation on soaking was significantly affected by showing a type of collapse behavior for the loosely compacted sample.

Fig. 37 Results of direct shear box test (DST)

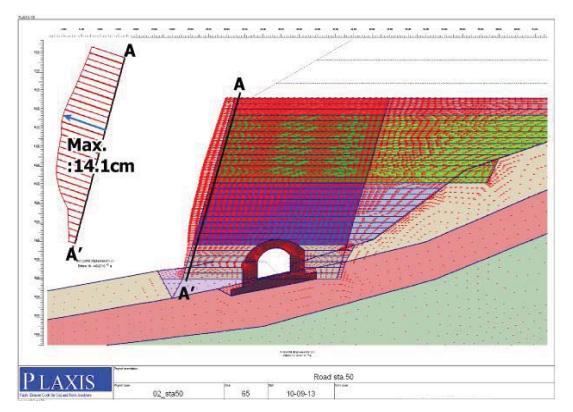
As results of site investigations, it was estimated that the large deformation of the reinforced soil retaining wall was caused by compressive settlement of lower part of the fill in particular. The settlement was probably triggered due to seepage water infiltrated into the insufficiently compacted soil layer. Why the reinforced soil retaining wall exhibited large deformation may be described in the following:

Fig. 38 Results of back analysis by using MC model

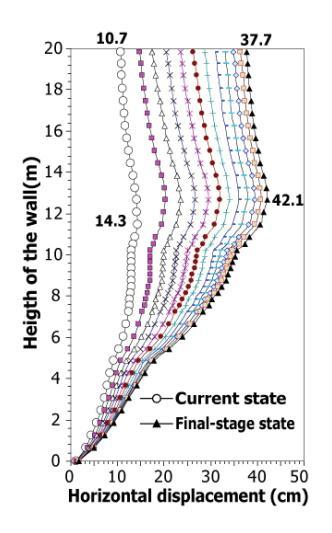
Figure 39 shows a tendency for the horizontal displacement of the wall surface expected when a road-bed embankment was put on the upper part of the wall. The maximum horizontal displacement was 42.1 cm at the middle part of the wall surface.

Fig. 39 Estimated horizontal displacement of the wall facing (No.50, 2D analysis)

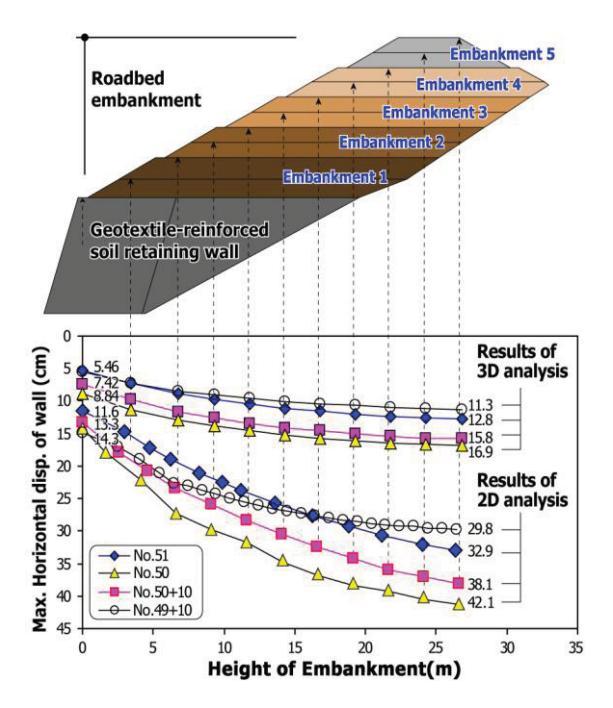
As seen in Figs. 40 and 41, the results of threedimensional analysis provided a smaller value as compared to the comparative result of twodimensional analysis, since the three-dimensional analysis compiled the effects of the boundary conditions such as arching effects. Nevertheless, it was expected that the accumulated displacement of the wall surface will be double or even triple against the current state (see Fig. 40).

Fig. 40 Estimated horizontal displacements of the wall facing by 2D and 3D numerical analysis

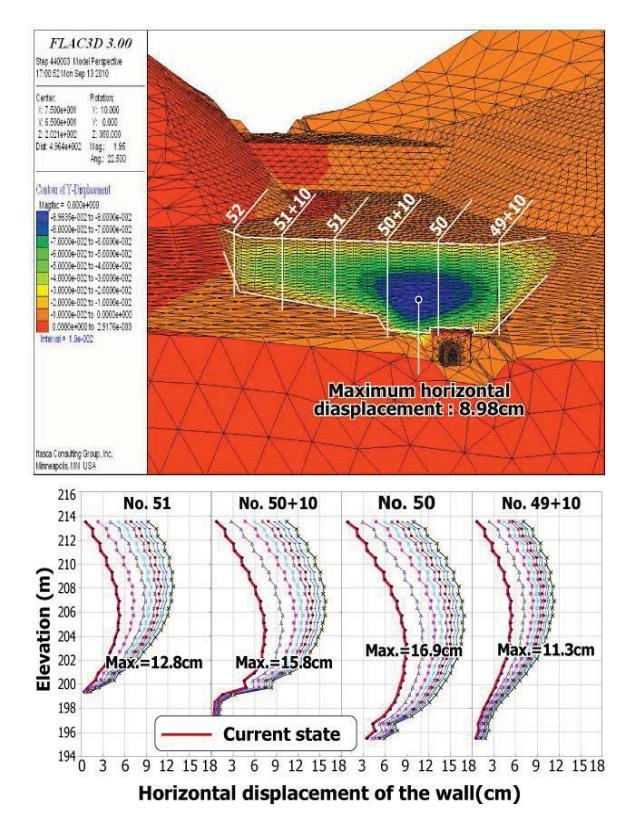
Fig. 41 Results of 3D analysis (FALC 3D)

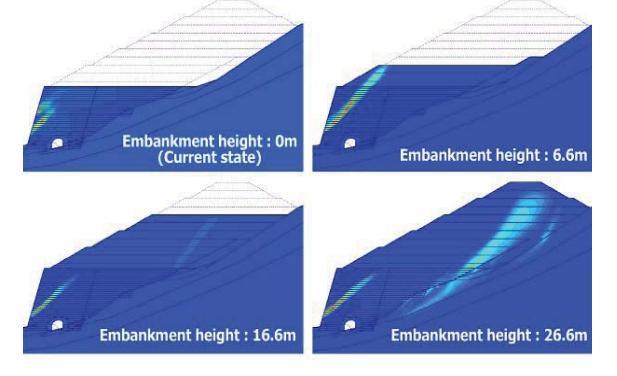
Figure 42 shows incremental shear strains associated with the construction of a roadbed embankment. This figure indicates that while the shear strain concentrates on the surface of the wall at an early stage of the roadbed embankment, it develops further inside of the filling at the final stage of construction. As described above, since the reopening of construction under the current situation will definitely induce serious instability of the whole structure, and also substantial increase of the wall deformation, a consensus was reached to apply countermeasures to re-stabilize the whole embankment prior to the reopening of the construction.

Fig. 42 Incremental shear strain in the fill (No.50, PLAXIS)

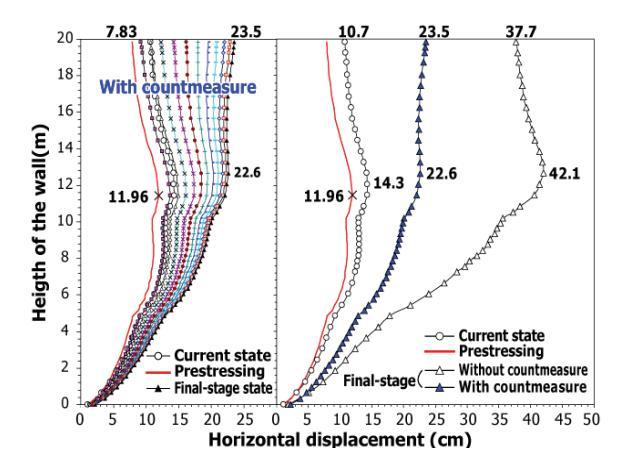
Fig. 44 Behavior of wall facing with and without countermeasure

Figure 44 shows a comparison of the wall deformation for two cases with and without the application of the countermeasure. The compressive deformation of the wall surface from 14.3cm to 11.96cm was predicted on pre-stressing the anchors. This may be attributed to the materials' properties assumed in the analysis, for which the geomaterial in the fill was assumed as elasto-plastic material, together with the geotextile, anchors, and the reinforced wall being postulated as elastic material. At an early stage of the construction, the maximum horizontal displacement was observed at 12m to 13m high of the wall. However, towards the final stage of the construction, it was observed at the crown edge. The maximum of the horizontal displacement with ground anchors was reduced to 23.4cm at crown edge, which was almost half of 42.1cm for the case without the countermeasure.

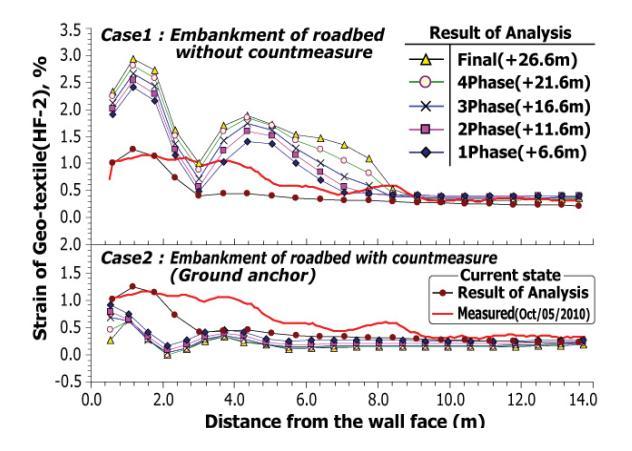
Fig. 45 Development of extensional strain of geotextile

Figure 45 shows the development of strain of the geotextile with and without the countermeasure. In the case of shiftlessness, the extensional strain of the geotextile reached to about 3%. Conversely, the effect of ground anchors was significant by showing the strain reduced down to about 1.5%. Fig. 46

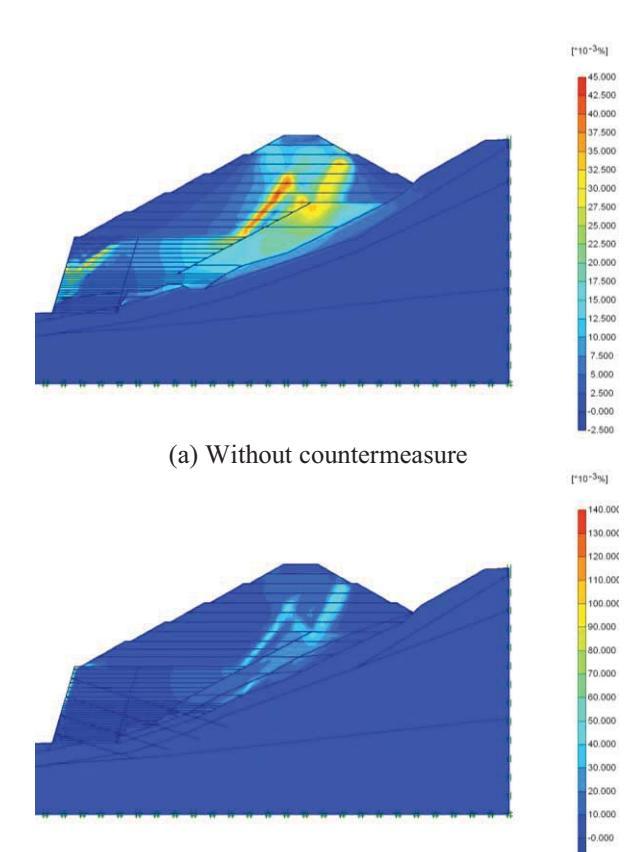
(b) With countermeasure Fig. 46 Incremental shear strain rate at No. 50+10

shows the generation of shear strain. It can be observed that after applying the countermeasure, the increment of shear strain inside the fill is negligible. The implementation of ground anchors with concrete wall is expected to reduce much the danger for the active failure.
