Remediation and reinforcement of embankments for flood protection

ABSTRACT: Big floods in Croatia in 2014 induced the analysis of flood protection system and remediation measures of embankments after flooding. This extreme hydrological phenomenon was higher than design criteria for flood protection system. The result was many defects on embankments and the largest were two breaches. High water levels caused piping in foundation ground and hydraulic breakdown in the area between trench and embankment base. Optimal was proved an interactive design approach executed parallel with the construction. Bad weather conditions during the remediation and clay with high water content at the site required a modification of design. After analysis was selected solution with reinforced soil using clay as it is on site. Embankment remediation with using reinforced soil was quickly implemented and less sensitive to bad weather conditions. During construction monitoring equipment was installed to keep track of construction and for forecasting and warning about embankment behavior during flood defense. In this paper the behavior of reinforced embankment is analyzed. The aim is a better understanding

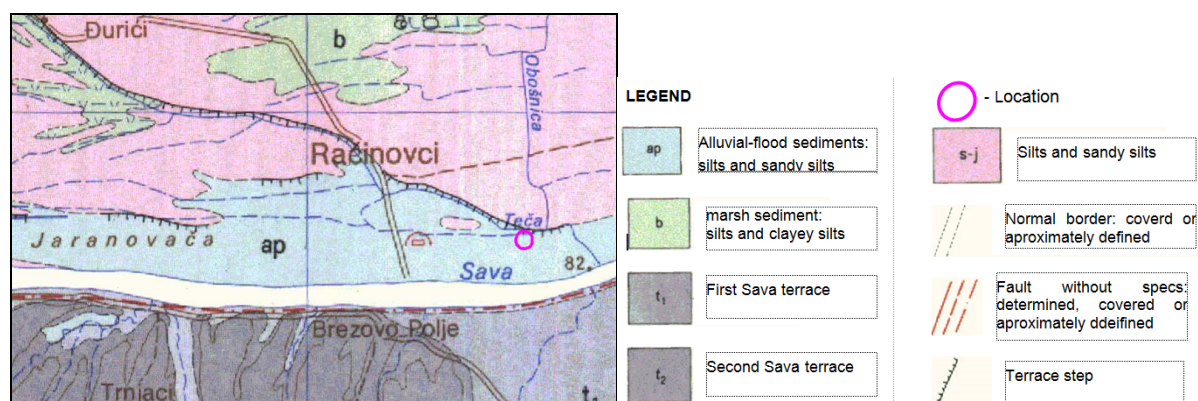
Figure 4: Basic geological map (Buzaljko et al., 1985),

In-situ investigation works on the levee breach in Račinovci included the geological, geophysical and geotechnical studies (Geokon-Zagreb, 2014a, 2014b). According to the Basic geological map (Buzaljko et al., 1985) the structure location is in an area that is covered by quaternary sediments from Pleistocene and Holocene represented with: alluvial-flood sediments - silts and sandy silts. Fig. 4 depicts an excerpt from the Basic geological map and shows the corresponding legend and location of the construction site.
