Geosynthetic reinforced soil structure - problems faced and lessons learned. Case studies from Romania

2 BACK-TO-BACK GEOGRID REINFORCED WALL WITH CONCRETE BLOCK FACING

3 GEOGRID REINFORCED FLOOD PROTECTION DIKE

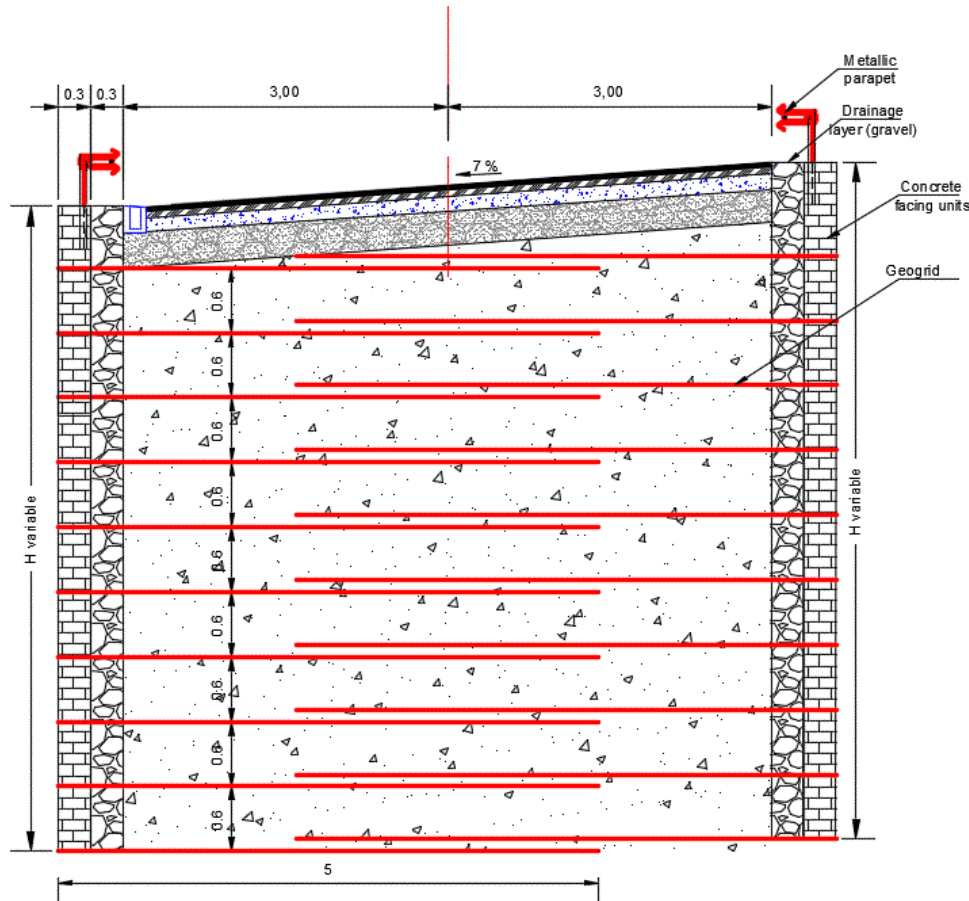
Figure 1. Typical cross-section of the designed back-to-back reinforced wall

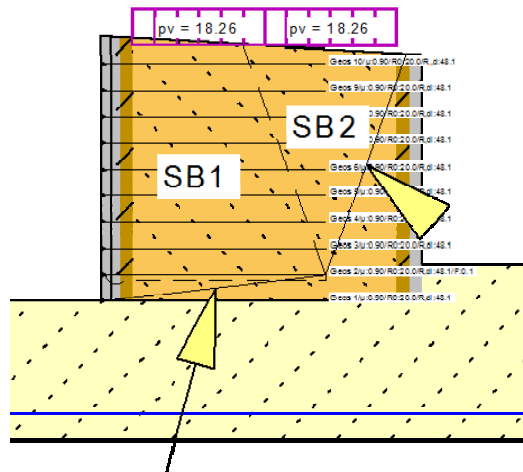
Figure 3. Two-part-wedge method internal stability analysis - critical wedge, maximum utilization degree $\mu=0.81$ - calculation according to EC7 in design approach 1, combination 2

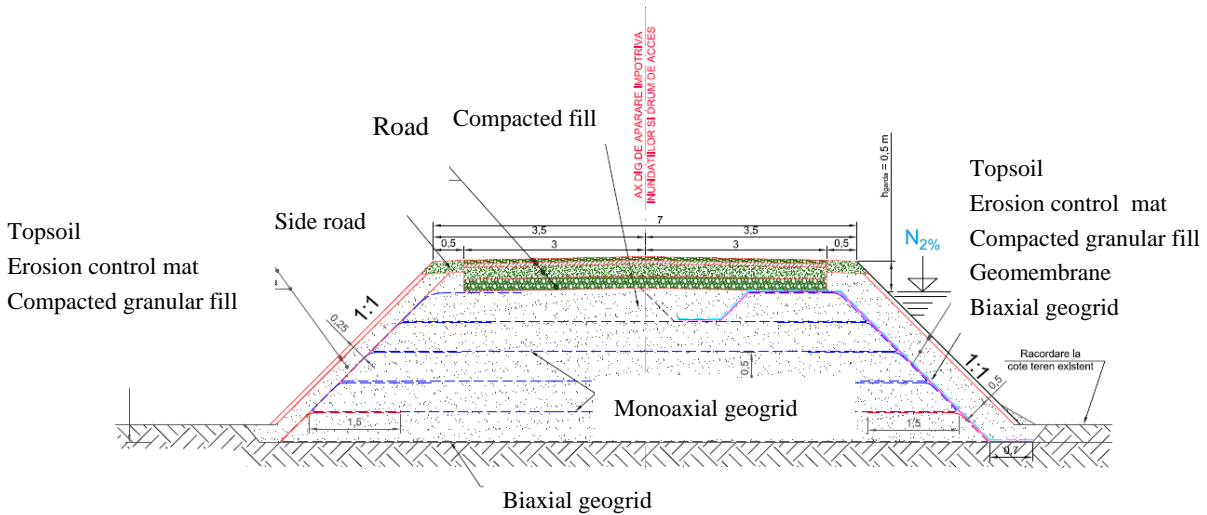
The face of the dike on the water side was designed to be covered with a 1.5 mm textured geomembrane to insure the waterproofing, followed by 50 cm of soil with an erosion control mat on top and 3-5 cm of pre-seeded topsoil for the establishment of the vegetation layer (figure 8).

Figure 8. Typical cross-section through the flood protection dike

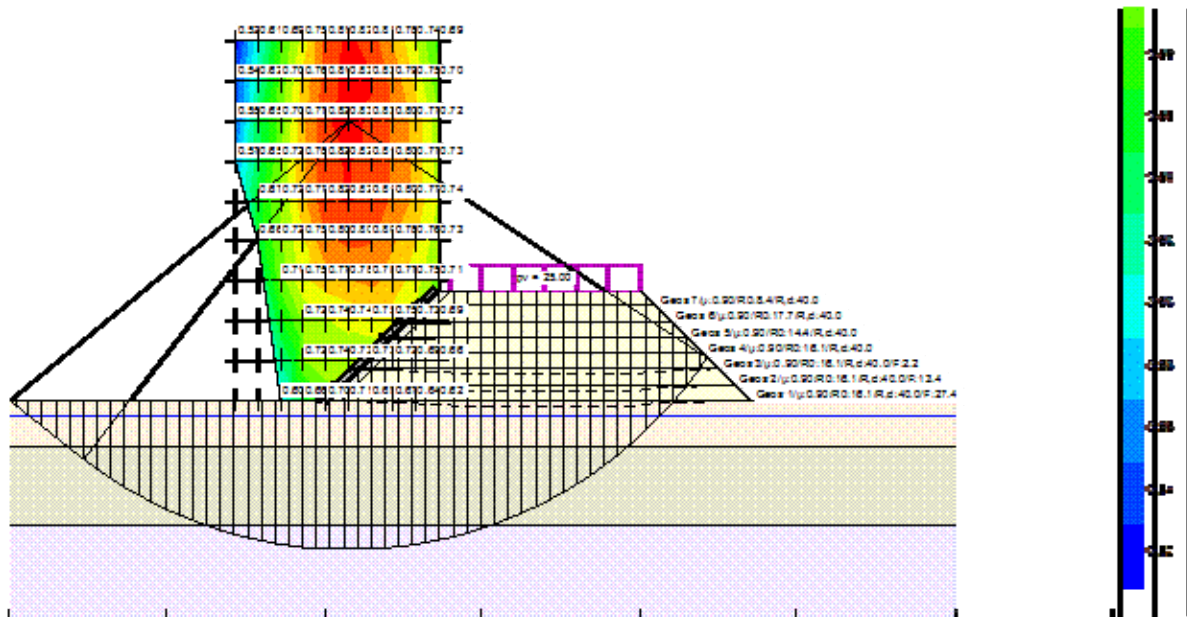
Figure 9. Bishop's global stability analysis - critical sliding circle, maximum utilization degree $\mu=0,83$ - calculation according EN 1997-1 using design approach 1 combination 2 = design approach 3

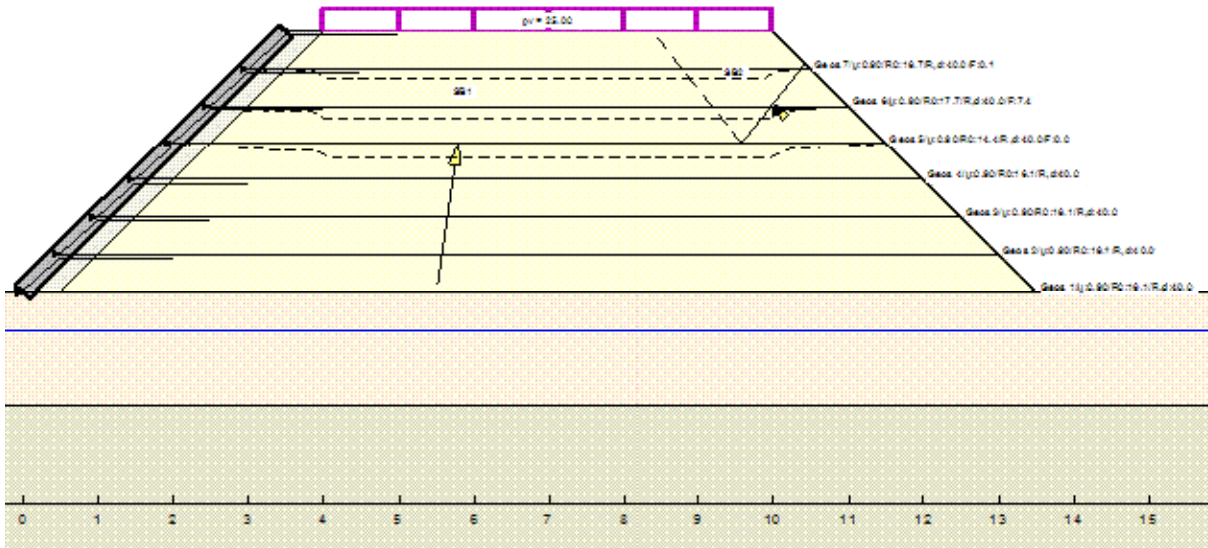
Figure 10. General wedge method internal stability analysis - critical wedge, maximum utilization degree $\mu=0,38$ - calculation according EN 1997-1 in design approach 1, combination 2 = design approach 3
