Designing, execution and using stage of highway A4 (E40) based on active geological fault

Jan Zych, Marek Tondera and Maciej Machowski

Abstract

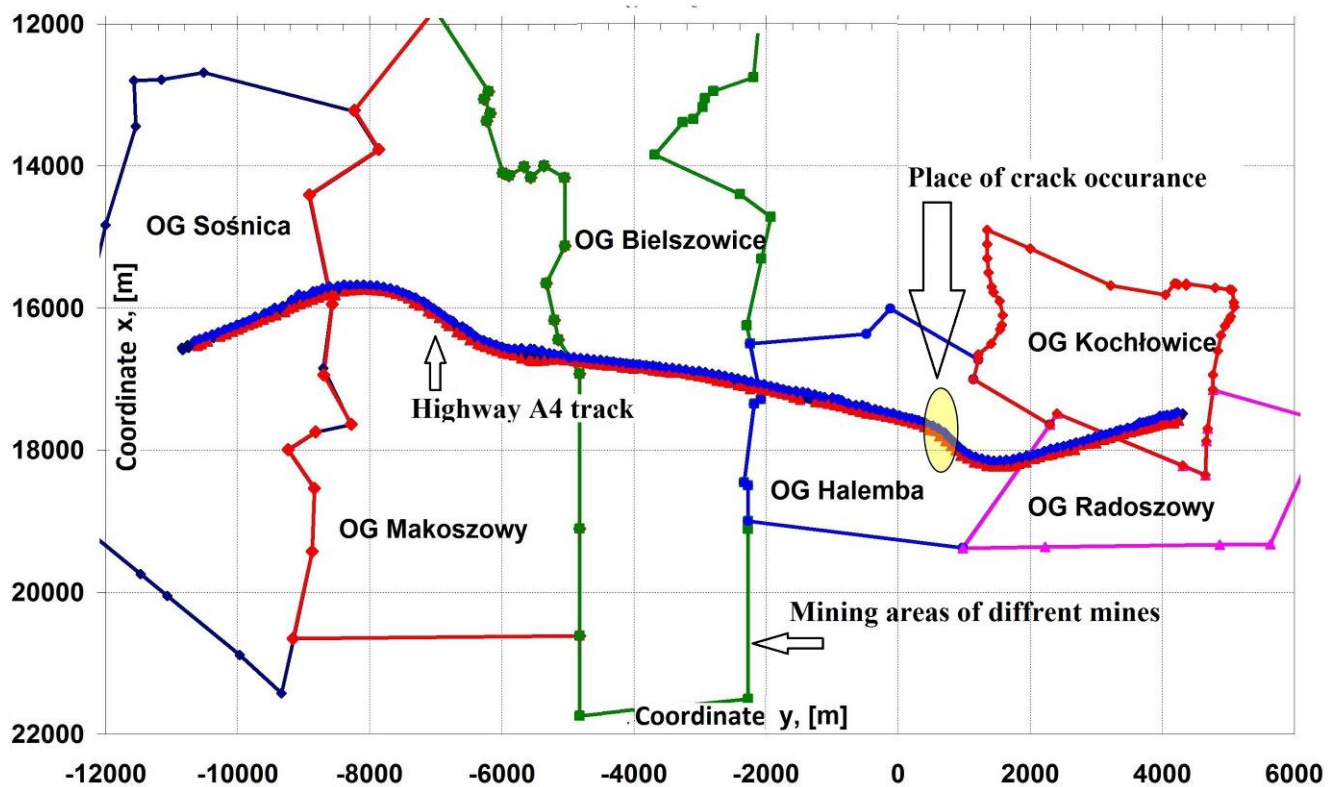
Considered section of the highway goes through the Silesia Region which has been and still is strictly connected with mining activities. The highway runs through several active coalmining areas (figure 2). Many years of mining extraction have left a significant influence on subsoil which is a base for highway construction. The subsoil become degraded by continuous and discontinuous ground deformation caused by mining activities. Discontinuous deformations occur, among others, as geological faults. There are about eight catalogued faults at the considered section. Two of them (number III and IV) are located near the place where the crack occurred.

Figure 2. The track of the A4 highway going through mining areas – section Gliwice - Chorzów

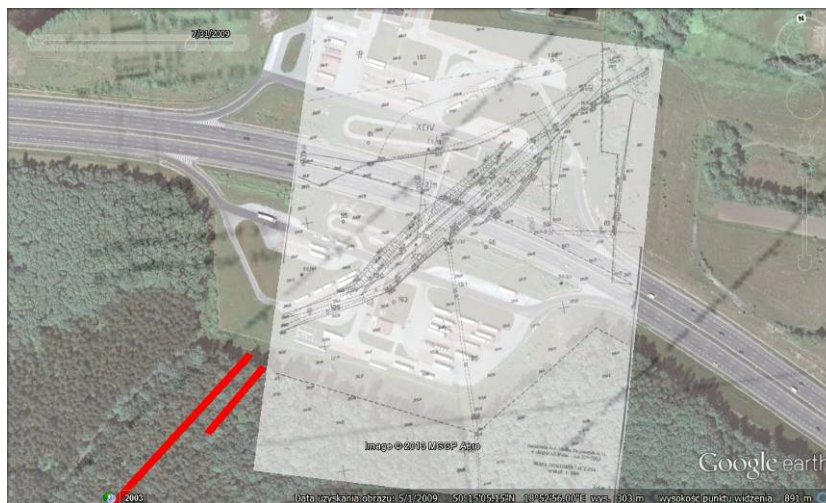
Landform in the area around highway, can confirm the hypothesis. Figures 14 and 15 were taken in 2012, and illustrated discontinuous deformations caused by mining activities.

Figure 16. The landform (figure 14,15) localization – red lines

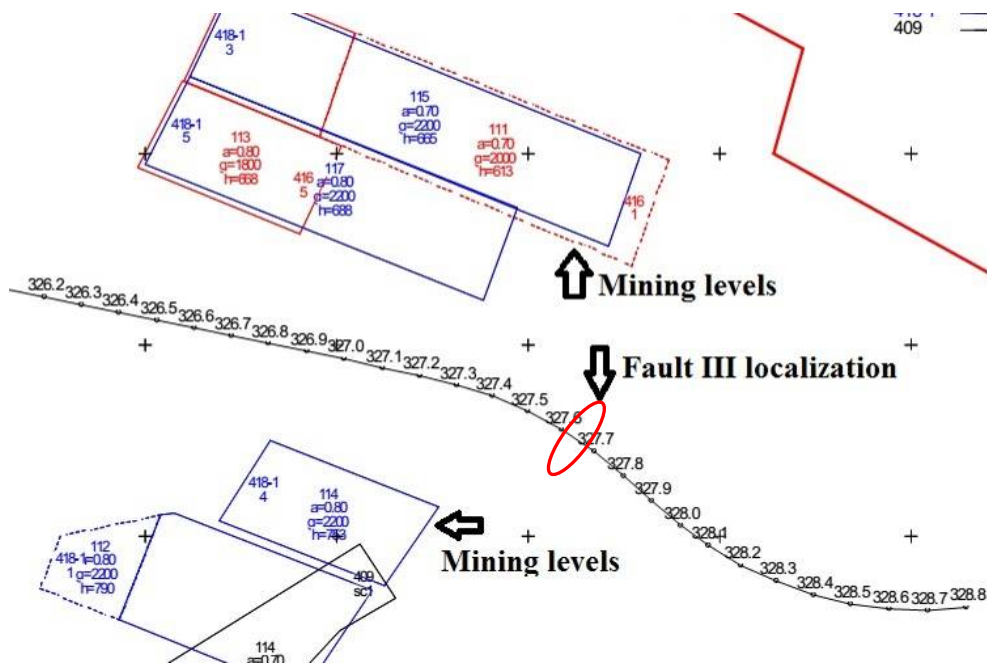
Figure 23. Mining levels predicted to exploited up to 2020.
