DEATHERAGE, J. D., BECKWITH, G. H. and HANSEN, L. A.

Sergent, Hauskins and Beckwith Consulting Geotechnical Engineers, USA

RESTORATION OF McMICKEN DAM

After being declared unsafe, and then breached, McMicken Dam was restored through the use of a geotextile-geomembrane cutoff and drainage system. Constructed in 1955, the 15 km-long flood control structure was breached in 1972, when extensive cracking was discovered. The use of a polypropylene-coated and uncoated woven geotextile lined rock-fill drain through the center of the existing structure proved the optimum economic solution. Design considerations required high-strength elastic geotextiles and geomembranes which could withstand future cracking, as well as intercept seepage through existing cracks during infrequent flood flow events. Tests were conducted in the laboratory to determine the ability of various materials to span a 25.4 mm simulated crack. McMicken Dam was restored to service after completion of construction in 1984. A total of 227,000 m² of polypropylene geomembrane and woven geotextile were used with a savings of over 1.5 million dollars from the next most economical alternative.

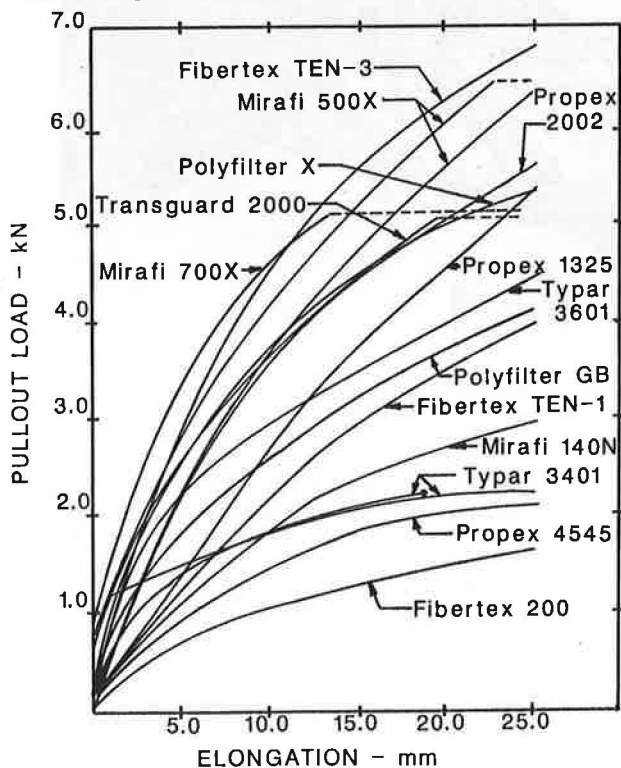
Figure 4: Pullout Test Results for Geotextiles with 34.5 kPa Surface Loading.

Results of pullout testing are presented in Table 2. The results of the pullout testing graphically determine which of the geotextiles will successfully bridge across a hypothetical 25.4 mm wide crack extending through the drain. The testing procedures modelled half of the crack, so a geotextile or geomembrane which elongated 25.4 mm in the test would successfully bridge a 50.8 mm crack in the dam. The 25.4 mm acceptance criteria yielded a factor of safety of 2 relative to failure, allowing for some loss of strength or elasticity with time.

Seven geotextiles were determined acceptable by pullout testing. These fabrics included Propex 1325, Polyfilter X, Fibertex Ten-1, Mirafi 140N, Mirafi 500X, Typar 3601 and Transguard 2000.

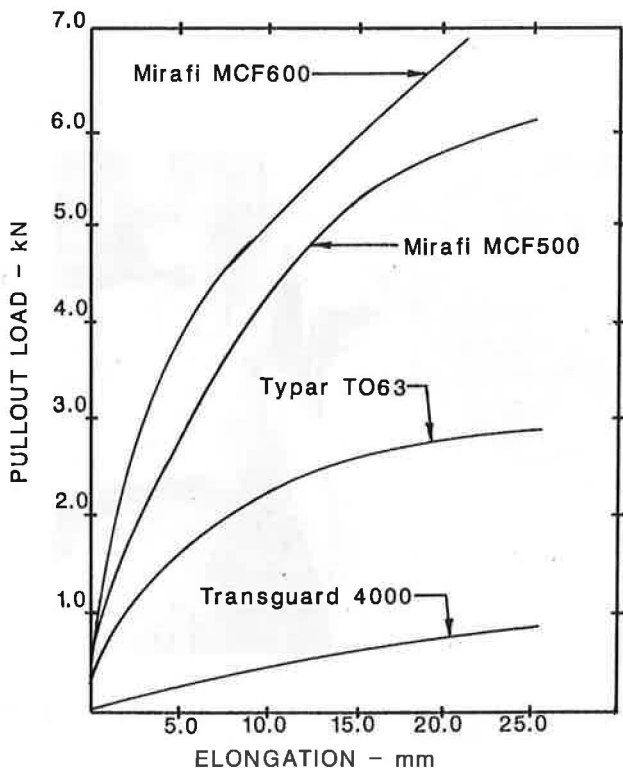
Figure 6: Pullout Test Results for Geomembranes with 34.5 kPa Surface Loading.

Of four geomembranes tested at 34.5 kPa surface loading, three successfully elongated 25.4 mm. These included Mirafi MCF600, Mirafi MCF500 and Typar T063. Subsequent testing at 69.0 kPa showed acceptable elongation in three of four geomembranes tested. Mirafi MCF500, Typar T063 and two new geomembranes, AMOCO C7305 and AMOCO P6838, were tested. The AMOCO P6838 continuously yielded from 20.5 mm to 30.5 mm prior to break, and was not acceptable. Therefore, three coated geotextiles were judged acceptable for use in the center drain, including Mirafi MCF-500, Typar T063 and AMOCO C7305.
