Long-term behavior of geodrain composites in landfill capping - results of exhumations

J. Müller-Rochholz

Z. Bronstein

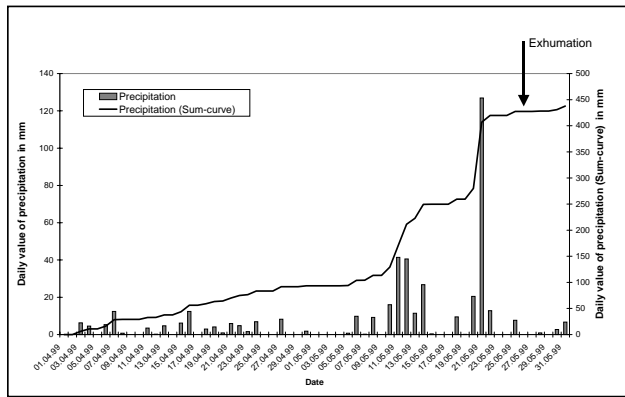
We exhumed this material short time after very heavy rainfall in that region (Fig. 7)

Fig. 7: Daily rain events and precipitation sum curve

and expected a waterfilled drain. We found some humidity in the nonwoven filter, but no signs of extreme flow. The drain composite was washed to find soil intrusion. The result is shown in Fig. 8, which shows some soil in the upper filter, no soil in the core, sometimes some clay from the underlying clay liner in the bottom geotextile.
