# Effects of large differential settlements on embankments on soft soils

E.M. Palmeira & A.R.S. Fahel  
*University of Brasilia, Brasilia, Brazil*

**ABSTRACT:** This paper presents the performances of four geosynthetic reinforcement abutments built on soft foundations. The embankments are part of highway developments in the north-east and south regions of Brazil. The first embankment is a geogrid reinforced bridge abutment constructed as part of the BR-101 highway-widening programme. In this case the new embankment was built with part of its width resting on the existing embankment. The other three reinforced embankments were built in the Linha Verde highway to allow the crossing of rivers in the region. One of these embankments was built on a concrete slab and on piles with caps, another on a group of piles with caps and the last one directly on a top sand layer overlying a compressible clay layer. The designers of these works heavily reinforced the abutment, but little concern was put on the effects of differential settlements caused by foundation consolidation and erosion. This paper shows that, in spite of the large deformations imposed to the structures, the overall performa

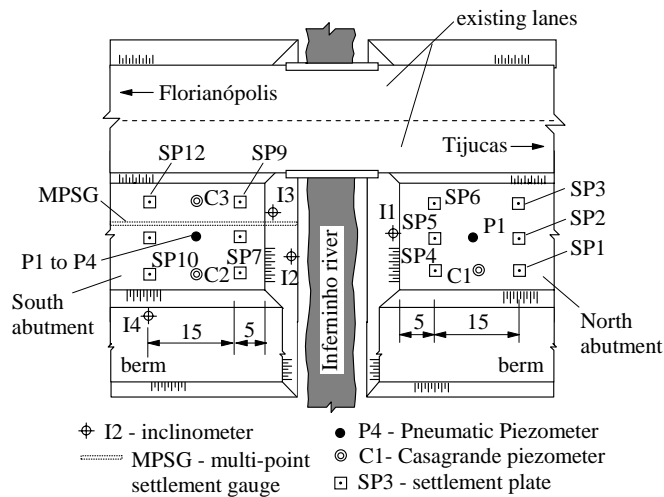
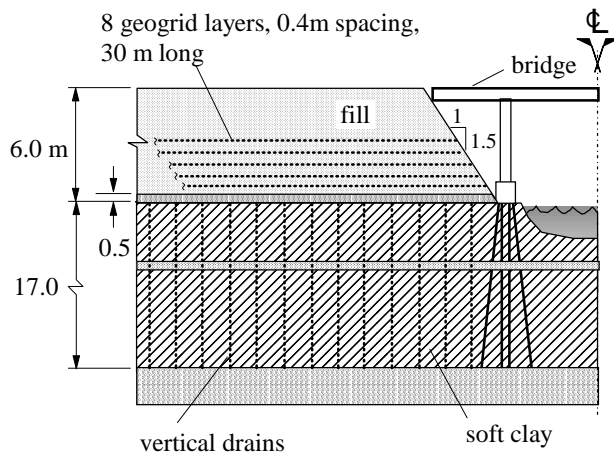
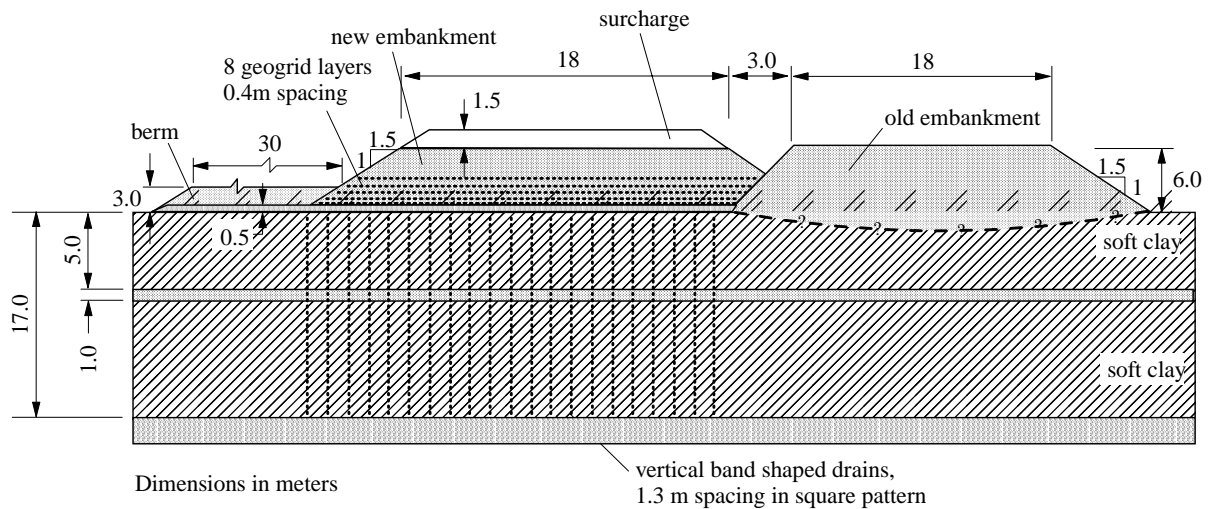
Figure 2. Characteristics of the reinforced embankment of Case History 1.

Case history 1 is a reinforced abutment built as part of the programme of duplication of the BR-101 highway, in Santa Catarina, Brazil. The abutment provides access to a bridge over the river Inferinho. The reinforced embankment final height is equal to 6.0 m, but during construction an additional 1.5 m high fill surcharge was installed to act in combination with vertical band shaped drains to accelerate consolidation settlements (Fig. 2 a to c). The vertical drains (100 x 5 mm) were spaced 1.3 m and installed along a length of 30 m from the embankment toe. The vertical drainage system was designed so as to provide 80% consolidation in a period of 8 months. Part of the new embankment rests on the side slope of the existing embankment and an excavation of the berm of the latter was made before the construction of the new embankment. Eight layers of geogrid reinforcement spaced 0.4 m were installed in the embankment base. A 30 m wide berm was also prescribed by the designers for the stabilisation of the side slope of the new embankment. The need for this berm can only be explained by the smaller reinforcement strength along the embankment transversal direction, as described below. However, the berm might have been avoided (or shortened) had the strongest reinforcement direction been also orientated along the embankment transversal direction or biaxial grids or geotextiles had been used.

The fill material used in Case History 1 was a coarse sand with a unit weight of  $15.5 \text{ kN/m}^3$  and a friction angle of  $33^\circ$ , determined by direct shear test. The foundation soil in the site is a 12 to 17 m deep soft clay deposit with the presence of sand layers (Fig. 2 a). The undrained strength obtained from CPTU and vane tests varied between 20 and 40 kPa.

The instrumentation of the embankment consisted of Casagrande and pneumatic piezometers, settlement plates, inclinometers, magnetic extensometers, a full profile settlement gauge and geogrid strain measurement devices (Fig. 2a).

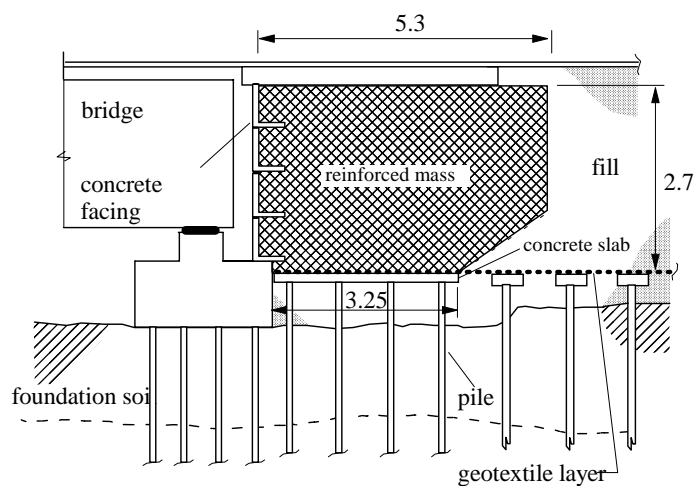
Figure 3. Cross-section of the reinforced abutment of Case

The reinforced abutment in Case History 2 was not affected by foundation settlements because most of the reinforced mass rested on a piled slab (Fig. 3). However, significant damage was caused to one of the lateral wall faces because of erosion of the fill material underneath the rear part of the reinforced mass, as shown in Figure 9. A river flood caused the removal of the soil below the base of the reinforced mass adjacent to the concrete slab, causing a severe differential settlement in that region and the collapse of some facing units. In spite of the large distortion of the reinforced mass, only some rather minor repairs were needed along the pavement surface. This behaviour of the geosynthetic reinforced mass emphasises the benefits of having a flexible retaining structure in this type of work, capable of accommodating large settlements with relatively minor damages.

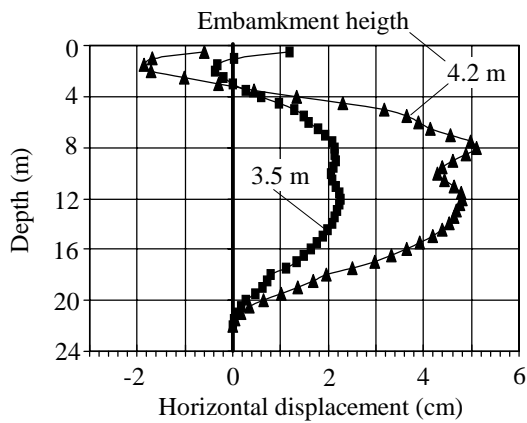
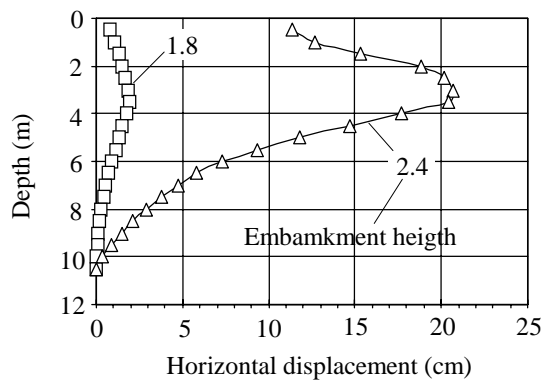
Figure 7. Horizontal displacements in Case History 1.

The presence of the geogrid reinforcement had an important effect in reducing horizontal displacements of the foundation soil. This can be visualised in the results obtained by the inclinometers I3 and I4 (Fig. 2 a) shown in Figures 7 (a) and (b). The foundation soil movements were smaller along the embankment longitudinal direction even with a steeper slope close to the river, no berm and the proximity to the river channel. This direction coincides with the orientation of the reinforcement having greatest tensile strength and stiffness. In spite of the presence of the 30 m wide berm the displacements along the embankment transversal direction (weaker reinforcement direction) were rather large. This results suggest that the use of the berm might have been avoided with an appropriate reinforcement of the embankment transversal direction.

(a) Inclinator I3 – Displacements towards the north direction.

(b) Inclinator I4 – Displacements towards the east direction.
