# LANDSLIDE AT THE JAKUSEVEC LANDFILL

A. Vukelic

Civil Engineering Institute of Croatia, Zagreb, Croatia

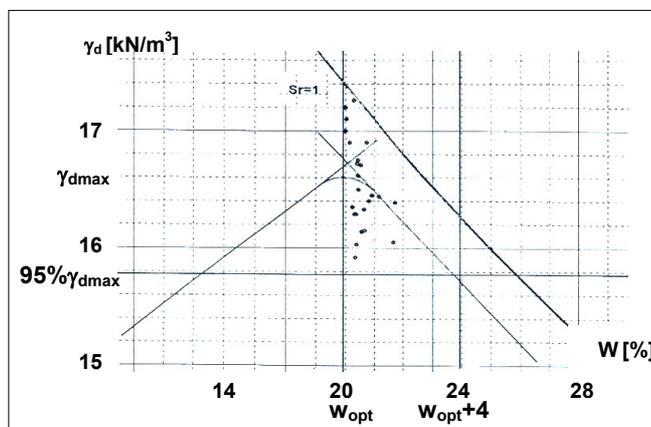
Figure 4. Compaction curve with bottom liner clay control test results

Control test results and clay compaction curve indicate that the moisture content of placed clay is within limits from  $w_{opt}$  to  $w_{opt}+4\%$ , as shown in Figure 4. It must be kept in mind, that the shearing resistance and soil permeability are extremely sensitive to the compaction conditions (Mitchell et al., 1990). Although the design specification could be made according to the methodology proposed by Daniel and Benson (1990), stringent control of some parameters (compactive effort, molding moisture content) should be done during construction to achieve the desired goal.

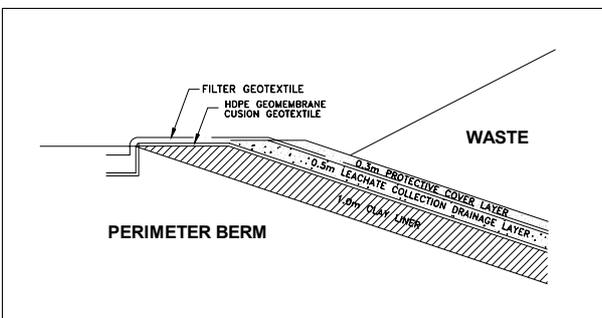
Figure 9. Perimeter berm detail constructed as designed

The detail of the perimeter berm constructed in accordance with the design is shown in Figure 9, whereas material deformations in the central zone of the slide are shown on the perimeter berm detail in Figure 10. Maximum horizontal waste displacement in the central slide zone is approx. 8 m.

It was noticed by visual inspection at the bottom edge of the slide (perimeter berm crest) that the slide has developed at the interface between the clay liner and the berm.

In this section the geomembrane is deformed along with the drainage gravel, and filter and protective geotextile (Fig. 10). Furthermore, it has been assumed that the slip plane has affected the clay liner right underneath the geomembrane, except at the top of the perimeter berm (Fig. 10) where the slip plane has also affected the soil underneath the clay liner.

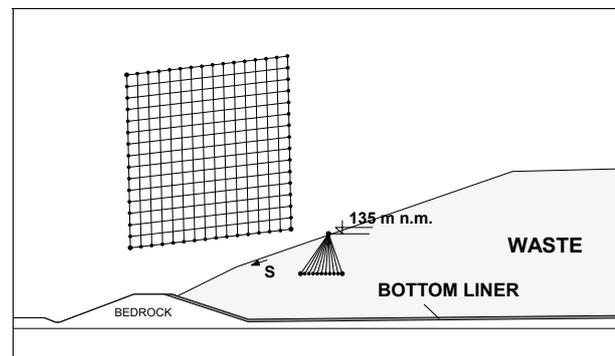
Figure 12. General model used in back analyses

In order to determine possible causes of the slide, a series of back analyses was carried out subsequently using SLOPE/W program and Spencer's method. General model used in calculations is shown in Figure 12.

By selecting material parameters in accordance with Chapter 4.1 (waste -  $c=19 \text{ kN/m}^2$  and  $\phi=24^\circ$ , bottom liner -  $c=0 \text{ kN/m}^2$ ,  $\phi=12^\circ$ ), the obtained safety factor is  $FS=1.78$ . Input parameters (shear strength of materials) had to be reduced or additional external load applied in order to obtain safety factors approximately equal to 1.0 by back analyses for the purpose of establishing what may have caused the slide.
