Trial construction of the reinforced river dike and its performance

K. Sawada, A. Yashima, Y. Sato & Y. Fujita
Gifu University, Gifu, Japan

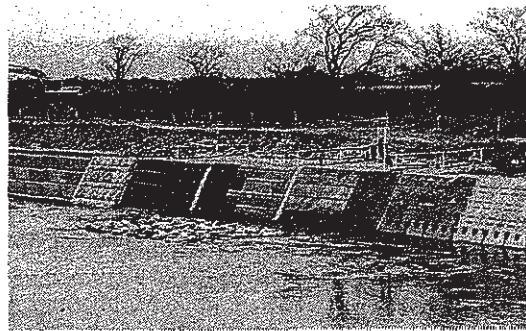
Figure 2. View of the tested river dike.

Figure 2 shows the overall view of the tested river. The river dike is embanked with 1.1 m in depth in Sections A and B and 1.5 m in Section C. The lengths of geo-grid are arranged in the same as the embanked depths in Sections A, B and C. The back-filled materials of the dike are sand above water lever and gravel beneath the water level. The tensile strength of the geo-grid is about 35 kPa. There is a metallic cover grid on the dike slope, taking a L-shaped structure whose gradient is the same as the

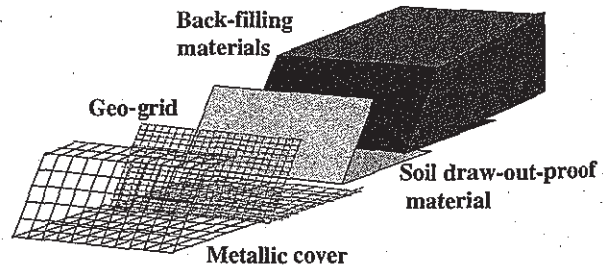
Figure 3. Construction of river dike embankment.

dike, that is, 2:1, as shown in Figure 3. Figure 3 shows the metallic cover, the geo-grid, the soil draw-out-proof material and the back-filling materials. In order to investigate the effectiveness of the coating used for the metallic cover, two kinds of coating, that is, electronic coating and PE (Polyethylene) coating are used. Because the main attention is paid to the deformation of the dike, various measuring instruments are installed to measure the deformation of the surface of the dike and the failure mechanism of the reinforced soil dike. Figure 4 shows the outlet of the measuring instruments and the dike composition.

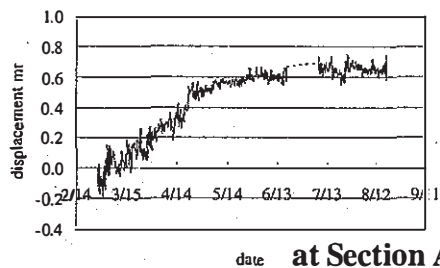
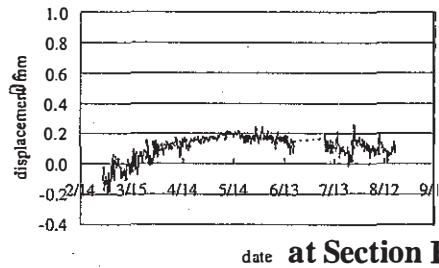
Displacement of the river dike

From the observation, it is found that the deformation mainly occurred during the first three months, that is, from February to May.

After May, no remarkable deformation was observed. The deformation is considered to be the compression of the dike itself. As will be discussed later, the self-compression of the dike was finished around in September when the dike was fully immersed in water because of the flood caused by the heavy rain. The dike itself, however, did not fail anymore.
