# Geosynthetic reinforcement in distressed canal embankment in Gujarat, India : a case study

Vivek P. Kapadia

Water Resources Department, Government of Gujarat, India

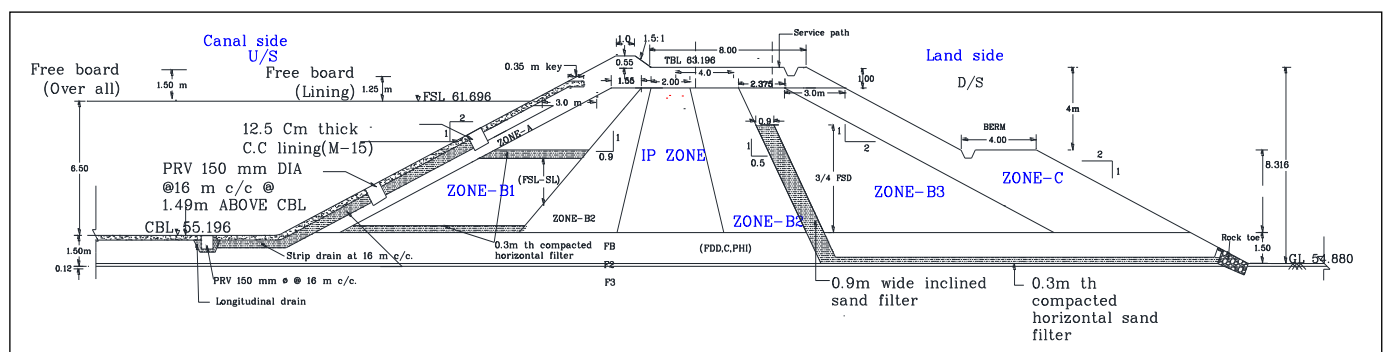
Figure 2. Designed section of canal embankment

The embankment design had been done according to the standard procedure laid down in IS-7894 (or IS 8826: 1978). For the stability of the canal side slope for the sudden draw-down condition, only 50% of the original undrained head of water has been considered for pore-pressures. This is on consideration that the lining is effectively impervious and that the horizontal filter blankets and the strip drains as well as Pressure Release Valves (PRVs) are adequately functional. As this is not the case now in most of the situations, because the lining gets damaged due to various reasons and allows leakage, it would be advisable to check the slope stability considering full 100% pore pressures in the sudden draw-down condition. Of course, the breach in the present case cannot be attributed to this aspect as the canal had been flowing only partially and no sudden draw-down condition had been created. Zoned embankment designed to suit the codal provisions, design practices and material availability is shown in Figure 2.

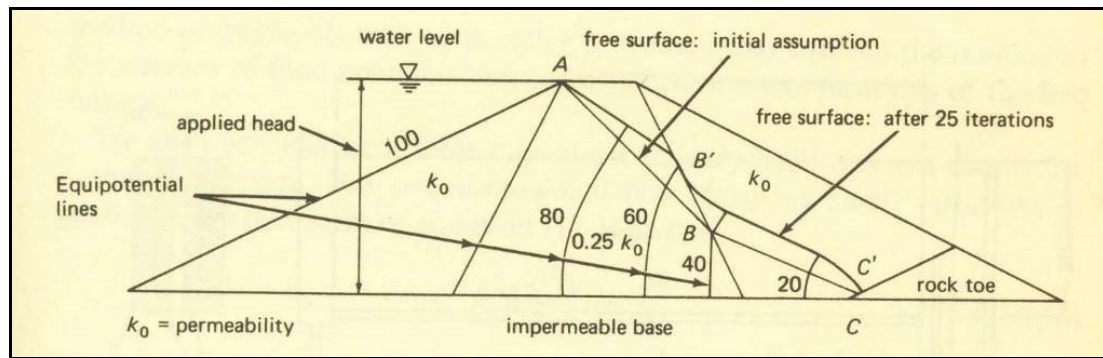
figure 3. Steady unconfined seepage problem

The behaviour of the embankment narrated above was tried to be understood by Finite Element Analysis of the as built section. Properties were obtained during investigation as time was sufficient (failures started taking place in 2005) and size of the problem was large enough to find it worth to make detailed study and come to proper conclusions. Slip circle modelling can not be taken as a reliable way in a problem in which stratification of soil is there and variations in density and material are many and therefore Finite Element modelling as steady unconfined seepage type problem was done using four noded element in the self developed program. Steady unconfined seepage problem is shown in Figure 3. This type of problem is characterized by unique free surface, which does involve variations with time. The analysis suggested that the embankment with as built section property was unstable with the designed head in the canal. Continuous horizontal crack in the concrete lining was a sign of shear failure of concrete due to subsidence of soil mass behind it. Crumbling of soil behind the lining was due to presence of poorly compacted soil, which settled due to its own weight at certain depth within the embankment, which was observed during the investigation.

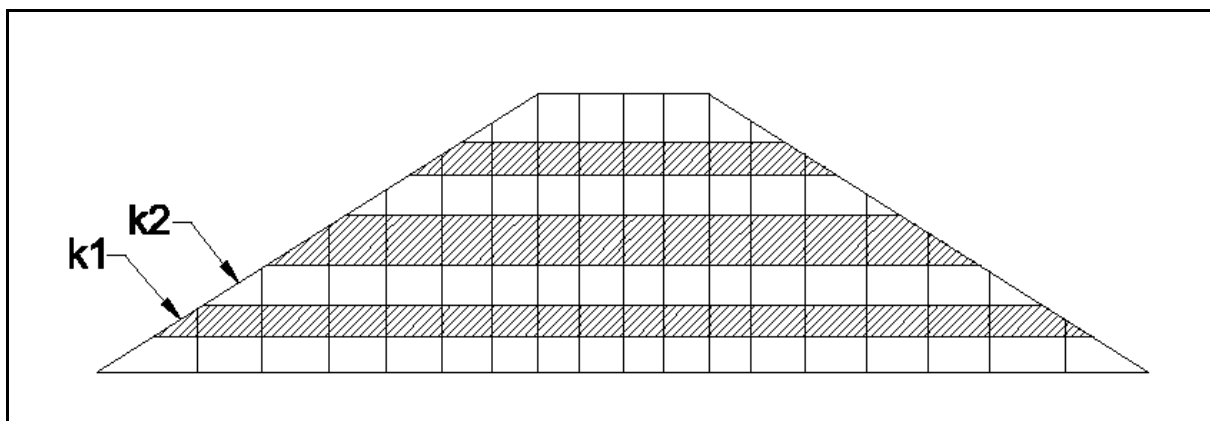
Figure 4 Conceptual modeling of stratified embankment

If there is zoned embankment, modelling as per Figure 3 is valid but in this case, there was no zoning but stratified layers were to be modelled and therefore conceptual mesh generation as shown in Figure 4 was followed. The actual mesh was much finer but conceptual basis with two different permeability values alternately varying vertically was adopted to go close to the reality.
