# Rapid restoration for a seriously damaged railway embankment during violent earthquakes

Kitamoto, Y. & Abe, H.

Keywords: geosynthetic, construction, railway, earthfill, reinforced soil

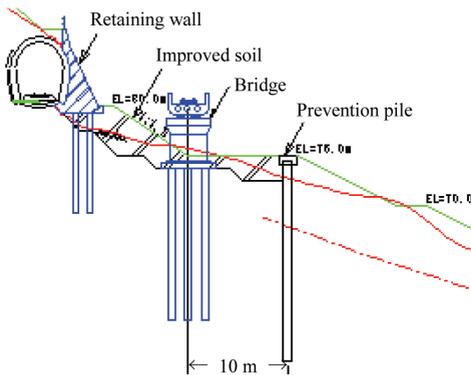
Figure 2. Remedial plan with bridge.

Colluvium fell from the track of the down line and was deposited on the slope about 70 to 80 m long and 50 m wide. Slope failures occurred continually in the vicinity of the restoration site, which endangered approaching from the riverside. In view of the seriousness of the damage, failure-restraining structures with piles or bridge construction was originally considered to provide resistance to earthquakes and precipitation (Fig. 2). However, it takes approximately six months to build such structures. As restoring the railways, a means of mass transit, was considered to be in the public's interest, early resumption of operation and guarantee of safety were defined as fundamental goals. It was then decided

The damaged site was on a steep slope, and bringing in large heavy equipment such as pile drivers would require large-scale temporary work such as building a platform and acquiring piles, which was also difficult. Therefore, a method to restore the embankment to the level of the track was finally selected. A plan to remove all the colluvium and construct the embankment at the designated stable gradient would likely require embankment material of more than  $10,000 \text{ m}^3$  and a construction period of more than two months. In order to reduce the volume of embankment material, which would have a great impact on the construction period, the RRR method was adopted (Fig. 3).

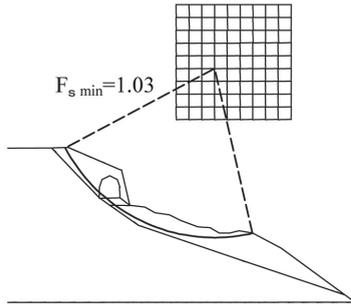
Figure 4. Result by reverse analysis.

Based on the soil boring logs at the damaged site, steep hill deposits lay around the up-line tunnel. The soil was estimated to have an  $N$ -value of 25 to 30 and the internal friction angle  $\phi$  was set at  $35^\circ$  according to the formula  $\sqrt{15N + 15}$ , where specific weight was set at  $\gamma = 18 \text{ kN/m}^3$ . The thickness of slid clod was approximately 5 m and cohesion  $c$  was then assumed to be  $5 \text{ kN/m}^2$ . For the down-line section, reverse analysis was carried out for the ground shape after slip failure under the condition of a safety factor of 1 (Fig. 4). As a result, the internal friction angle of colluvium on the down-line section was set at  $20^\circ$ . (Cohesion  $c$  was also set at  $5 \text{ kN/m}^2$ ).

By introducing ground anchors with a strength of  $150 \text{ kN/m}$  on both the upper and lower levels of the tunnel to repair the up-line section, a minimum safety factor of 1.31 was obtained in the cross section shown in Fig. 3; that is, a normally required safety factor of 1.2 was secured.
