# The effects of large scale earthquakes on EPS structures

Masuo, T. & Hara, K.

Civil Engineering Products Division Taiyokogyo corporation (SUN)

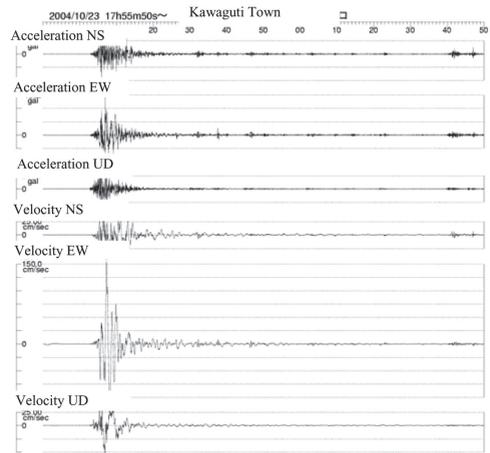
Figure 2. Seismic wave at Kawaguti town.

The M6.8 size Mid-Niigata Earthquake arose in mountain area of Niigata prefecture 17:56 23 Oct. 2004. Maximum 1500 Gal and over 150 Kine seismic wave motion was recorded at Kawaguti town near the epicenter. Afterquakes of JMA Seismic Intensity Scale 6 and over arose several times. Other than many people suffered from this earthquake, many buildings and civil engineering structures were collapsed and it caused severe damage on lifelines.

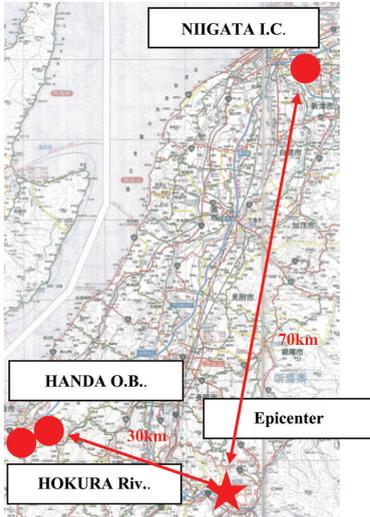
Figure 3. Locations for survey.

Figure 3 shows locations where surveys were made. Since those locations are rather distant from the epicenter, the aim of the surveys were to check if there were any direct damage caused by the earthquake.

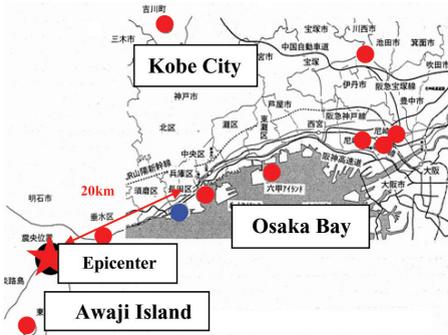
Figure 5. Location of survey for Southern Hyogo Earthquake.

Since the damage caused were wide spread, survey was made for 10 locations as shown in Fig. 5. The results show no direct damage on any EPS embankments by the earthquake. Only slight EPS displacement caused by the settlement of foundation itself was found for one location. Port structure and

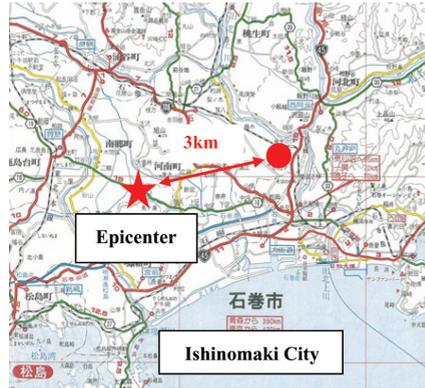
Figure 7. Location of survey for Miyagi Earthquake.

As survey results show, no damage caused by the earthquake was found on EPS embankment itself, wall structure, and foundation. Stability of those EPS embankments studied by seismic response analysis at their design were confirmed.
