# Damage performance of steel-reinforced earth structures in the 1995 Hyogoken-Nambu Earthquake

Yoshinori Otani & Makoto Mega  
Hirose & Co., Ltd, Tokyo, Japan

Tamotsu Matsui  
Osaka University, Japan

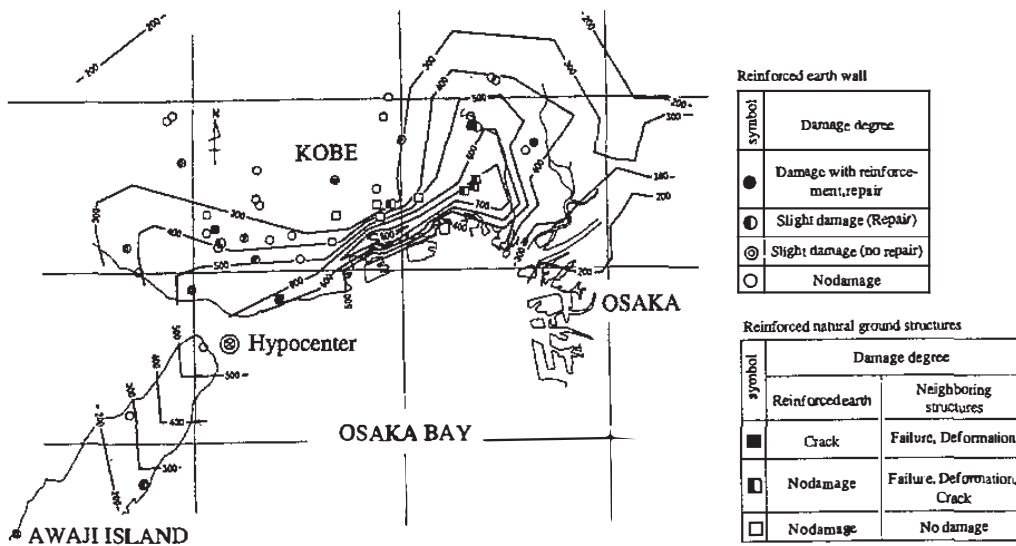
Figure 2 Investigated locations with damage degree of reinforced earth structures on a map displaying contour lines of maximum horizontal acceleration

visually investigated, and their damage is ranked. Figure 2 shows the investigated locations with damage degree of reinforced earth structures on contour map of maximum horizontal acceleration of the earthquake. According to the investigation, no complete collapse or destruction in either reinforced earth walls or reinforced natural ground structures with root piles. However, some examples of minor damage and deformation were observed, which might characterize the general performance of reinforced earth structures during earthquake.

As shown in Figure 2, all sites where neighboring structures around reinforced natural ground structures were damaged were located within area of maximum horizontal acceleration greater than 300 gal. Four sites among them are greater than 700 gal. The reinforced natural ground structures investigated, however, has slightly damaged. In two case histories, only slight damage of cracks was observed in the reinforced natural ground structures of Type B (see Figure 1), which were located on inclined ground experienced by maximum horizontal acceleration as high as 500 gal (see Figure 2). In these two sites, unreinforced natural ground structures, which were significantly damaged, are available adjacent to reinforced natural ground structures. This will make the comparison of damage between unreinforced and reinforced natural ground structures. These examples are described in detail below.

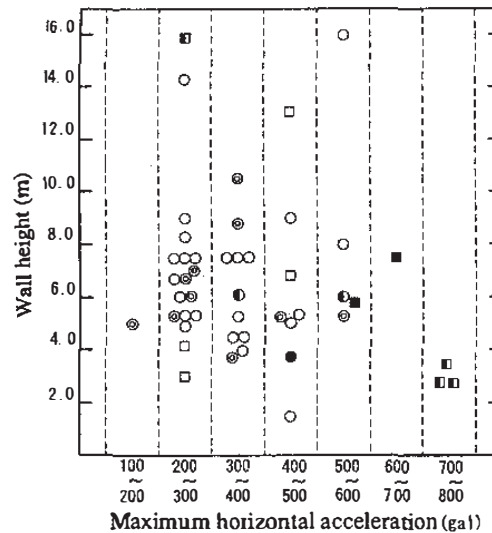
Figure 3 Relationship between wall height and estimated maximum horizontal acceleration as related to damage degree (same symbols as used in Figure 2)

Figure 3 shows the relationship between wall height of reinforced earth structures and estimated maximum horizontal acceleration at each investigated site, together with their damage degree. The height of reinforced earth structures ranges from 1.5m to 16.0m, and the average is around 6m. The damage degree tends to be moderately higher, as increasing the maximum horizontal acceleration. However, in the region of similar maximum acceleration, higher structures do not necessarily suffer more extensive damage. Structures required some repair (five cases marked by ●, ⊙, and ■) are located within area of maximum horizontal acceleration of greater than 300 gal and their wall heights are lower than 8m. In other words, there is no trend that the damage of structures becomes more severe, as increasing wall height and maximum acceleration. It is difficult to generalize the seismic performance of reinforced earth structures, because the ground motion at each site is not available and the topography and geological and geotechnical properties differ at each site. Therefore, seismic performance of reinforced earth structures are estimated based on their damage condition of wall surface and surrounding ground. The reinforced earth structures investigated have shotcrete wall, thin RC plate or a combination of concrete panels, which makes comparatively flexible wall structures. No overall cracks were found in these concrete wall surfaces after the earthquake, suggesting that the reinforcements absorbed a significant earth pressure acting on walls during earthquake with no meaningful damage, such as failure and overturning of walls. However, the wall surfaces deform following deformation of whole reinforced earth and, in consequence, this could result in damage to joints between wall elements and between adjacent structures.

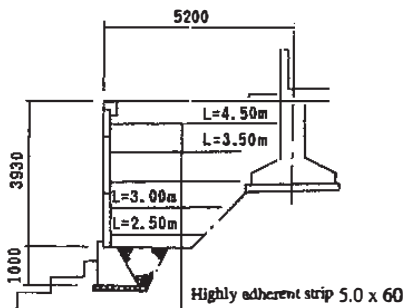
Figure 7 Cross section of Case history 3

Four cases of reinforced earth structures were selected for examination herein; that is, Case histories 3 and 4 as shown in Figures 7 and 8 respectively and Sections ① and ② in the reinforced natural ground structure in Case history 1 as shown in Figure 5. The seismic integrity of reinforced earth walls and reinforced natural ground structures was evaluated using Equations (1) and (2), and Equations (3) and (4) respectively, using horizontal seismic coefficient  $k_h$ .

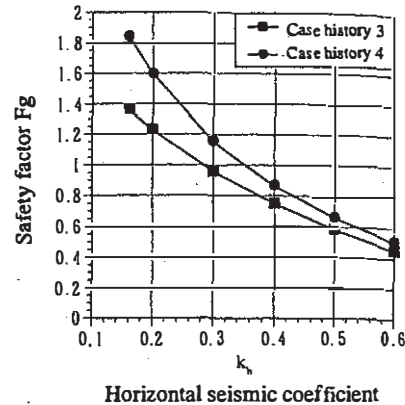
Figure 9 Relationship between safety factor and horizontal seismic coefficient in the reinforced earth structures

In all reinforced earth structures, the safety factor due to failure mode of pull-out was smaller than that of rupture, and the tensile force of reinforcement was calculated by the pull-out resistance of reinforcement. Figures 9 and 10 show the relation between the horizontal seismic coefficient  $k_h$  for design and the safety factor  $F_g$  to minimum pull-out resistance of reinforcement for reinforced earth wall and reinforced natural ground structure respectively. It is seen in these figures that the safety factor  $F_g$  decreases as increasing horizontal seismic coefficient, and becomes less than 1.0 for the range of  $k_h \approx 0.3$  (0.24 to 0.35). A comparison between Case histories 3 and 4 of the reinforced earth wall and between Section ① and ② of Case history 1 of reinforced natural ground structure revealed that a lower safety factor was obtained in more severely damaged structure in both types of structures. Considering the seismic performance of these reinforced earth structures, the horizontal seismic coefficient of about 0.3 in the seismic coefficient method corresponds to the estimated maximum horizontal acceleration of about 500 to 600 gal.
