A debris flow induced by the collapse of a reinforced earth wall

ABSTRACT: A reinforced earth wall (MSEW) was constructed at the edge of a tableland to establish a site for dumping abandoned soil. The site was also located on the top of a valley that has a mean slope of 18° and a length of approximate 400 m. The wall was 14.5 m high, 50 m long, and with a slope face of 70° . In the fall of 1998, a heavy storm caused the wall collapsed suddenly. Then the water blended with soil mass rushed down along the valley and formed into a debris flow that ruined a two-story house downstream and buried two people in the house. To investigate the cause of this disaster and the mechanism of the failure, a series of tests and stability analysis were conducted. The results of the analysis show that there are three factors that possibly triggered or resulted in the failure of the wall: poor compaction during construction, the heavy storm dropped more than 590 mm of rainfall in 48 hours, and the adverse effect of dumped soil piled up on the top of the wall. Hence, even the wall could maintain its stability from the design point of view, the failure still occurred because adverse conditions were not

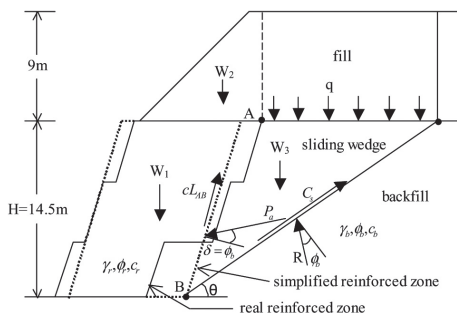
Figure 4. The free body diagram used for external stability analysis.

overturning, and bearing capacity. Figure 4 is the free body diagram used in these analyses) and internal stability (check for tensile and pull-out failure of the reinforcement, soil-geogrid interface sliding, and internal circular sliding) under ordinary and heavy rainfall conditions with a surcharge from the dumped soil. PCSTABL (version 6H), a computer program developed by Purdue University, which was written in FORTRAN and uses limiting equilibrium methods for the general solution of two-dimensional slope stability problems, was used for the circular sliding and interface sliding analyses of the wall.
