# Evaluation of an airport pavement after almost 8 years of overlay rehabilitation with a polyester geogrid asphalt reinforcement

Keywords: polyester geogrid, asphalt reinforcement, overlay rehabilitation

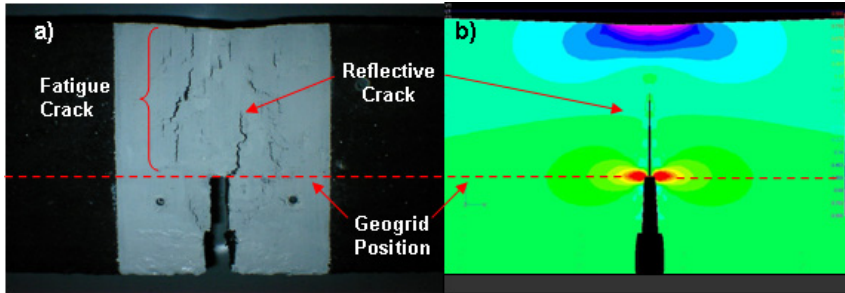
Figure 1 presents a comparison of the loaded beam at laboratory and the respective numerical simulation graphic on a similar stage. The numerical simulation allowed a better understanding of the crack propagation mechanism observed in laboratory. Geogrid, as an asphalt concrete reinforcement,

Figure 1. Comparison between the laboratory and the numerical simulation results (Montestruque 2004).

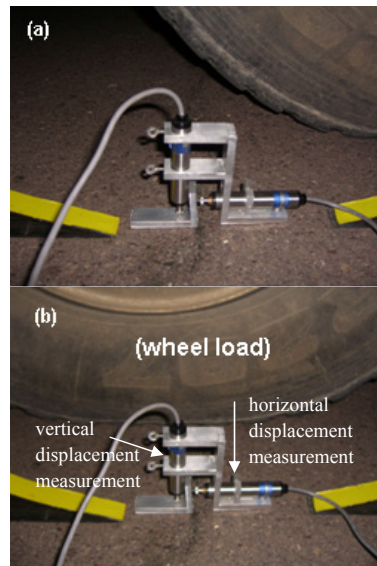
With the objective of evaluating the potential for crack reflection after a new rehabilitation work, measurement of vertical and horizontal relative movements of the crack walls against each others, was done by using an special device for that purpose, called “Crack Activity Meter” (Figure 4)

Figure 4. Crack Activity Meter and load position: (a) shearing mode, (b) bending mode.

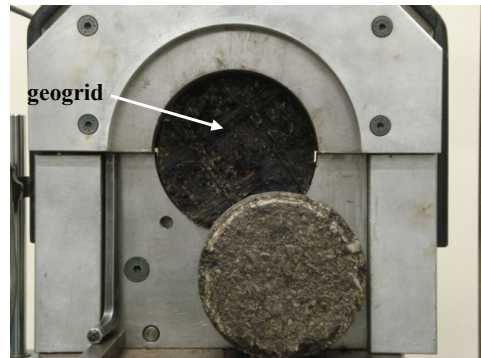
Figure 10. Front view of the equipment for direct shear test (interface adherence).
