## Failure mechanism of a geogrid reinforced abutment on soft soil

A.R.S. FAHEL, University of Brasilia, Brazil  
 E.M. PALMEIRA, University of Brasilia, Brazil

**ABSTRACT:** Geosynthetics can be effectively used to reinforce embankments on soft soils. However, some times basic conditions to be fulfilled for a satisfactory performance of the reinforced structure may be overlooked. This paper describes a case-history where the lack of observation of some basic concepts for this type of work almost yielded to a catastrophic failure of a reinforced abutment on soft clay. The main reasons for that were bad construction practice and insufficient design considerations. Even under these circumstances, the presence of the reinforcement layer minimised the consequences of the failure mechanism developed and showed the influence of reinforcement tensile stiffness on the reduction of the horizontal displacements of the embankment.

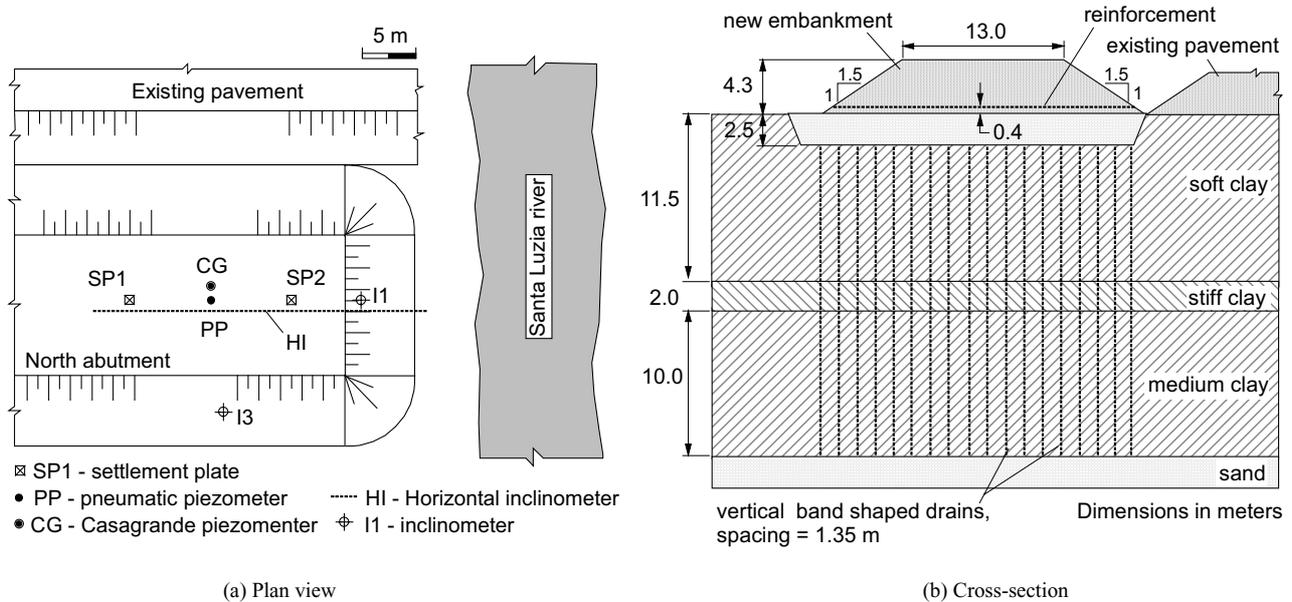
Figure 2. Geometrical characteristics of the reinforced abutment.

The project involved the construction of a new embankment, 4.3 m high, adjacent to the existing embankment, as part of the duplication of the highway. Figures 2 (a) and (b) show the proposed initial geometrical characteristics of the project, with respect to the north abutment, the one considered in this paper. The first 2.5 m depth of the soft soil below the new embankment was substituted by compacted fill material because of the very low shear strengths of the foundation soil at its surface. The inclination of the embankment slopes with the horizontal direction were 1.5:1 (H:V).

To reinforce the embankment, the designers prescribed the installation of a single layer of an uniaxial geogrid reinforcement along its base, 0.4 m above the original foundation surface. The geogrid used is made of polyester fibres protected by a polypropylene cover. The tensile strength of the reinforcement along its longitudinal direction (coincident with the embankment axis) was equal to  $200 \text{ kN/m}$  and along its transversal direction (normal to the embankment axis) was equal to  $15 \text{ kN/m}$ . As will be seen later in this work, this difference in tensile strengths and lack of proper consideration on this in the design played a major role in the embankment failure.

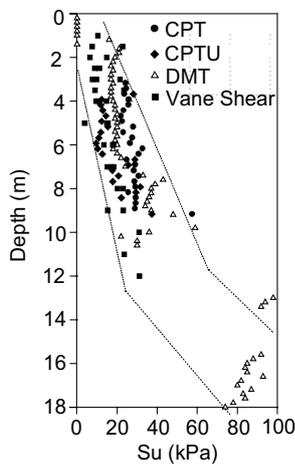
Figure 3. Undrained strength of the soft soil foundation versus depth.

The embankment rests on a 23.5m thick clay foundation. The upper half of the foundation soil is composed of a soft clay layer with undrained strengths ranging from 5 to 40 kPa. The lower half of the foundation soil is composed of stronger and stiffer clay layers. Figure 3 presents the variation of undrained shear strength of the foundation soil with depth, obtained from different types of in-situ tests, such as cone penetration tests (CPT and CPTU) and vane shear tests. A rather large scatter of undrained strength values with depth can be observed in Figure 3, as is common in this type of soil deposit.
