FAILURE OF A REINFORCED EMBANKMENT ON AN EXTREMELY SOFT PEAT CLAY LAYER

Marcio de Souza S. Almeida,¹ Maria Esther S. Marques,² Bruno T. Lima¹ & Felipe Alves¹¹ COPPE-UFRJ (e-mail: almeida@coc.ufrj.br).² Military Engineering Institute.

Abstract: A case study of the failure of a reinforced embankment on soft clay is back analysed. The site consists of an 11 m thick very soft clay deposit. Measured (uncorrected) vane strengths vary in the range of 2 kPa on the ground surface to 20 kPa at 10m depth. The top 3m peat clay layer with water content as high as 900% showed some erratic high strength values due to the presence of fibres which misled the measured vane strength. The water content decreased rapidly with depth, displaying values of around 100% for the depth range from 3 to 6m, and around 50% for greater depths.

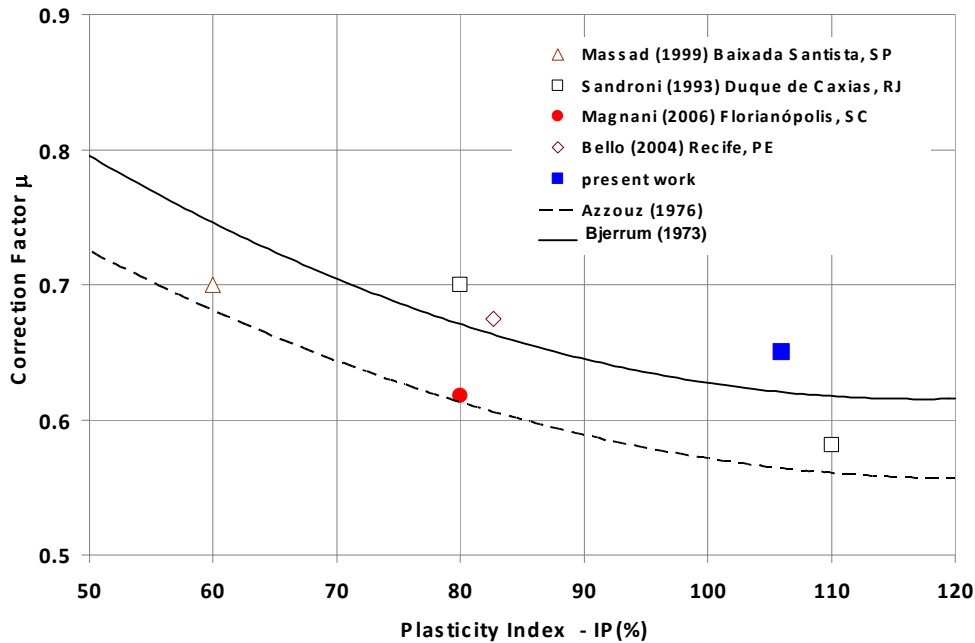
Figure 10. Vane correction versus plasticity index: present work and Brazilian case histories.

Figure 10 shows vane correction factors including the present work of 2-D failure (using the design value $\mu = 0.65$), and a number of Brazilian case histories. The relevant plasticity index to be used here is $I_p = 106\%$, the average value at the depth of the slip surface. It is observed that $\mu = 0.65$, following the Brazilian practice (Sandroni, 2006), appears to be quite acceptable.
